DOT/FAA/AR-xx/xx

Federal Aviation Administration
William J. Hughes Technical Center
Aviation Research Division
Atlantic City International Airport
New Jersey 08405

Annex C to Task A17: Airborne Collision Severity Evaluation – Engine Ingest Test Report

Final Report

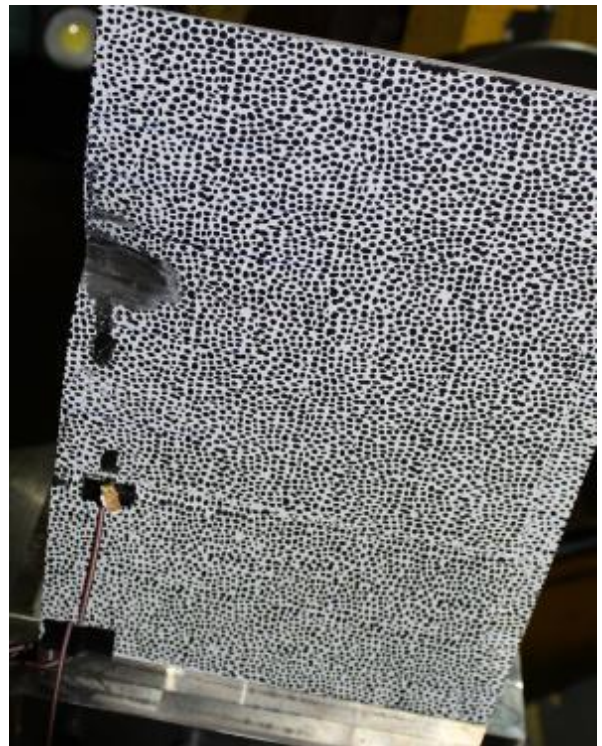
| Test Results Summary | Plastic deformation in blade leading edge without loss of material |

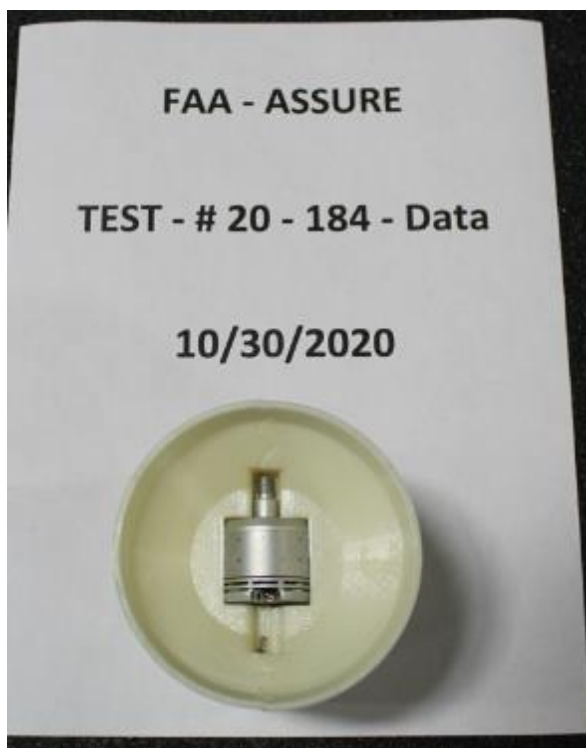
3.1.2.2. Test M50L5-005

| Test Results Summary | Plastic deformation in blade leading edge without loss of material |

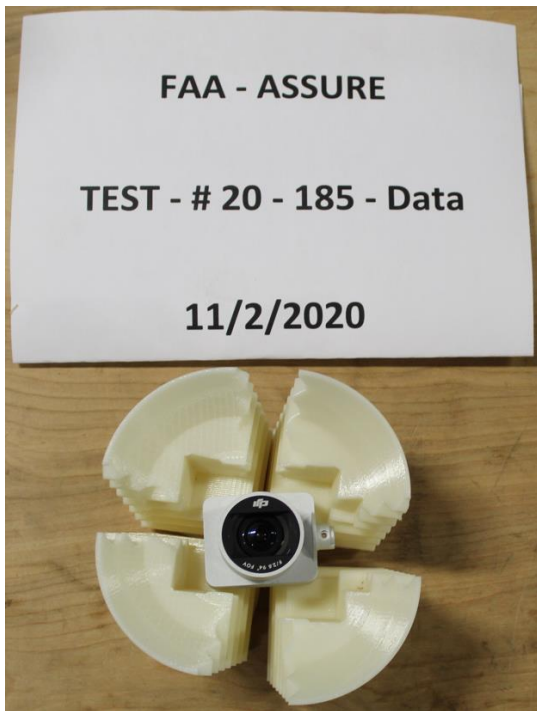
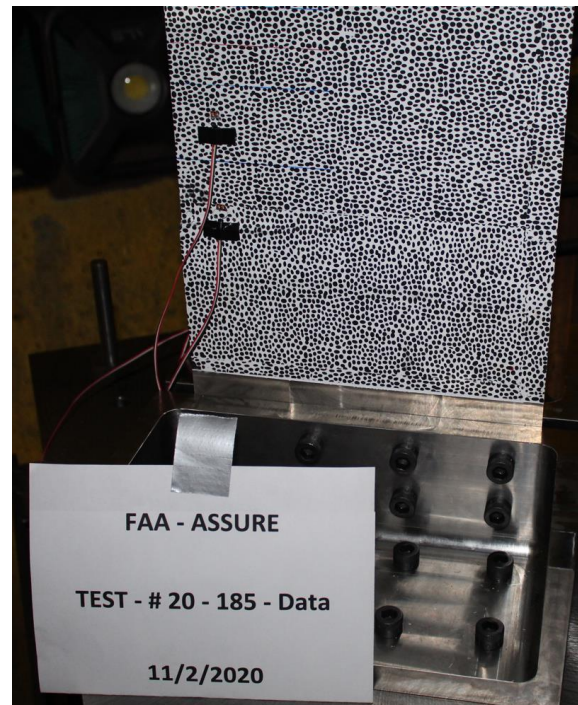
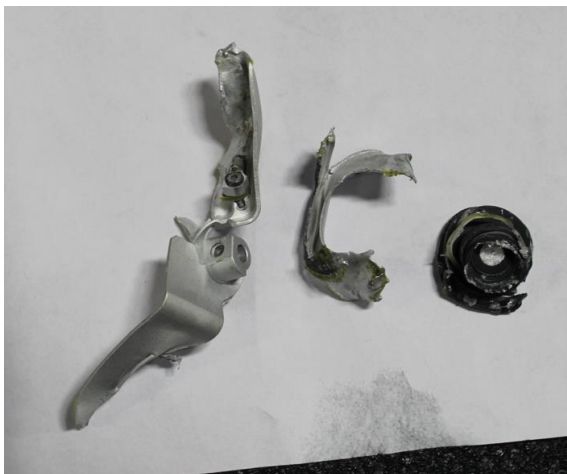
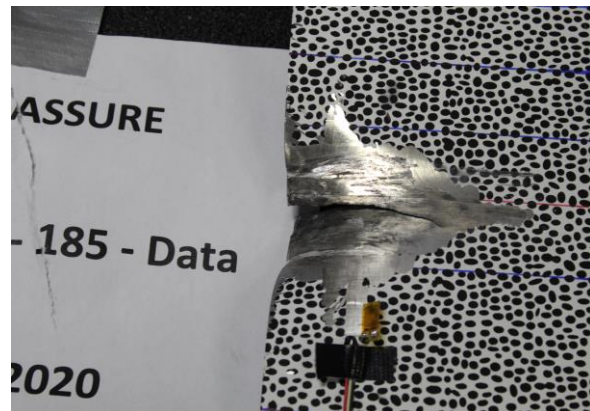
3.1.2.3. C50L5-016

| Test Results Summary | Plastic deformation in leading edge with a single fracture/tear extending approx. 3'' back from point of impact |

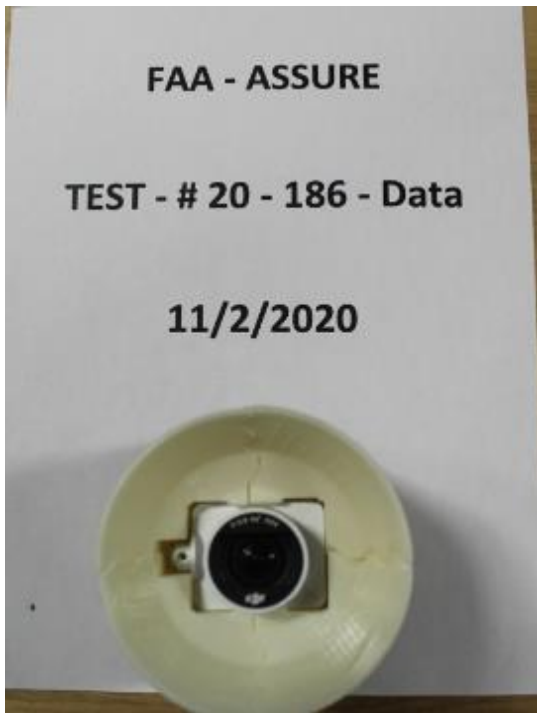
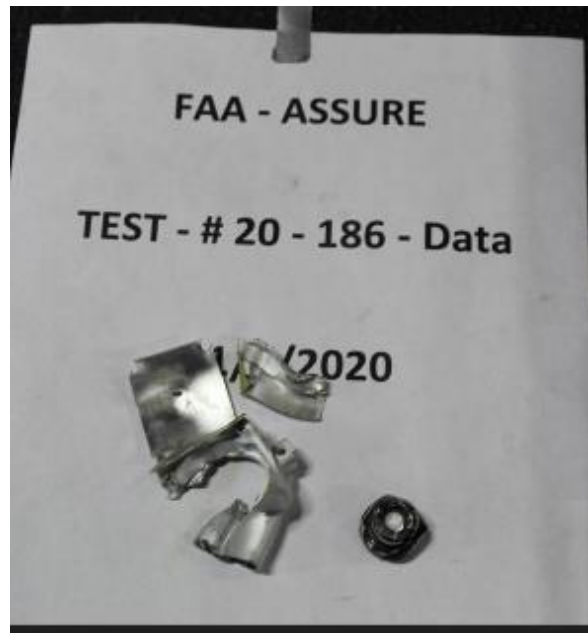
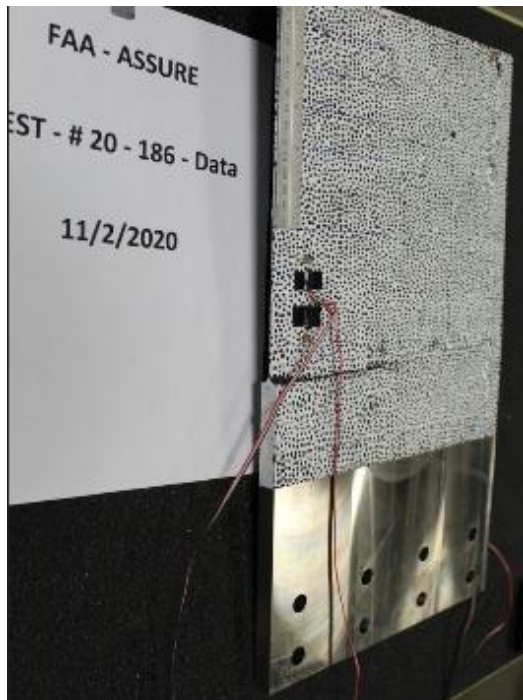
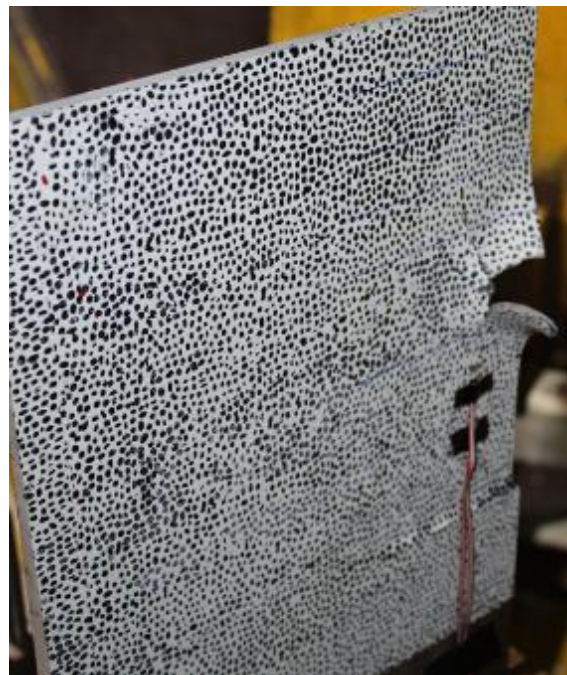
3.1.2.4. C50L5-017

| Test Results Summary | Plastic deformation in leading edge with a single horizontal fracture/tear that splits into two vertical fractures |

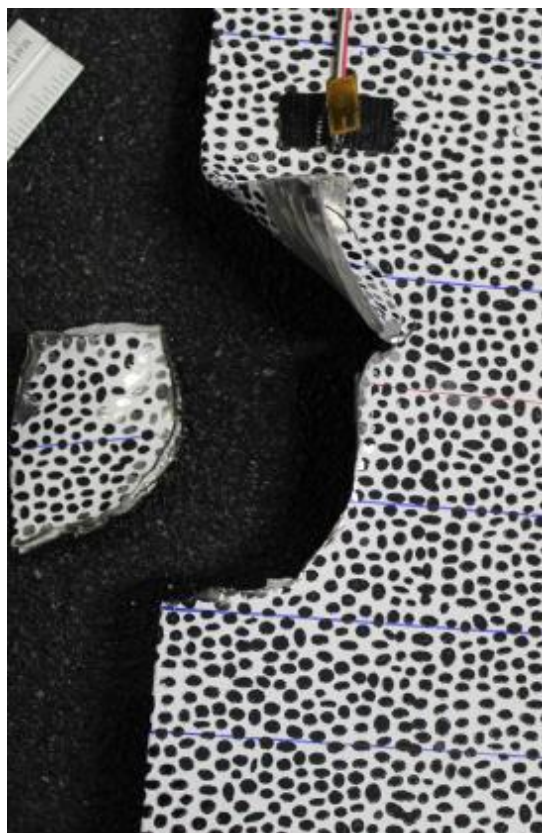
3.1.2.5. C50L5-018

| Test Results Summary | Impact created a petal-shaped section that tore off away from the point of impact |

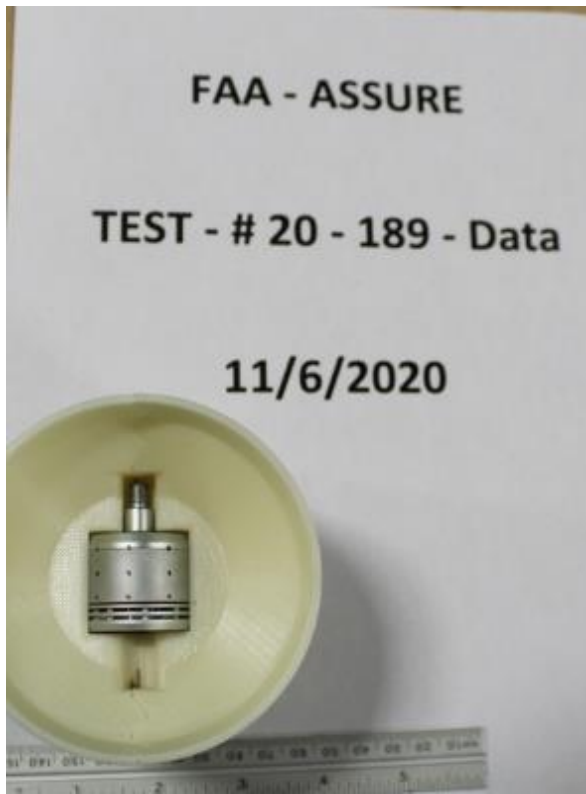
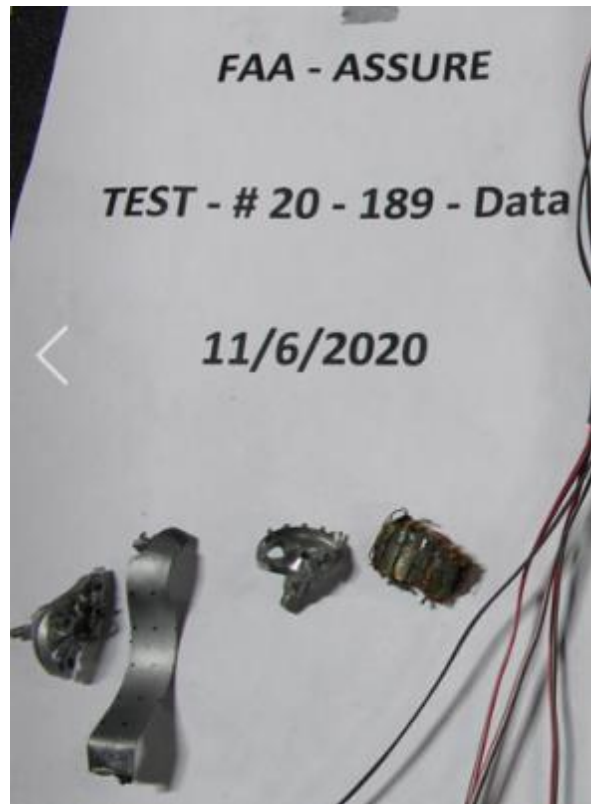
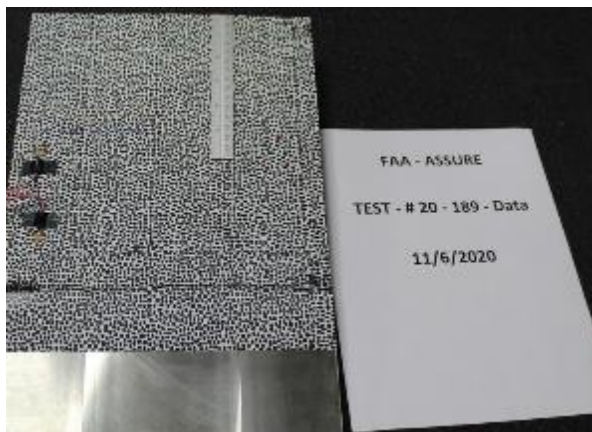
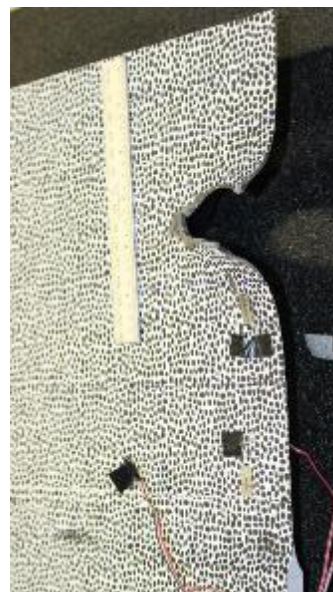
| Test Results Summary | Impact created a 3'' horizontal tear/fracture in the blade |

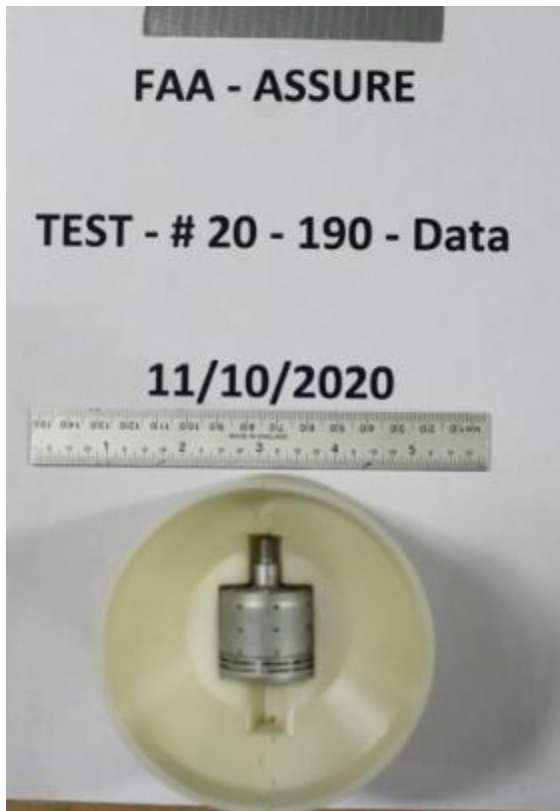
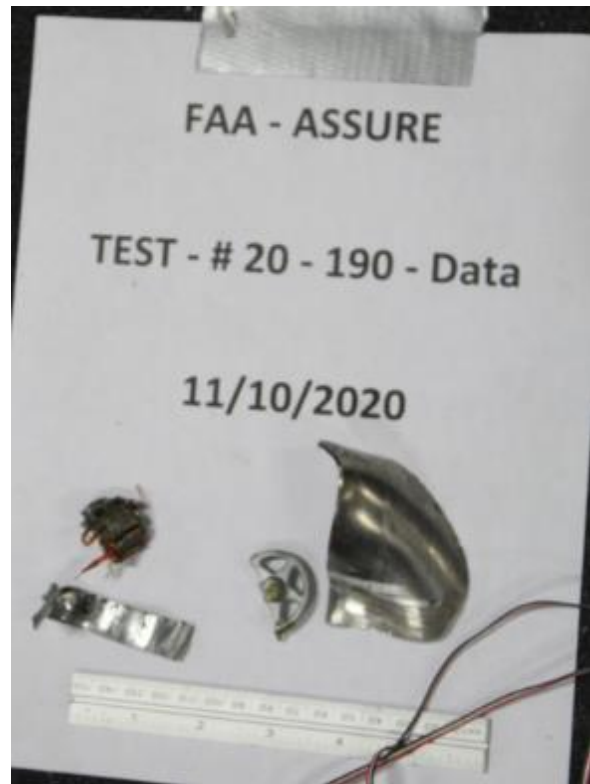
3.1.2.8. M80L7-003

| Test Results Summary | Impact broke a crescent-shaped section out of the leading edge of the blade |

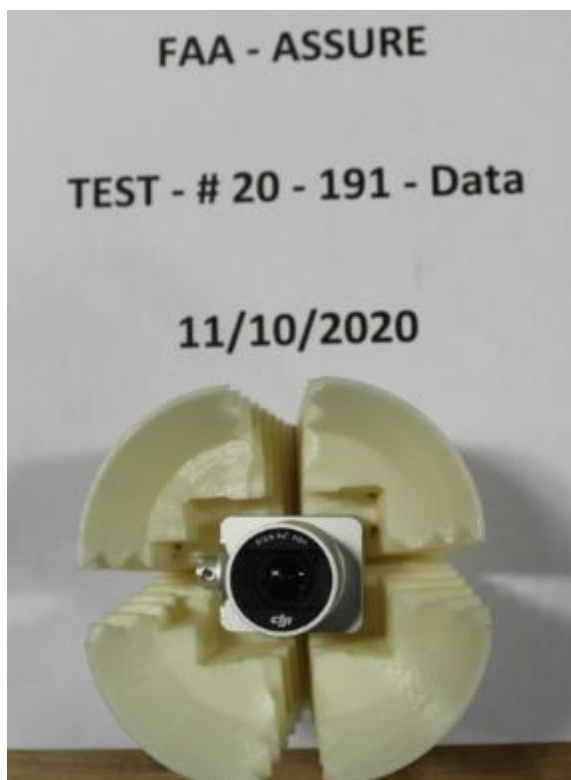
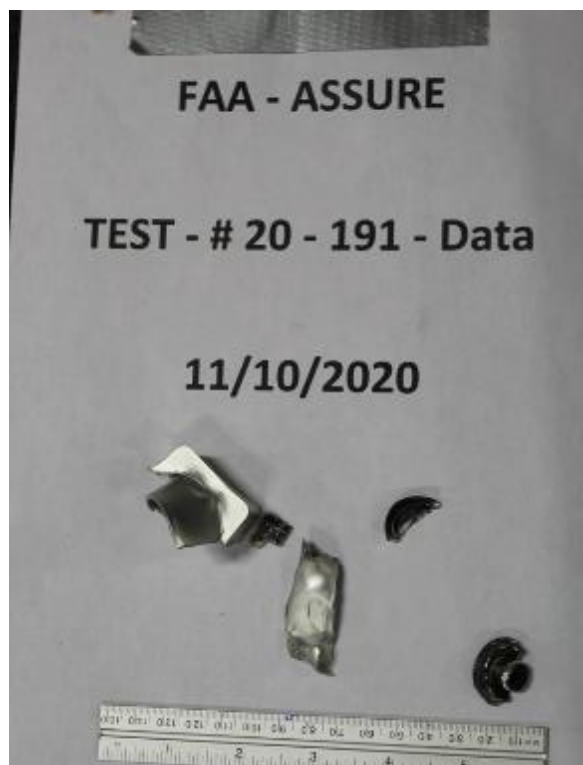
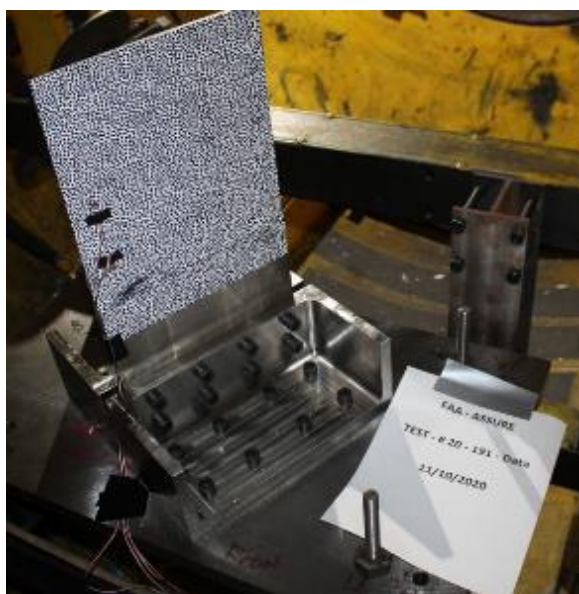
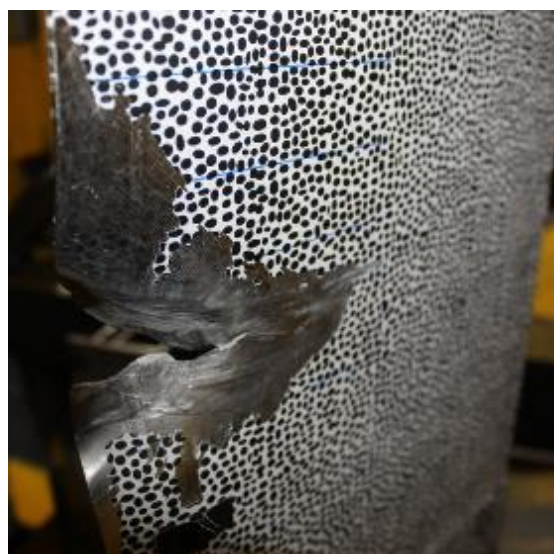
3.1.2.9. C80L7-013

| Test Results Summary | Plastic deformation in leading edge with a single fracture/tear extending approx. 3'' back from point of impact |

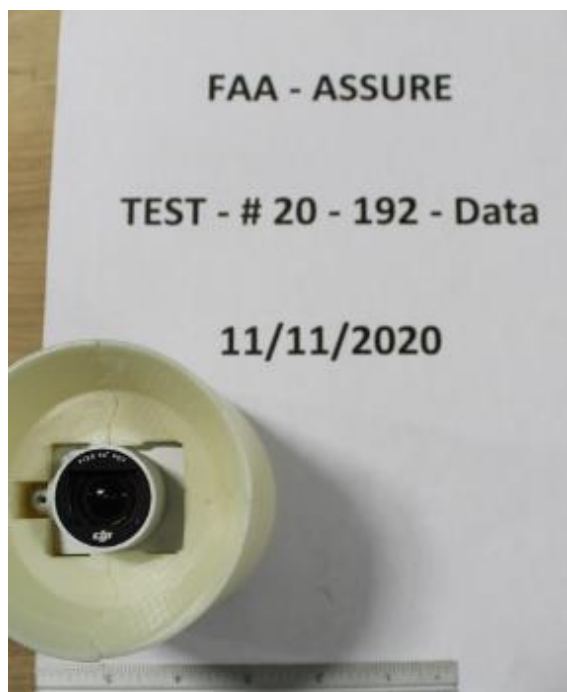
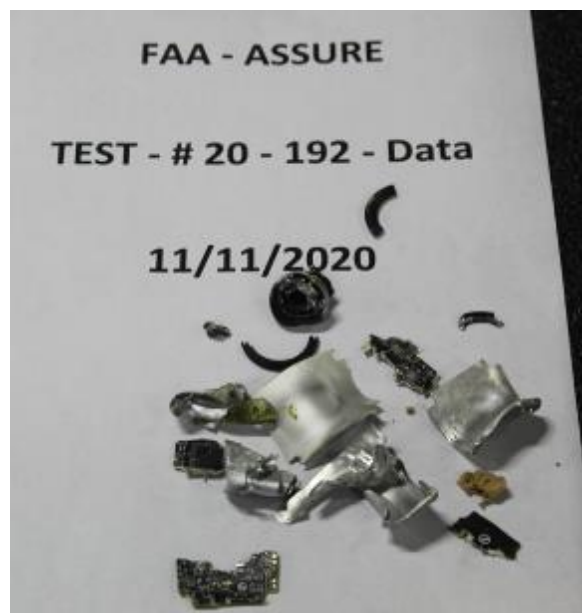
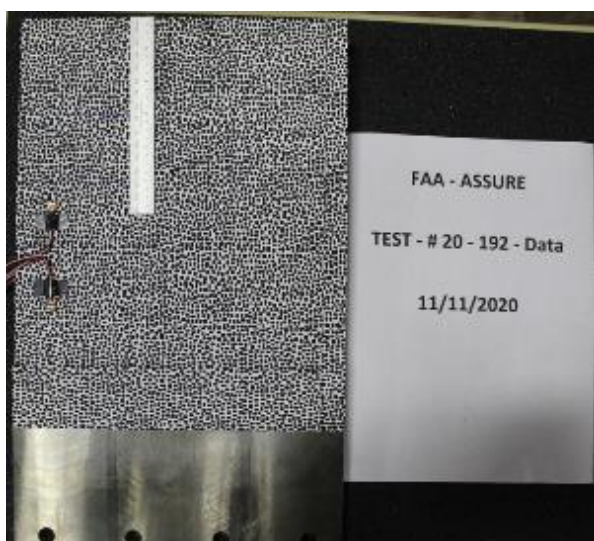
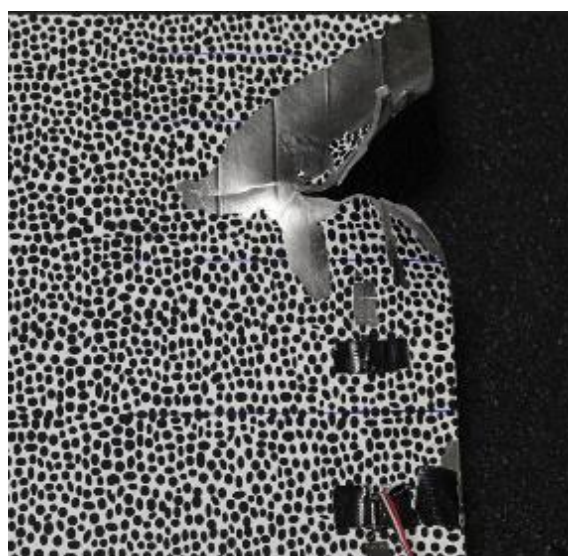
3.1.2.10. C80L7-014

| Test Results Summary | Plastic deformation in leading edge with a single fracture/tear extending approx. 3'' back from point of impact |

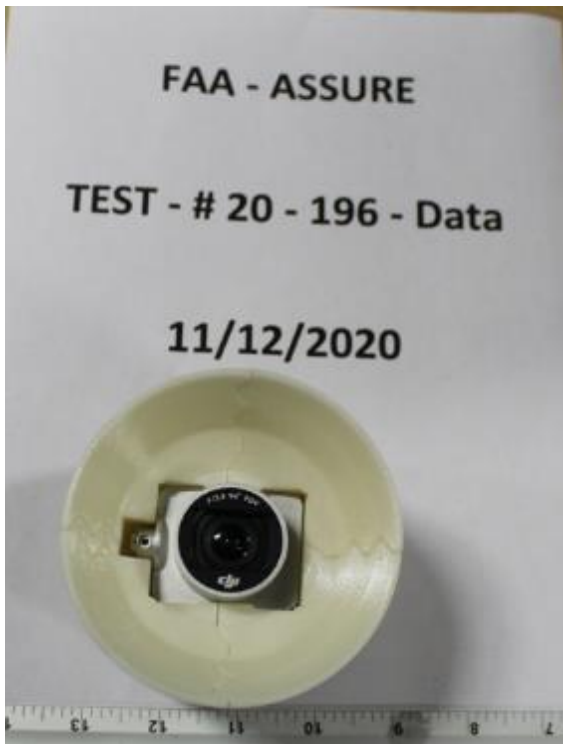
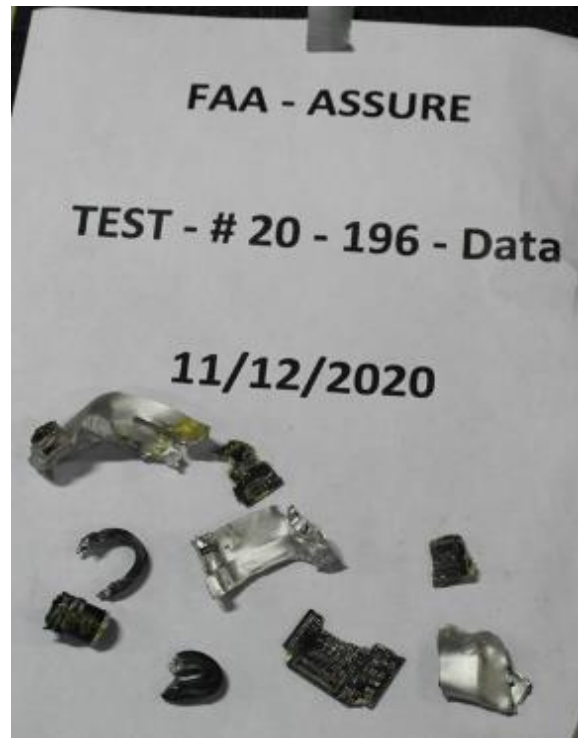
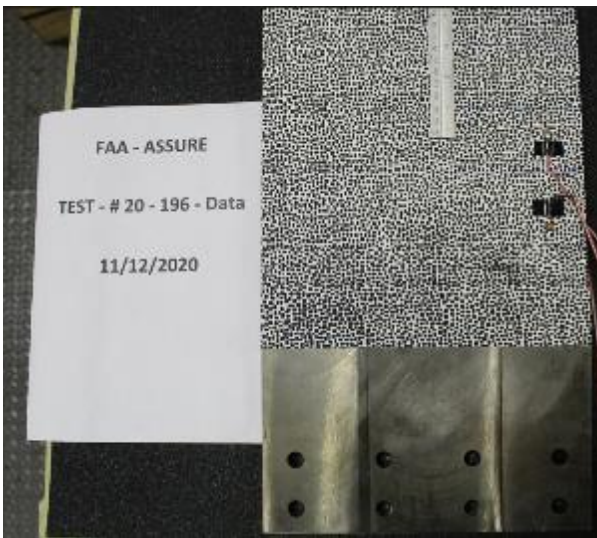
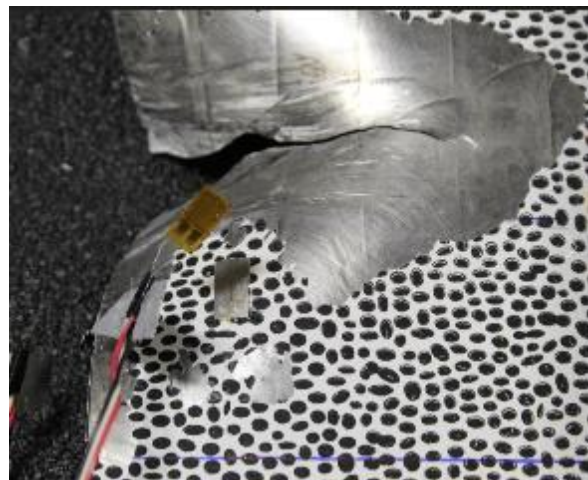
3.1.2.11. C80L7-015

Test Results Summary Orthogonal cameras and the right DIC cameras did not trigger properly. No usable visual strain data for the right side or orthogonal video could be gathered. Plastic deformation in leading edge with a single fracture/tear extending approx. 3'' back from point of impact.

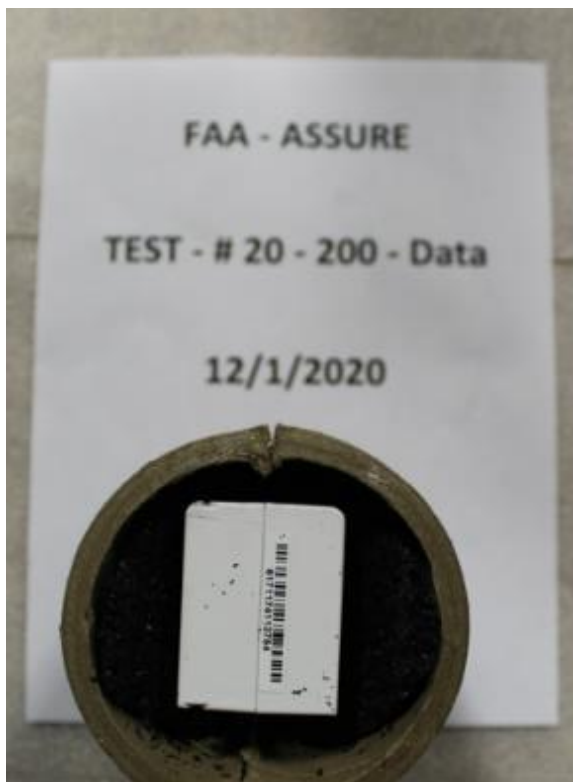
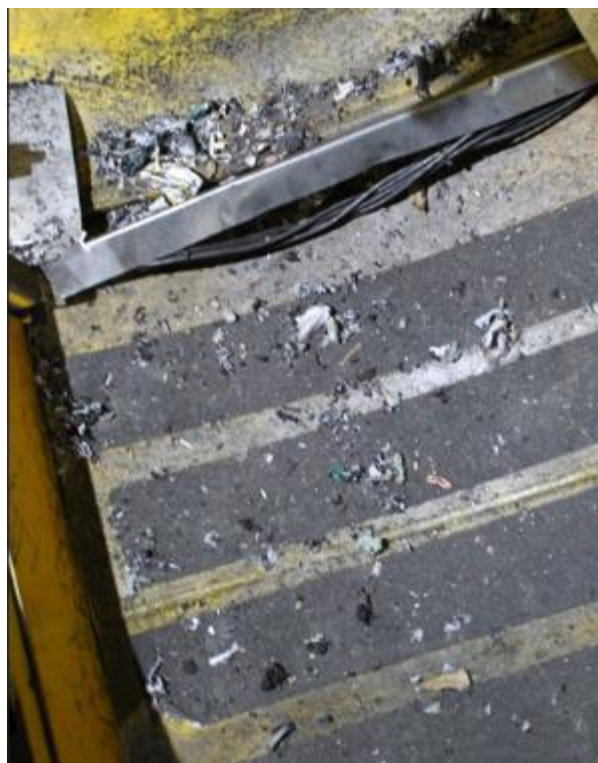
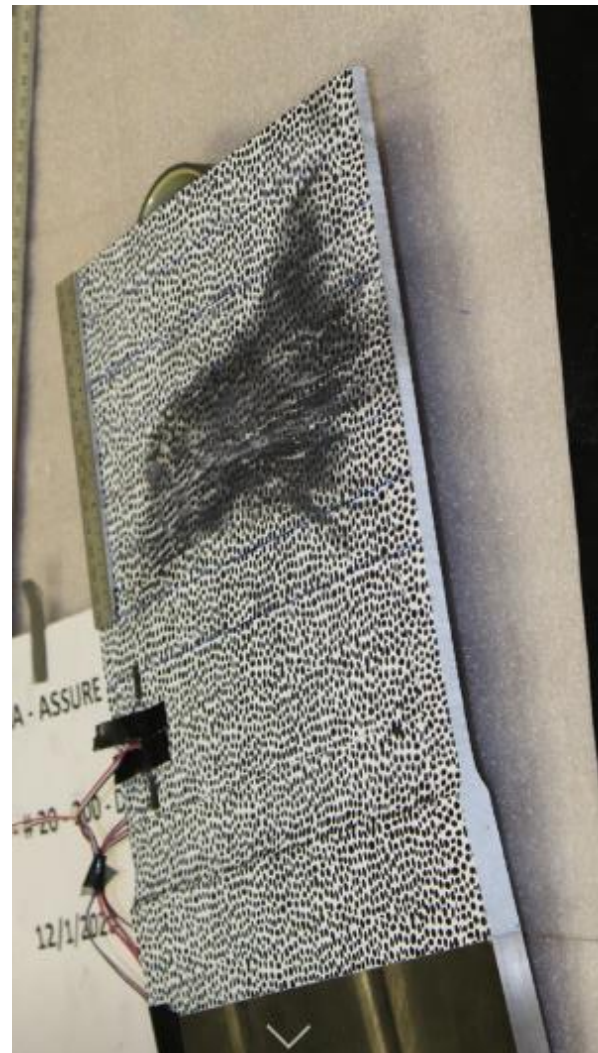
3.1.2.12. B80A5-007

| Test Results Summary | Blade bent away from the impact in vicinity of the base at the fixture grip. Battery broke apart into plastic parts, pieces of film, and Lipo dust. |

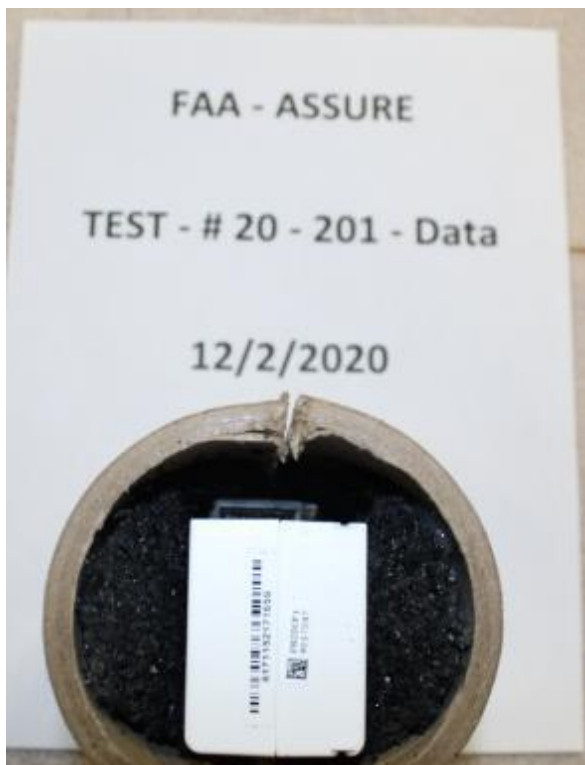
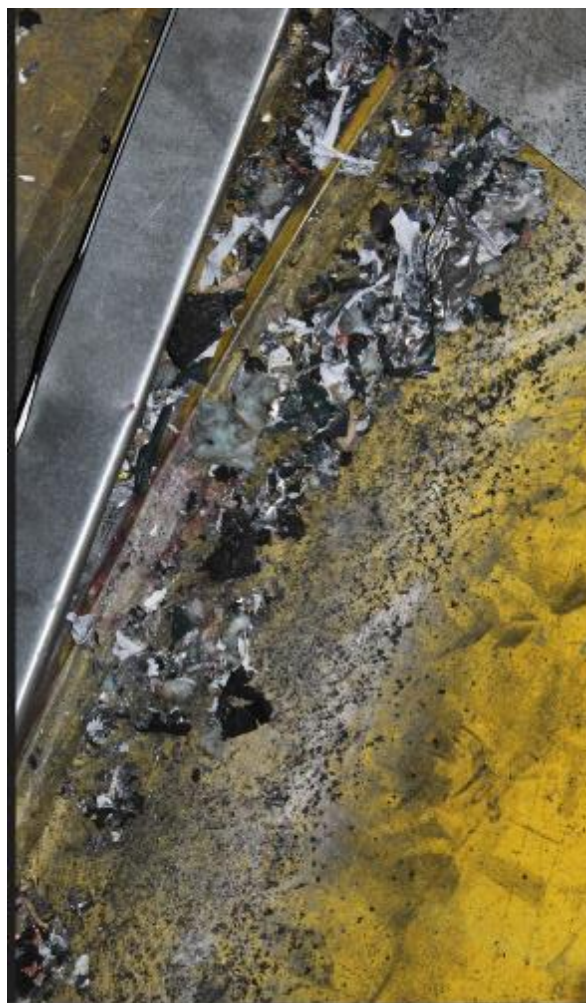
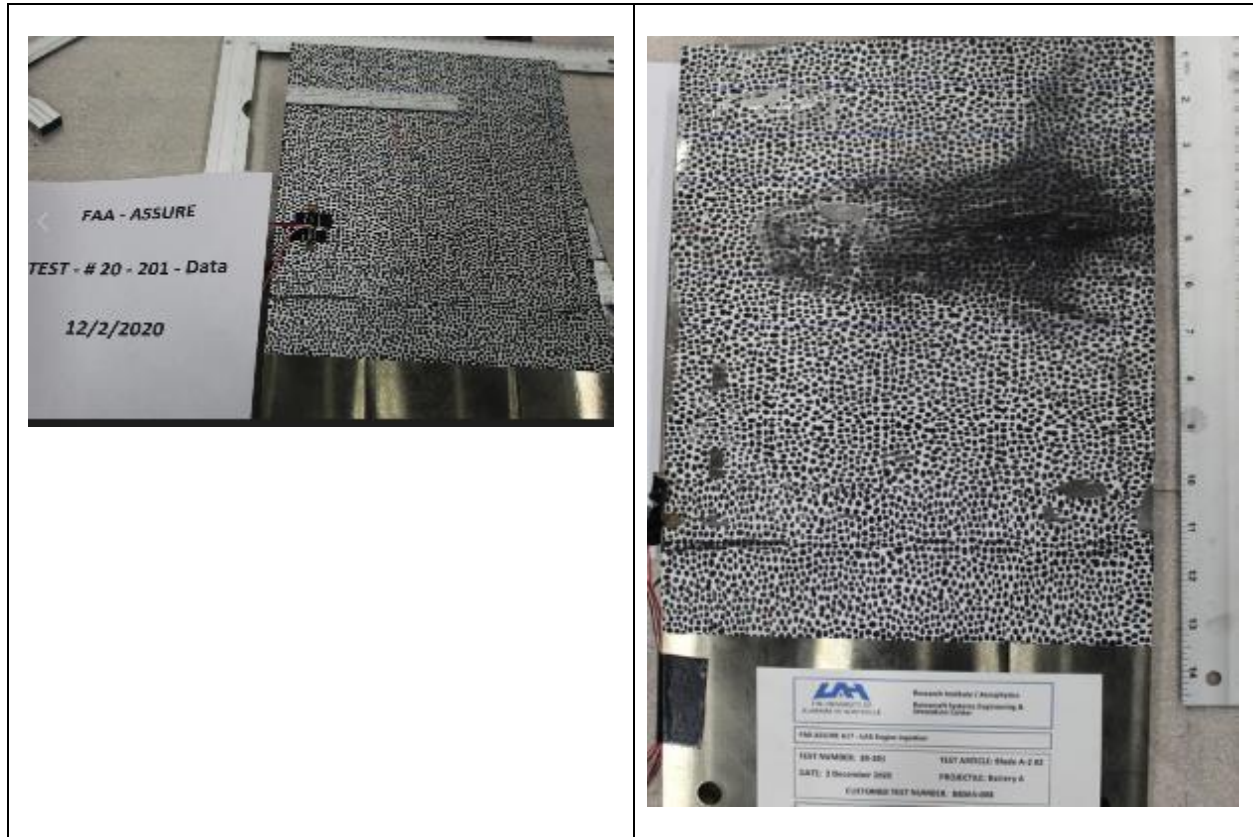
3.1.2.13. B80A5-008

| Test Results Summary | Blade bent away from the impact in vicinity of the base at the fixture grip. Battery broke apart into plastic parts, pieces of film, and Lipo dust |

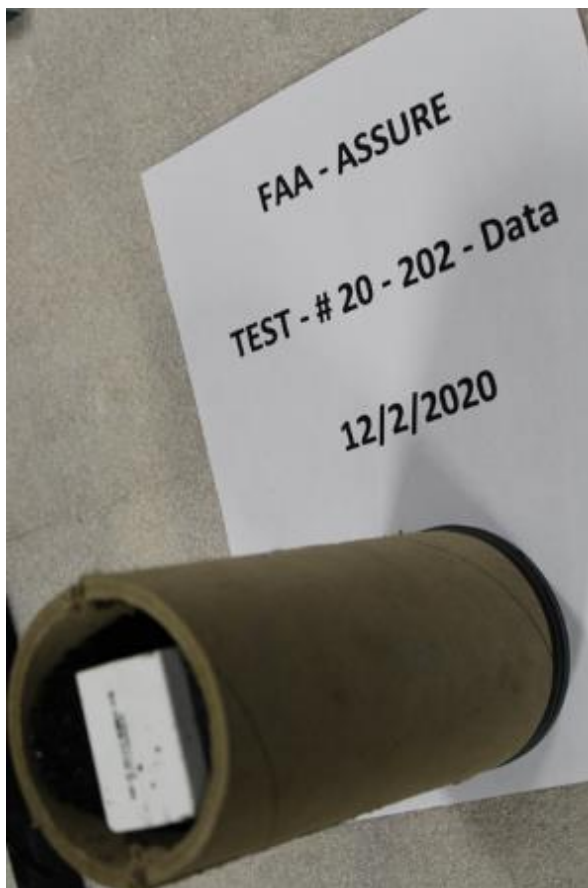
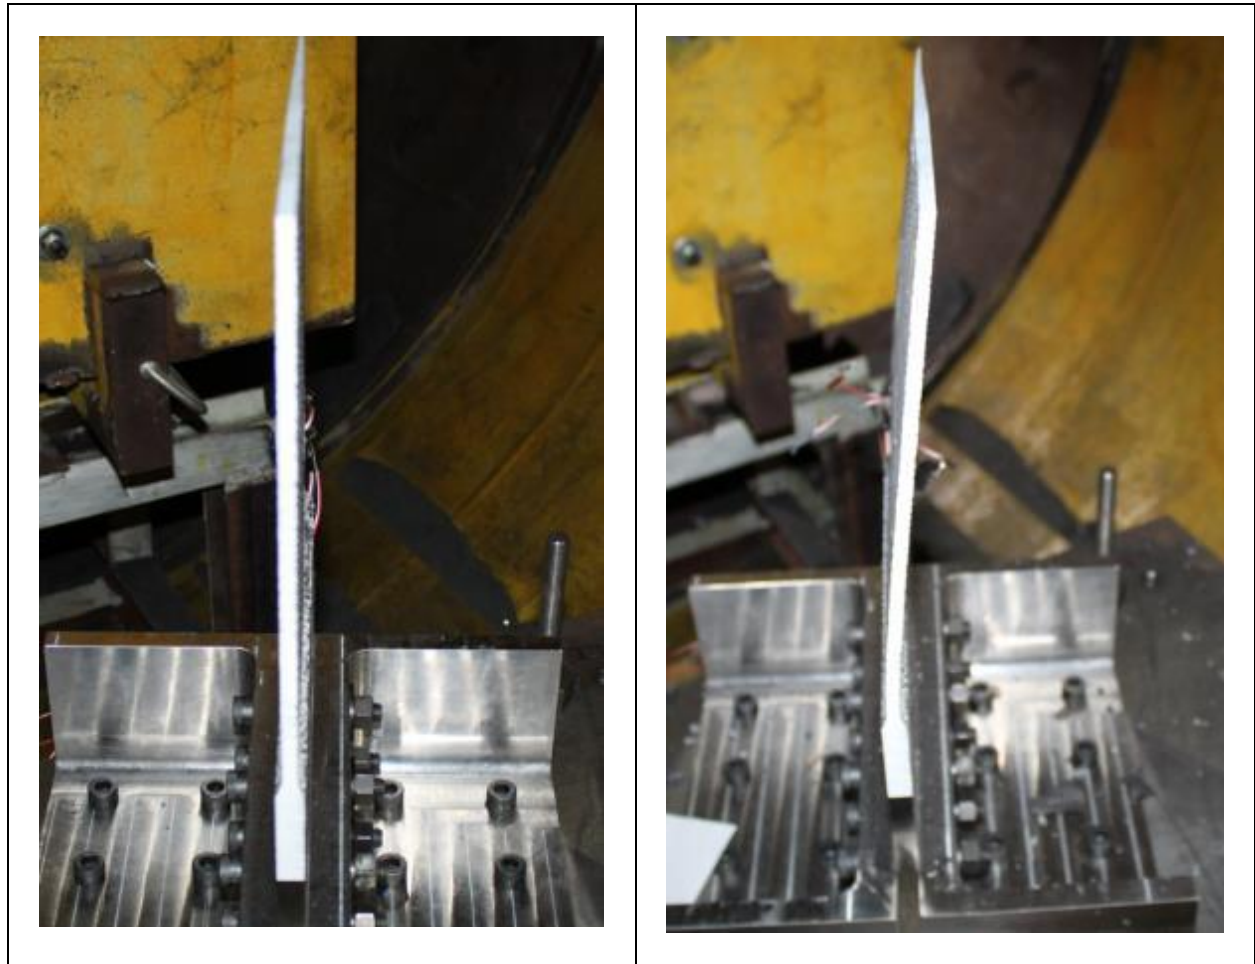
3.1.2.14. B80A5-009

| Test Results Summary | Blade bent away from the impact in vicinity of the base at the fixture grip. Battery broke apart into plastic parts, pieces of film, and Lipo dust |

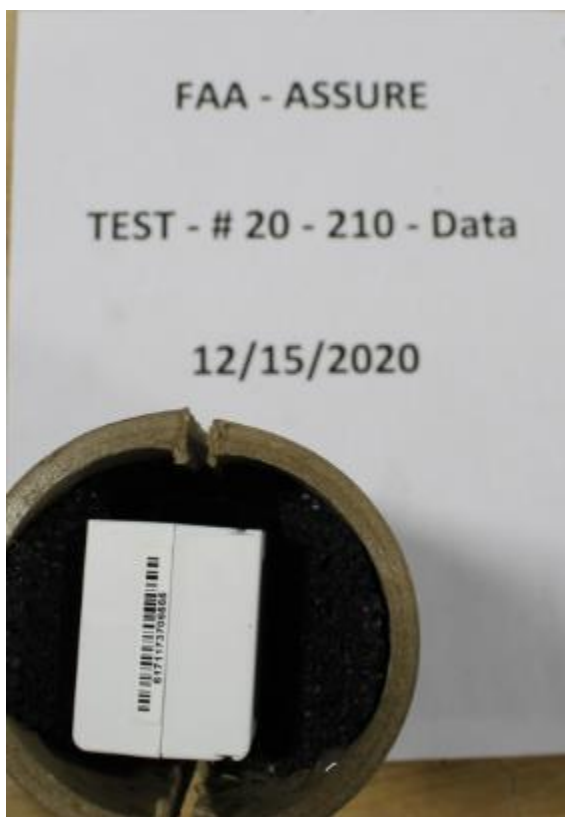
3.1.2.15. B50L7-010

| Test Results Summary | Velocity was reduced from 710kts because of battery deformation during acceleration. Battery impact removed an approximately 7'' high and >3'' wide crescent-shaped section of material from the leading edge. |

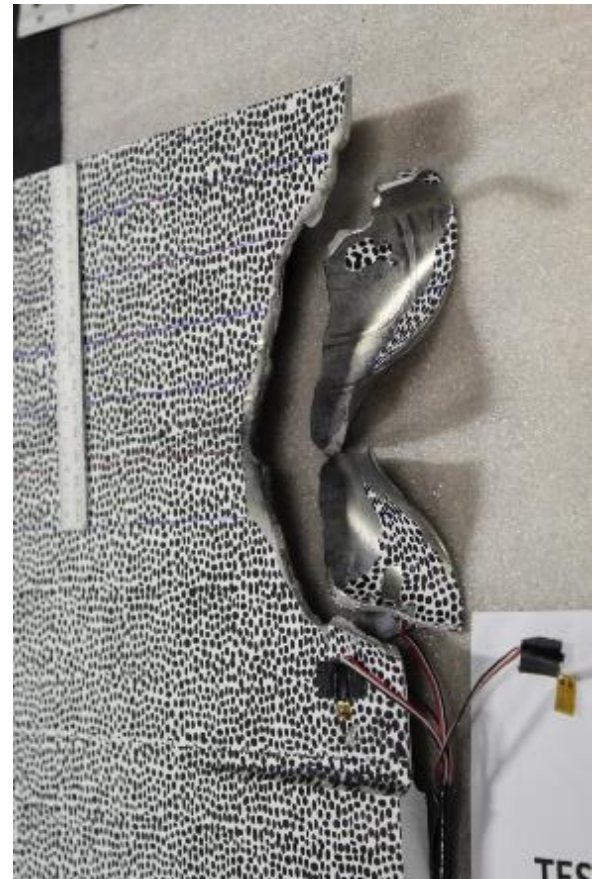
3.1.2.16. B50L7-011

| Test Results Summary | Velocity was reduced from 710kts because of battery deformation during acceleration. Battery impact removed an approximately 8'' high and >4'' wide crescent-shaped section of material from the leading edge. |

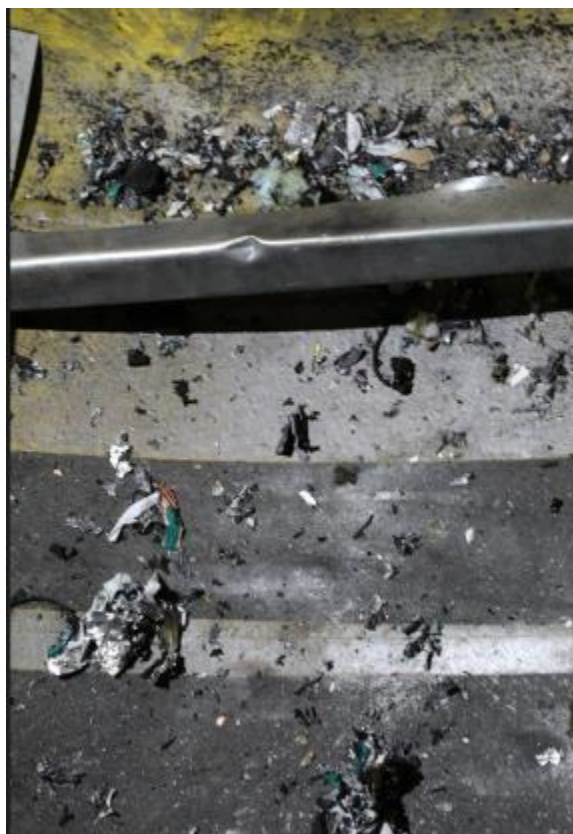
3.1.2.17. B50L7-012

Test Results Summary Velocity was reduced from 710kts because of battery deformation during acceleration. Battery impact removed an approximately 6'' high and >3'' wide crescent-shaped section of material from the leading edge.

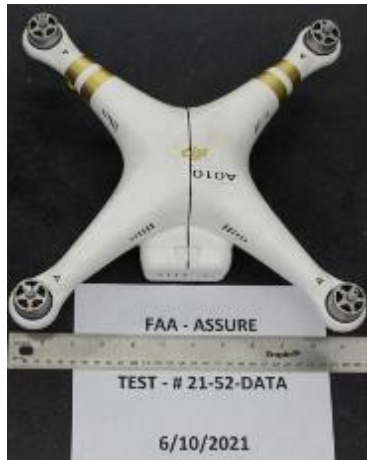
| Test Results Summary | The aircraft impact created an approximately 6'' bowed-out deformation in the leading edge of the blade. The impact did not appear to create any leading-edge fractures or tears. |

Post-impact aircraft pictures unavailable. Per discussion with ARF test personnel, the sUA was reduced to debris and battery dust during the impact.

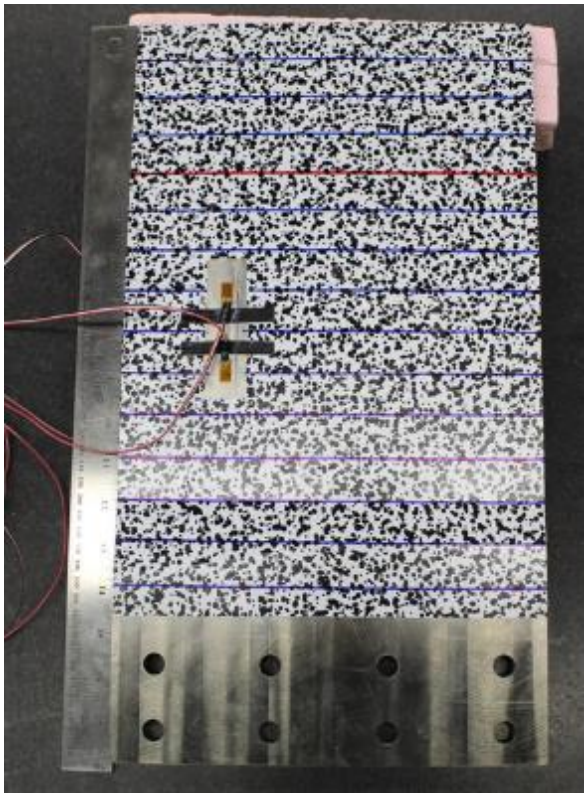
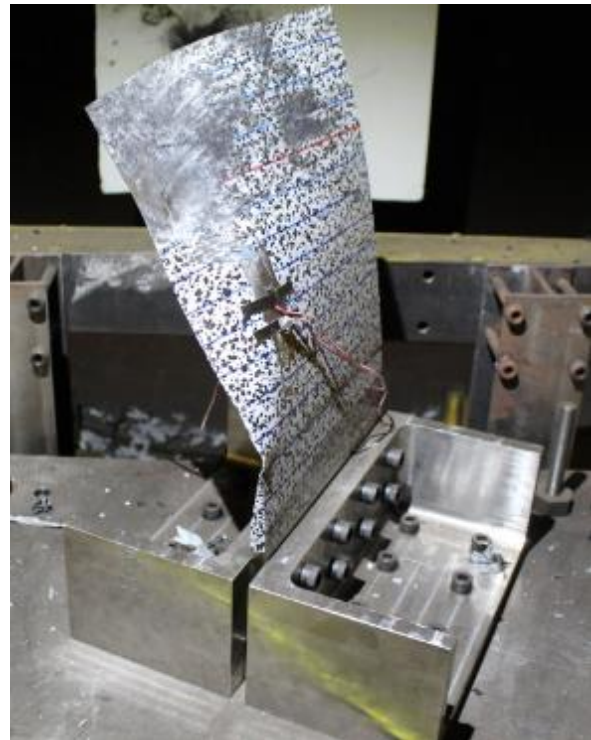
4.1.2.3. D80L7-002

| Test Results Summary | The impact resulted in a significant plastic deformation in which the blade was bent away from the impact. |

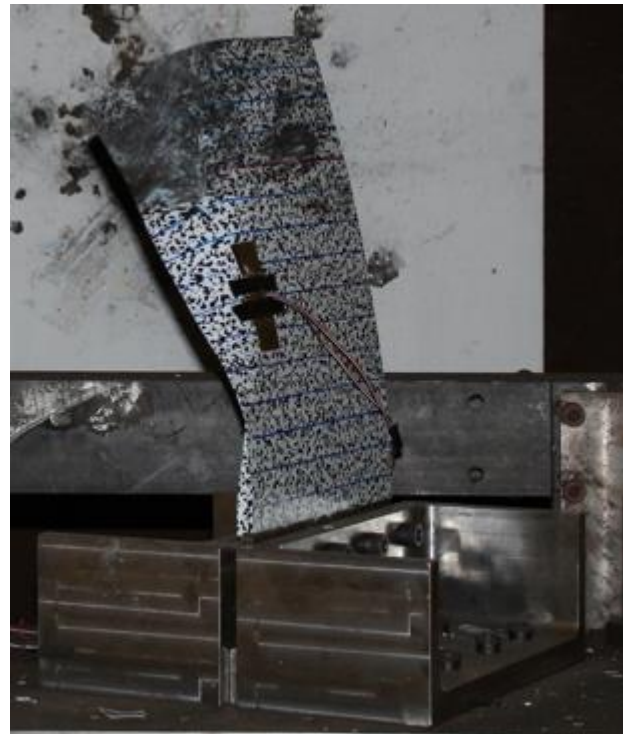
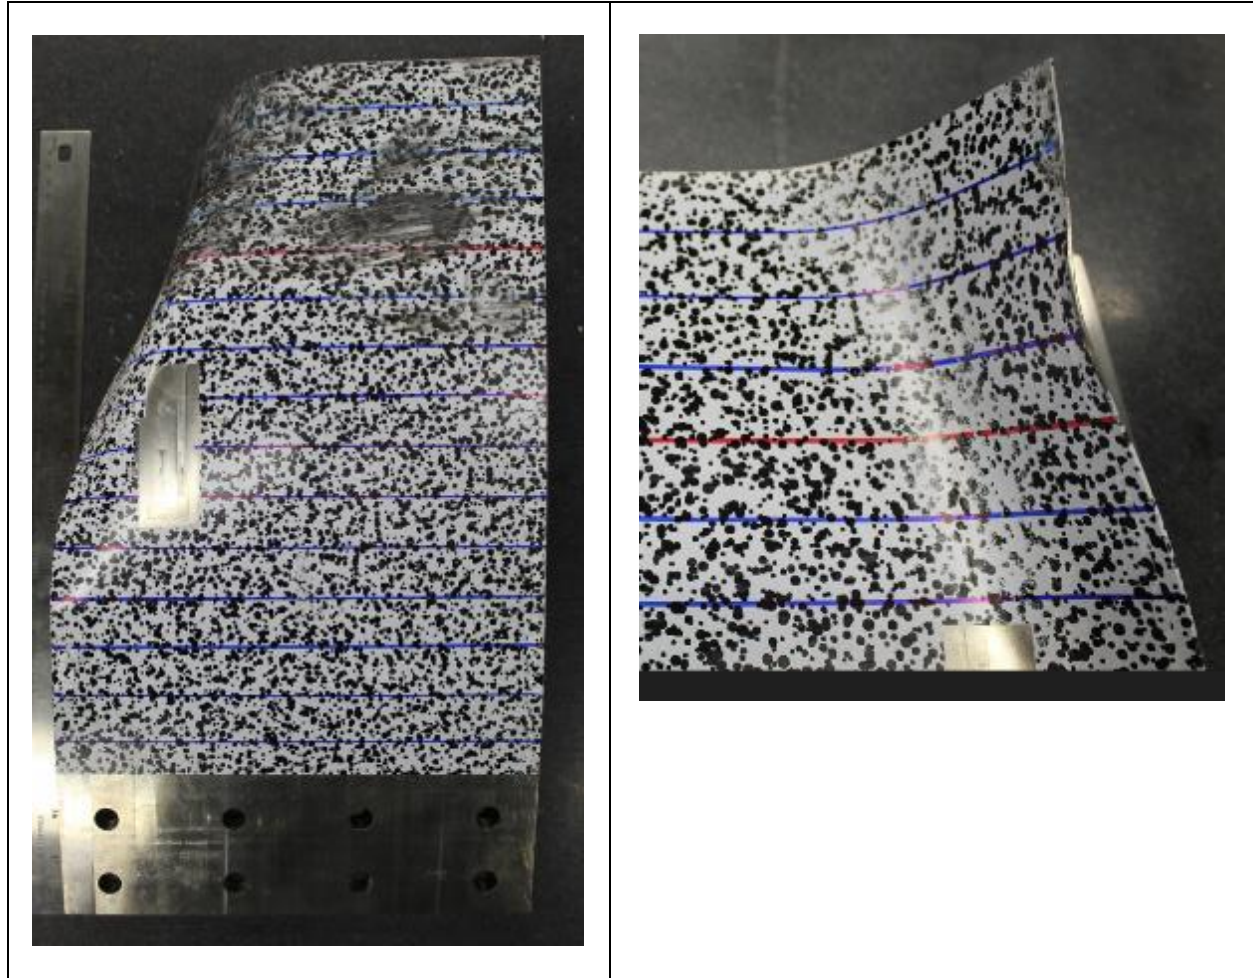
4.1.2.5. D80L7-003

| Test Conditions The impact resulted in a significant plastic deformation in which the blade was bent away from the impact. | | | |

There are no images of the aircraft after impact; however, ARF test personnel reported that the aircraft was reduced to debris and battery dust during the impact.
