DOT/FAA/AR-xx/xx

Volume VI – UAS Airborne Collision Severity Evaluation – 14 CFR Part 29 Rotorcraft

June 2022

Final Report

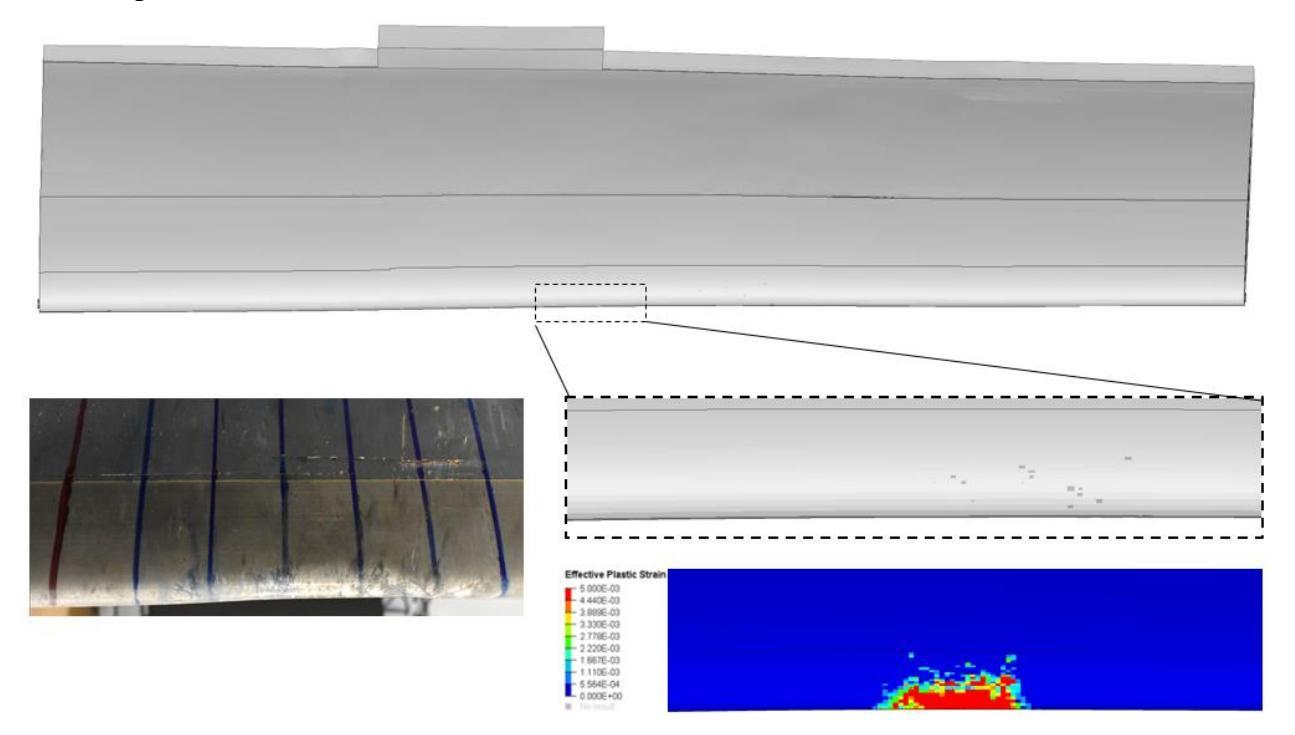
Figure 97. Test 21-126 blade leading edge damage.

The post-test examination of the test article revealed two areas of damage in the blade section: the leading edge and the inside of the blade. Figure 97 shows a small dent on the test article's leading edge compared to the damage observed in the simulation. Although the FEM does not have a noticeable dent as in the test, the effective plastic strain contour indicates permanent deformation in the impact area.

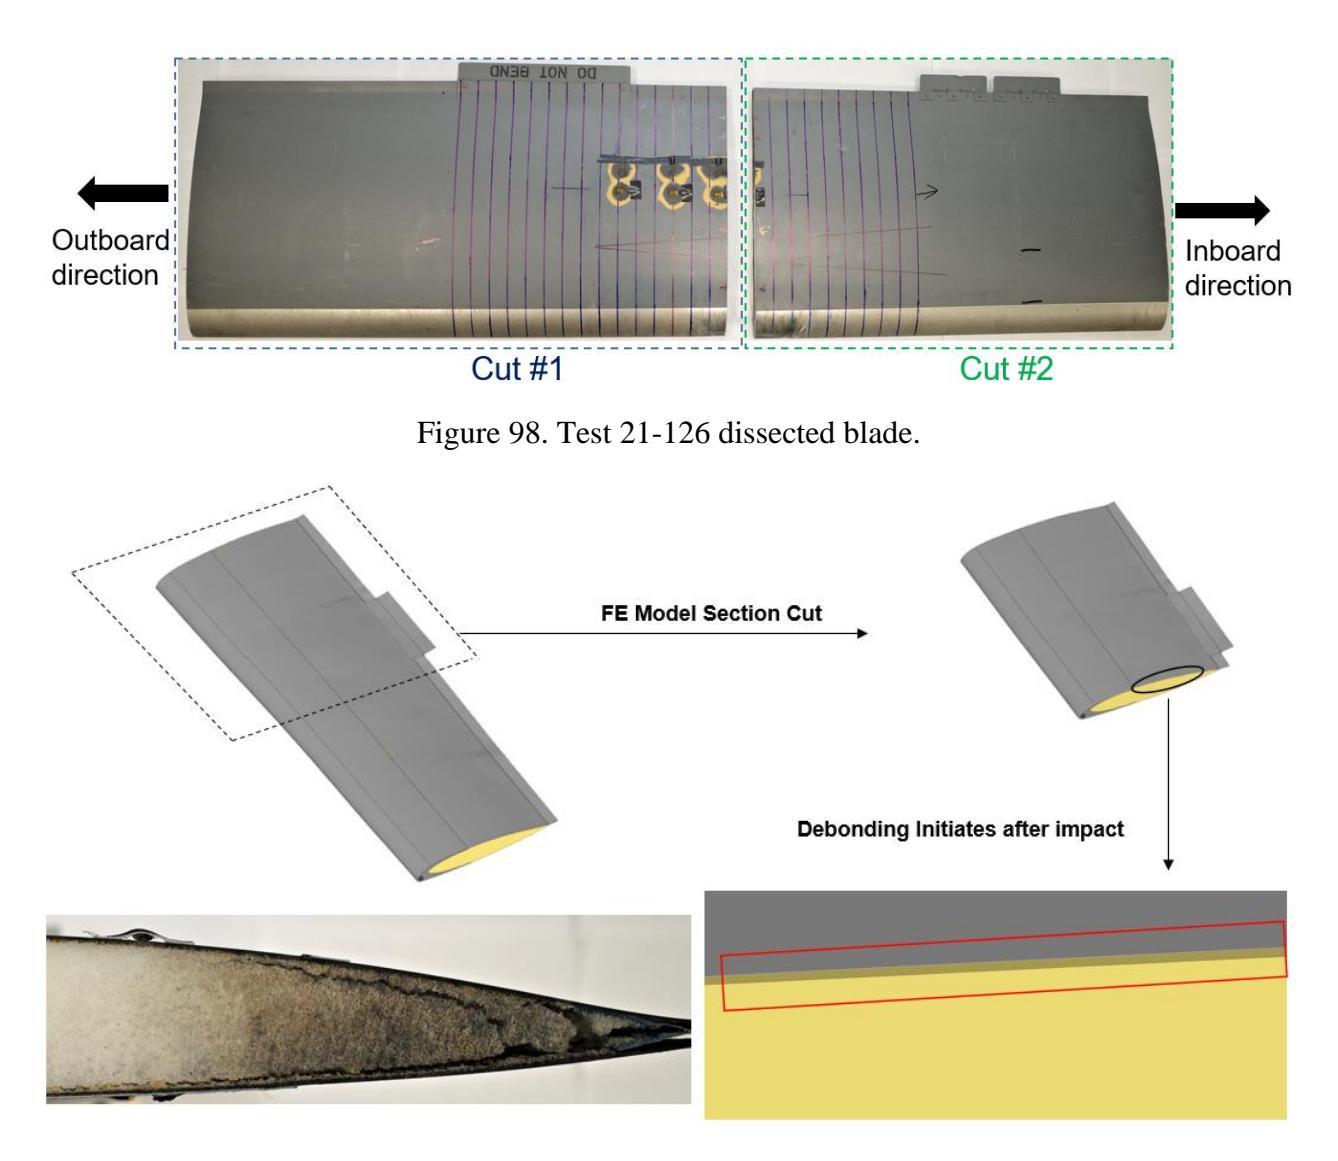
Figure 99. Test 21-126 blade skin debonding.

NIAR dissected the Test 21-126 blade section into two pieces to examine the damage inside the test specimen. Figure 98 shows the post-test blade dissection. The inboard direction points towards the blade root, whereas the outboard direction points towards the blade tip. Figure 99 presents the cross-section between cuts #1 and #2 in the outboard direction, indicating that the skin was debonded from the foam in the test and the simulation. In addition, Figure 100 shows the trailing edge skin debonding, which was also captured by the simulation.

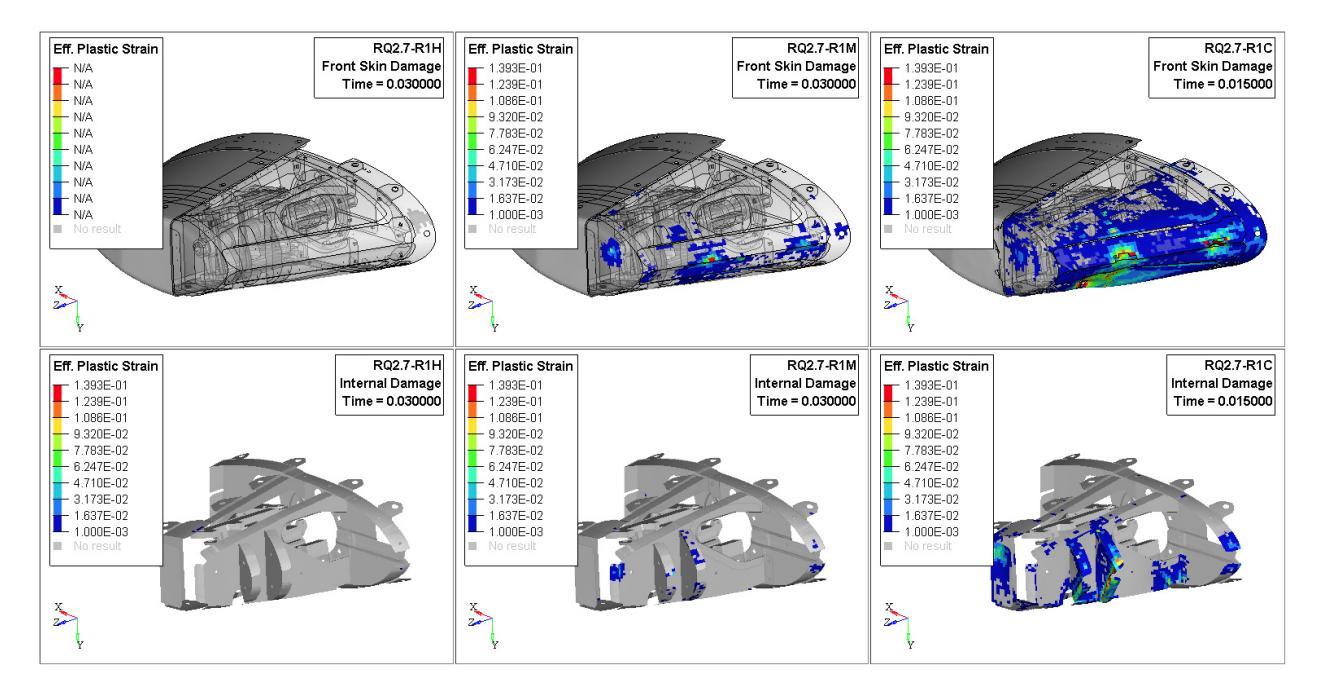
Figure 126. Skin and internal structures plastic strain for RQ2.7-R1H, RQ2.7-R1M and RQ2.7-R1C (left to right).

Figure 126 shows the damage to the servo skin (upper images) and the internal structure (lower images). RQ2.7-R1H shows no permanent deformation of the skin and internal structure. Likewise, RQ2.7-R1M indicates little permanent deformation to the skin and internal structure. However, RQ2.7-R1C presents large skin permanent deformation and localized damage to the nose ribs. Thus, RQ2.7-H1H and RQ2.7-H1M have a damage severity of level 1 and RQ2.7-H1C of level 2.

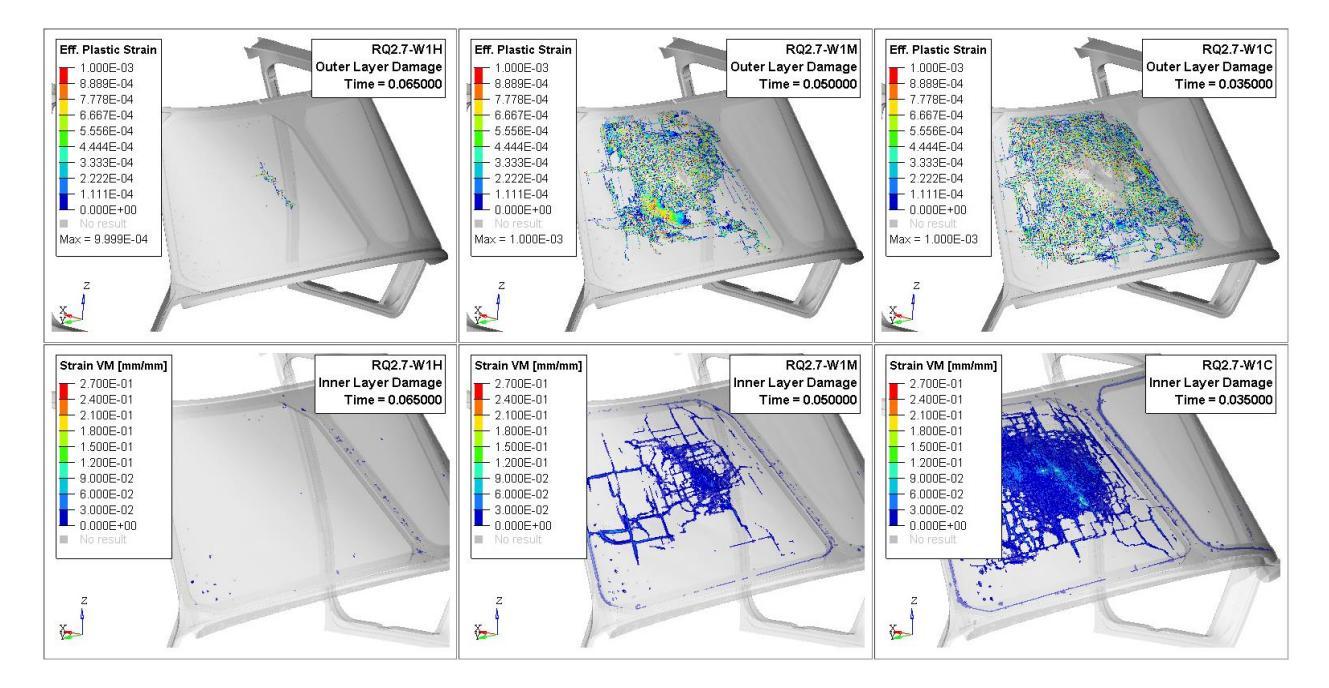
Figure 130. Outer and inner layer damage for RQ2.7-W1H, RQ2.7-W1M and RQ2.7-W1C (left to right).

Figure 130 depicts the damage to the outer (upper images) and the inner (lower images) windshield layers for the location 1 impact cases. The windshield shows more damage as the velocity increases. RQ2.7-W1H contains a localized scratch on the outer layer. RQ2.7-W1M shows shattering of the windshield outer layer and partial damage to the inner layer. RQ2.7-W1C captured a larger shattering of the outer layer, which propagated to the entire surface of the windscreen. There is also damage to the inner layer. The UAS did not penetrate the cockpit in any of the cases. Thus, RQ2.7-W1H, RQ2.7-W1M and RQ2.7-W1C have a damage severity of level 2.

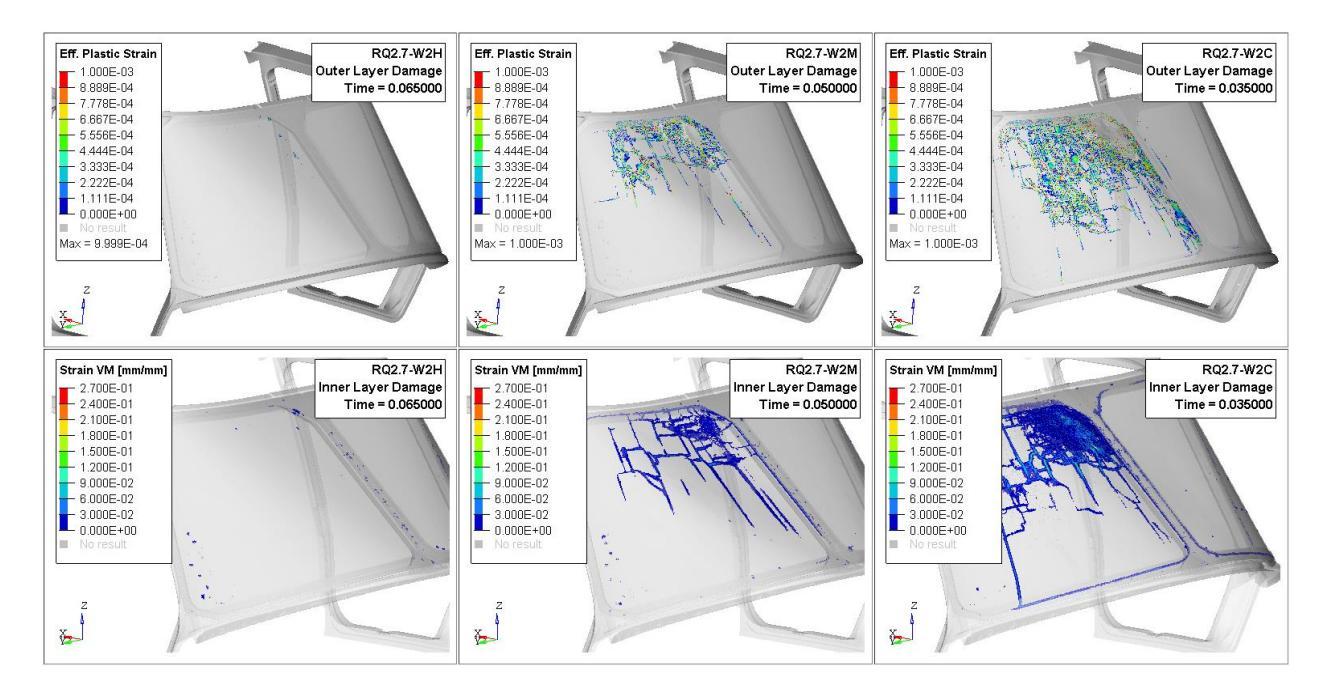
Figure 134. Outer and inner layer damage for RQ2.7-W2H, RQ2.7-W2M, and RQ2.7-W2C (left to right).

Figure 134 depicts the damage to the outer (upper images) and the inner (lower images) windshield layers for the location 2 impact cases. The windshield shows more damage as the velocity increases. RQ2.7-W2H contains a small localized scratch on the outer layer near the impact location with the UAS. RQ2.7-W2M shows shattering of the upper area of the windshield outer layer and damage to the inner layer. RQ2.7-W2C captured a larger shattering of the outer layer, which propagated to the middle and upper region of the windscreen. There is also damage to the inner layer. The UAS did not penetrate the cockpit in any of the cases. Thus, RQ2.7-W2H damage severity has been determined of level 1. RQ2.7-W2M and RQ2.7-W2C captured damage severity of level 2.
