Annex B to Task A17: NIAR/WSU sUAS Numerical Model Validation (Component and Full-Scale Level) for Engine Ingestion Analysis

September 15th, 2022

Final Report

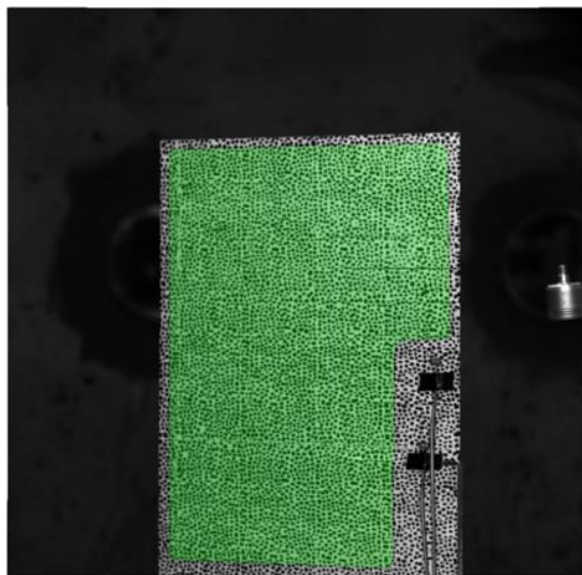
Due to the slicing nature of the test, parts of sUAS debris obstructed the blade surfaces during the impact, making it challenging to process the DIC data. Therefore, only partial blade surfaces were selected where DIC data collection was deemed possible. Figure 2.16 shows the selective areas of the blade for the DIC processing in this test M50L5-004.

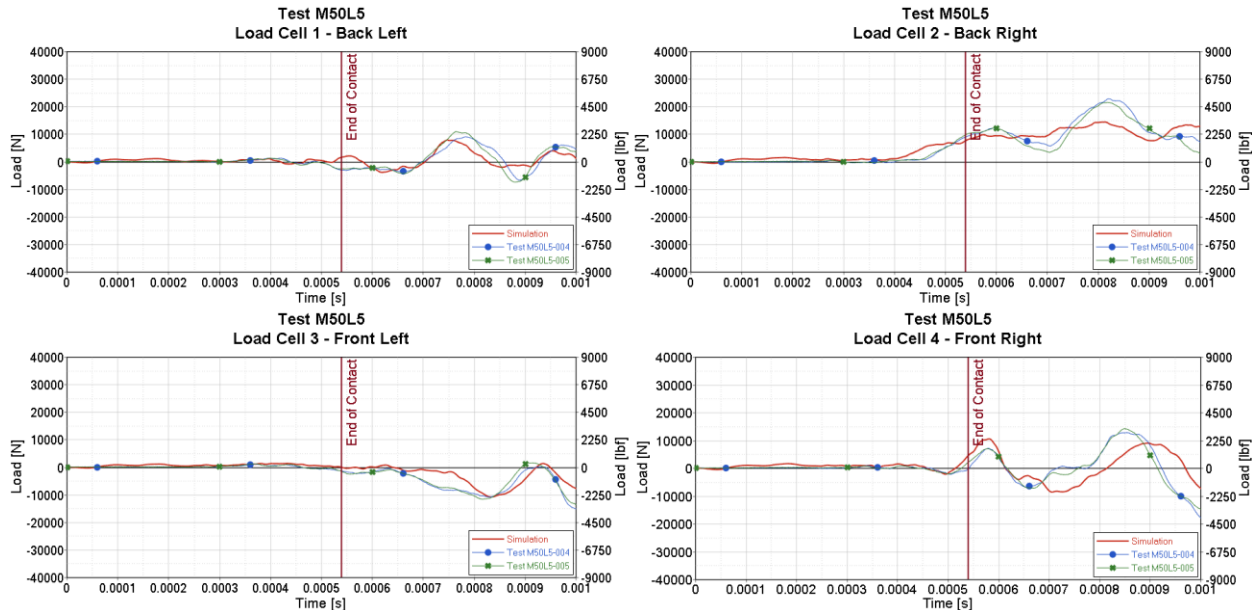
Figure 2.21. Test M50L5 configuration load cells data comparison

Figure 2.21 shows the load cell data comparison between the simulation and the two test repetitions. The data has no filter, and its sampling rate was 1MHz for both the simulation and tests. The simulation results show good agreement with the test data. The strain gages' data comparison was not possible due to corrupted test data.

The results in this section show a good qualitative correlation between simulation and physical test data in terms of blade damage, loads, and DIC. Thus, for this M50L5 configuration, the motor component of the sUAS is considered validated.

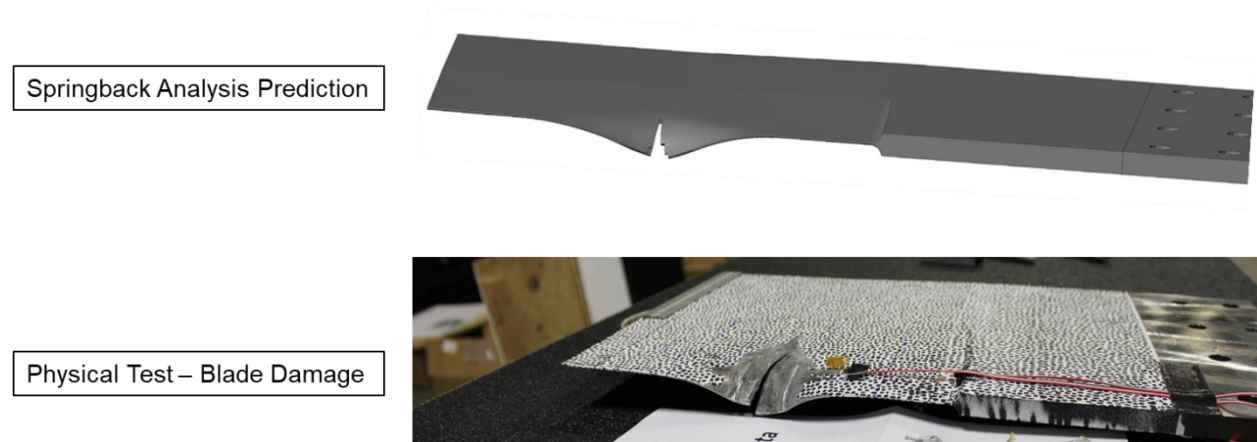
Figure 2.36. Spring back analysis prediction of blade damage vs. physical test damage

After 0.7ms of the shown simulation, the blade continued vibrating due to the impact's residual energy. Thus, an additional spring back analysis was performed on the blade to obtain its final deformed shape at its equilibrium state. Figure 2.36 compares the final blade damage after the spring back FE analysis and the physical test damage. The FE result for the blade's LE shows a good correlation with the final deformed shape of the physical blade's LE.
