DOT/FAA/AR-xx/xx

Federal Aviation Administration
William J. Hughes Technical Center
Aviation Research Division
Atlantic City International Airport
New Jersey 08405

Annex C to Task A17: Airborne Collision Severity Evaluation – Engine Ingest Test Report

Final Report

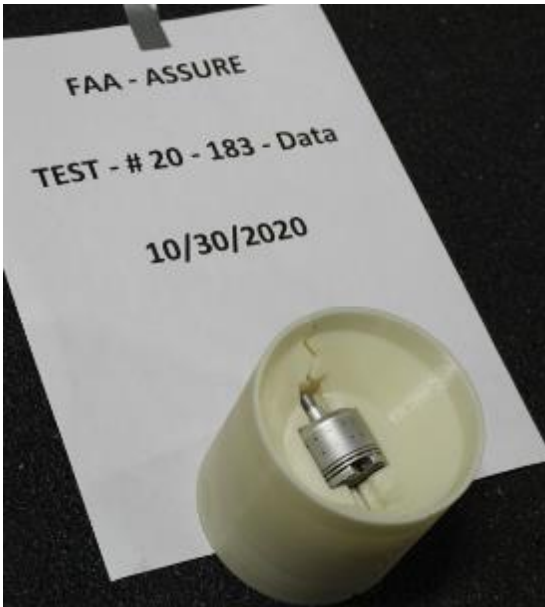
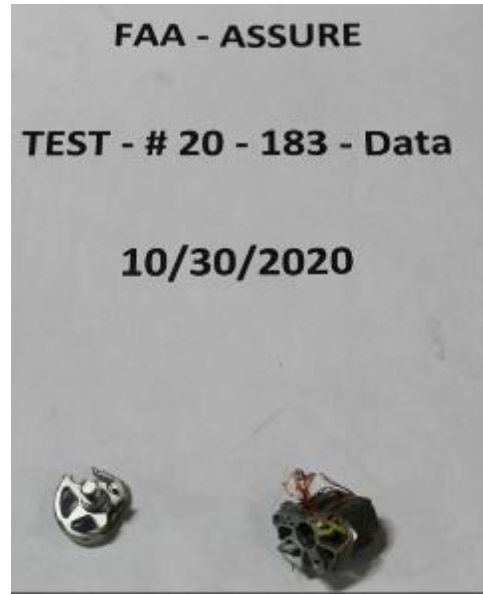
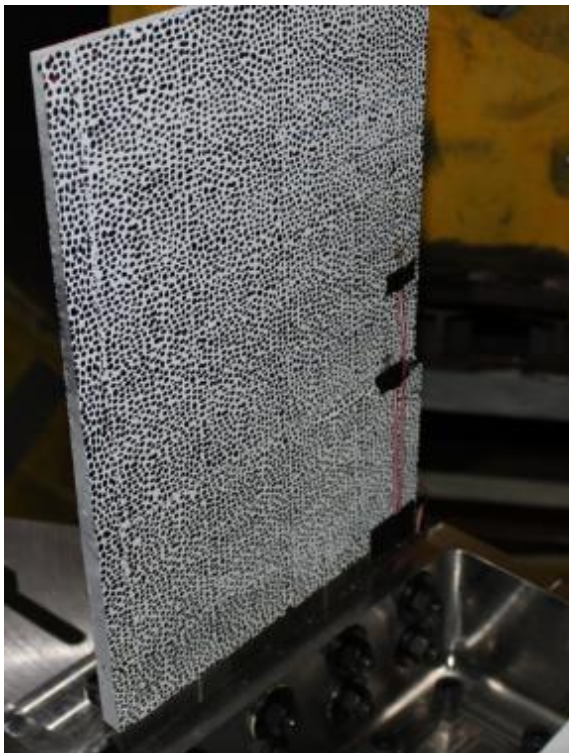
| Test Results Summary | Plastic deformation in blade leading edge without loss of material |

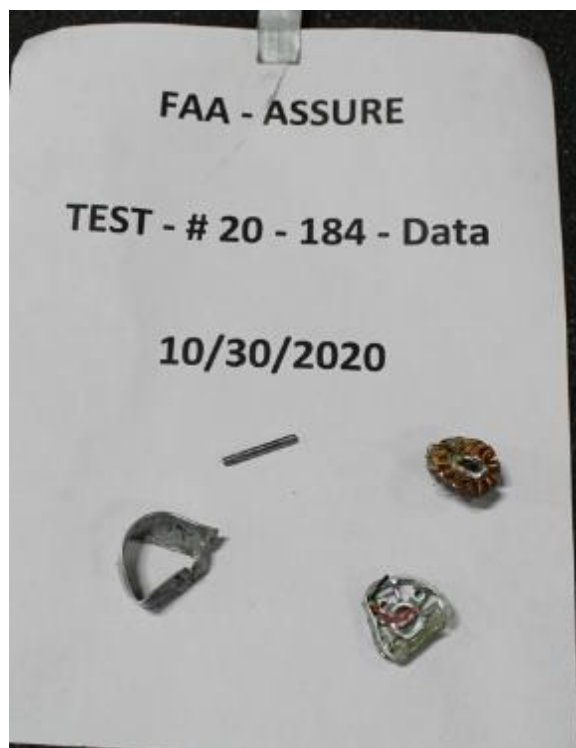
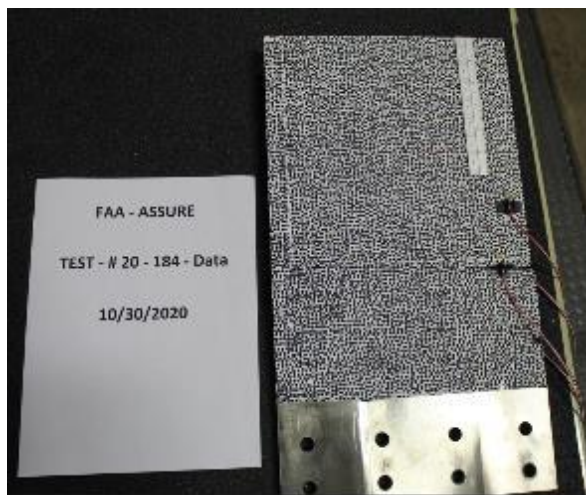
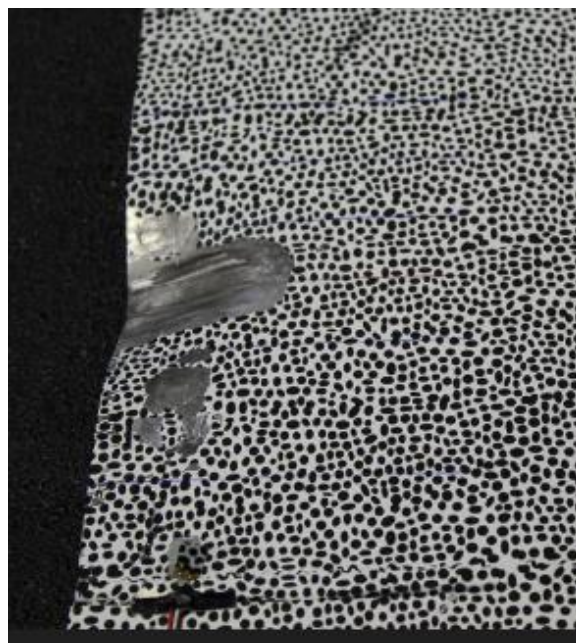
3.1.2.2. Test M50L5-005

| Test Results Summary | Plastic deformation in blade leading edge without loss of material |

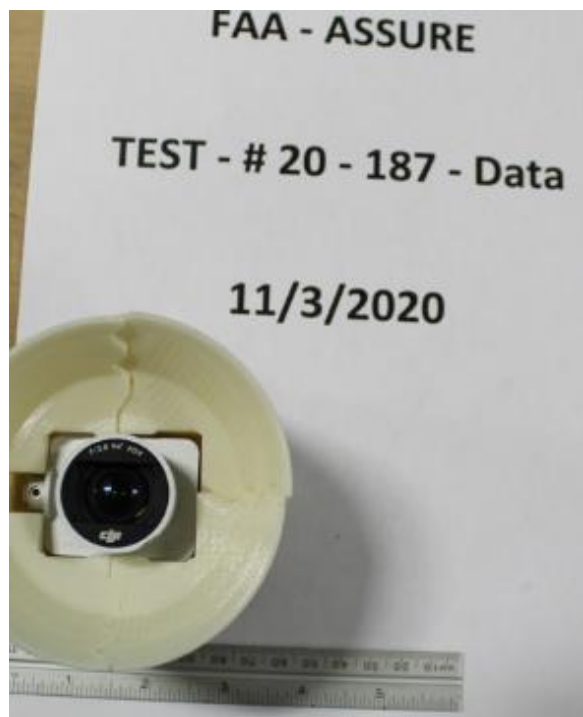
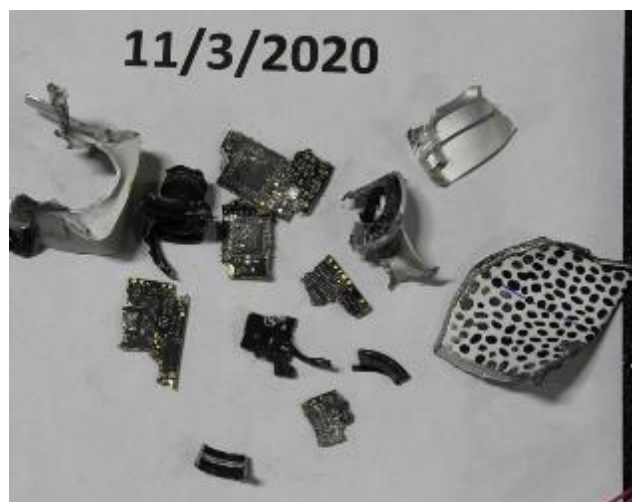
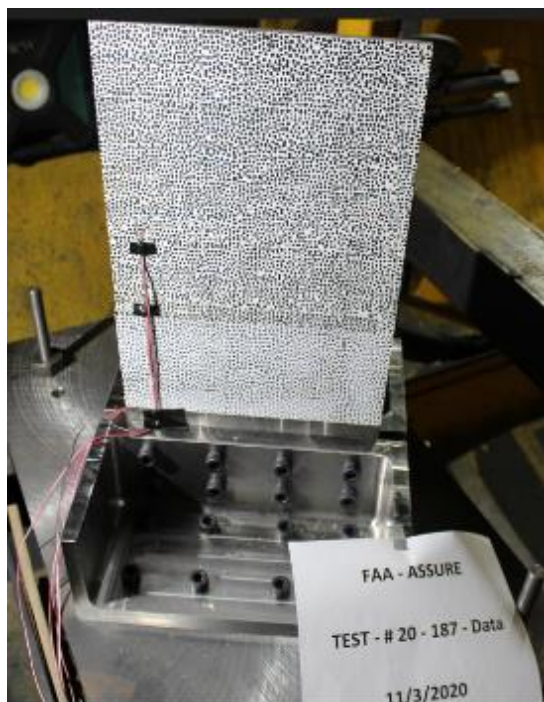
| Test Results Summary | Impact created a petal-shaped section that tore off away from the point of impact |

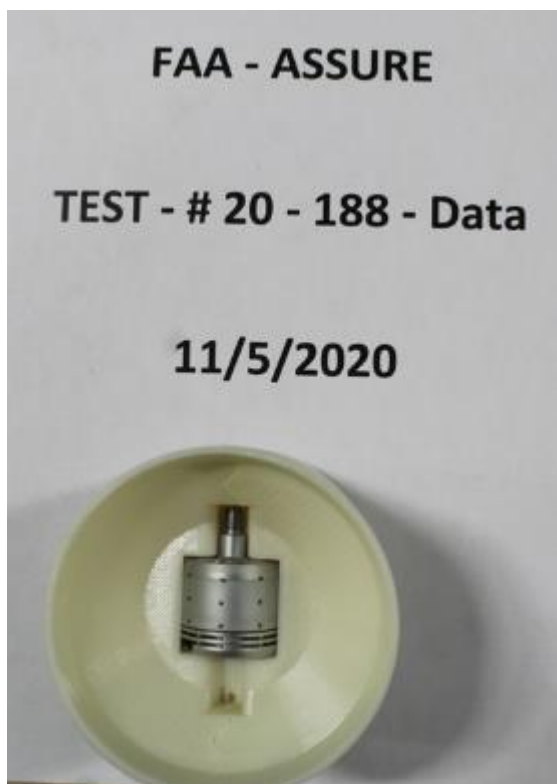
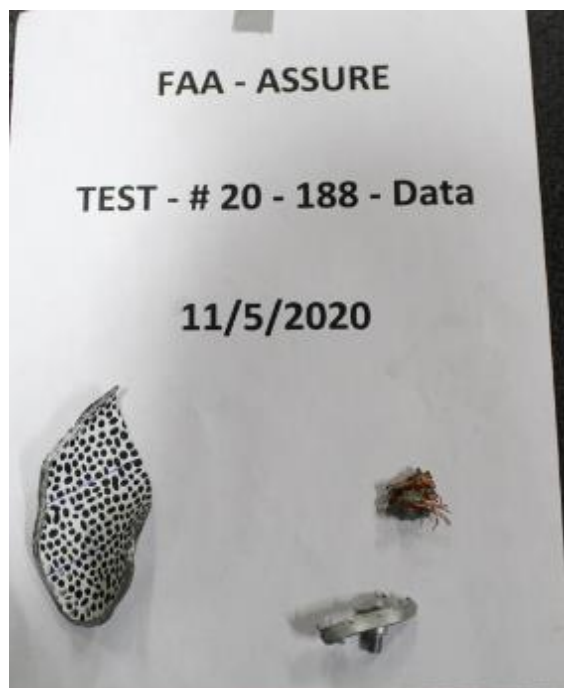
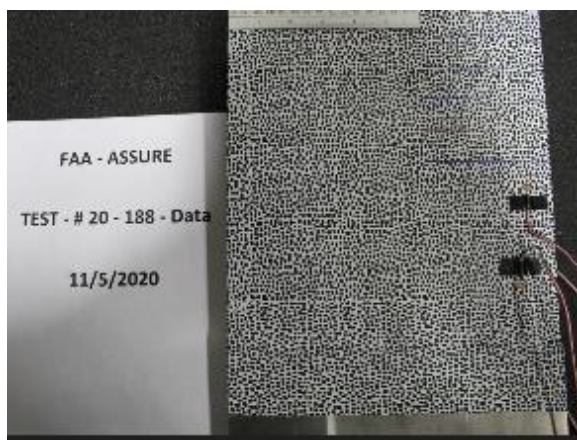
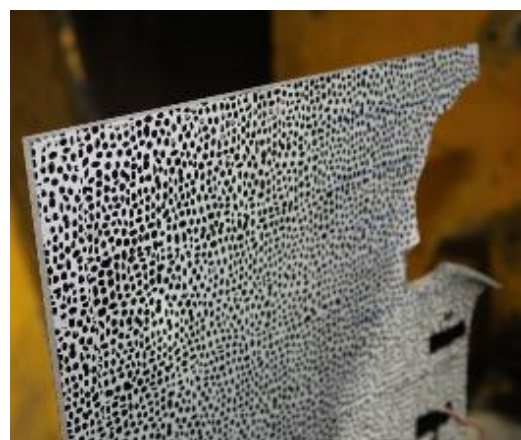
3.1.2.6. M80L7-001

| Test Results Summary | Impact broke a >4'' section of material off from the leading edge of the blade |

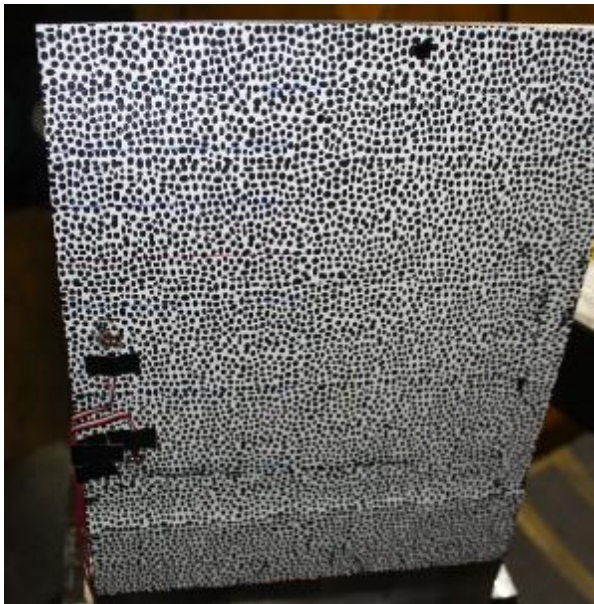
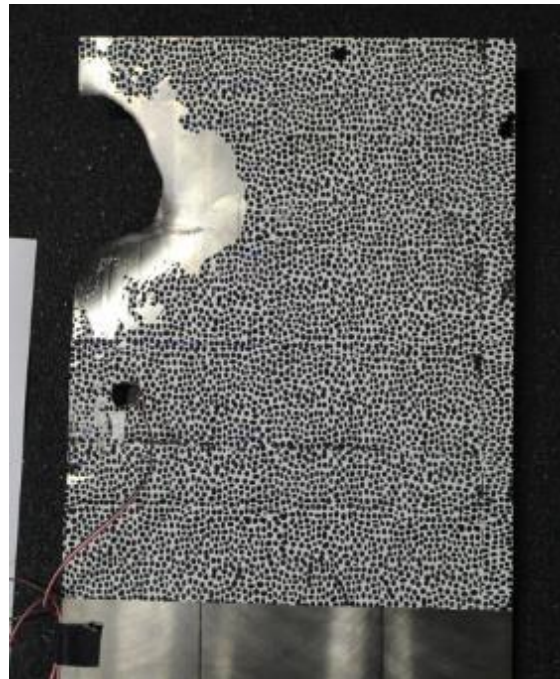
| Test Results Summary | Impact broke a crescent-shaped section out of the leading edge of the blade |

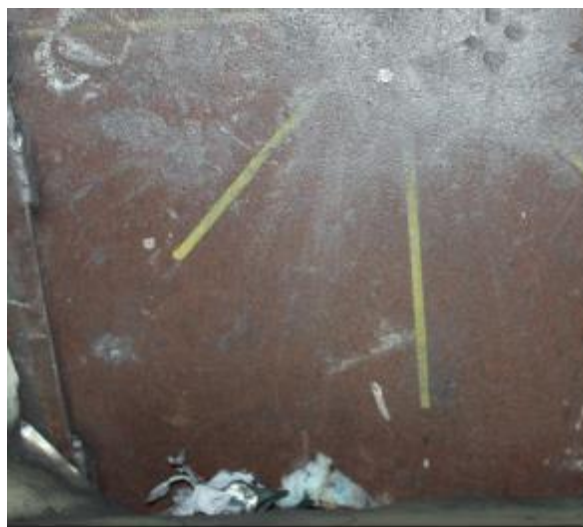
| Test Results Summary | Blade bent away from the impact in vicinity of the base at the fixture grip. Battery broke apart into plastic parts, pieces of film, and Lipo dust |

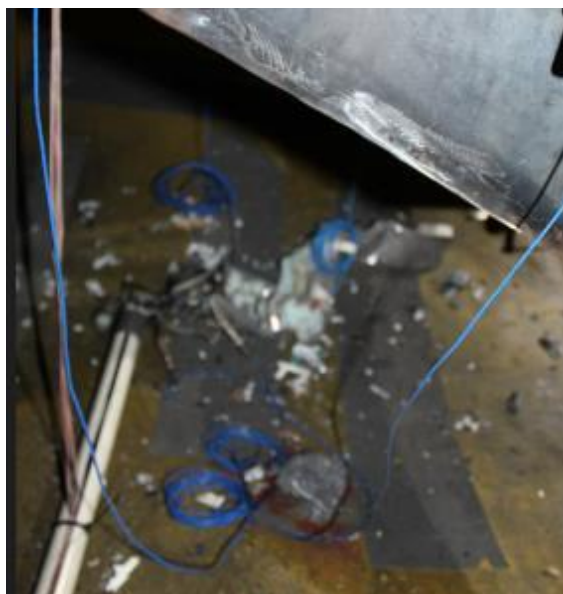
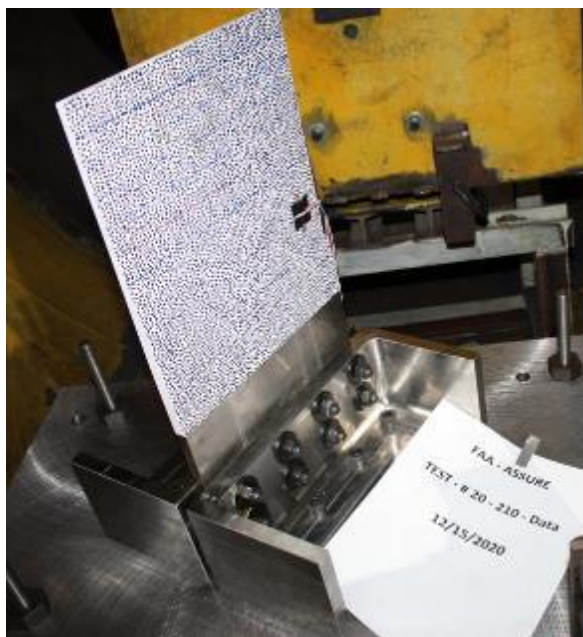
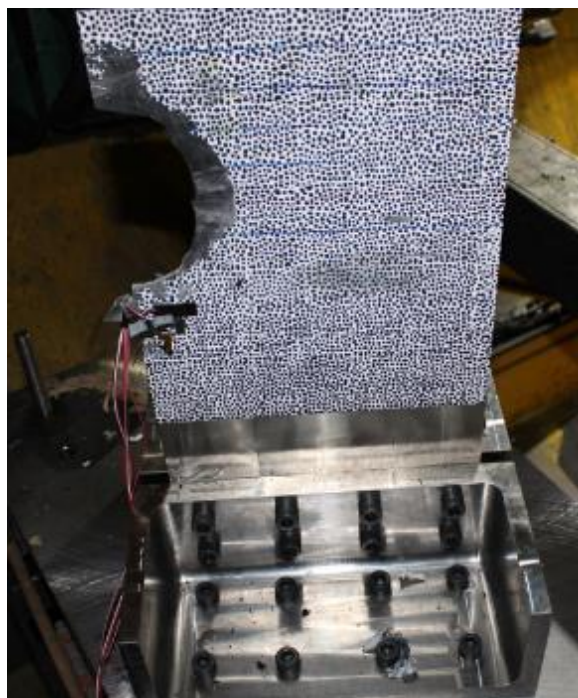
3.1.2.15. B50L7-010

| Test Results Summary | Velocity was reduced from 710kts because of battery deformation during acceleration. Battery impact removed an approximately 7'' high and >3'' wide crescent-shaped section of material from the leading edge. |

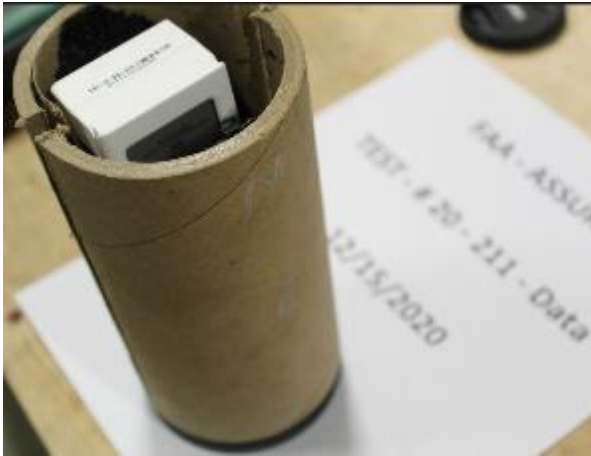
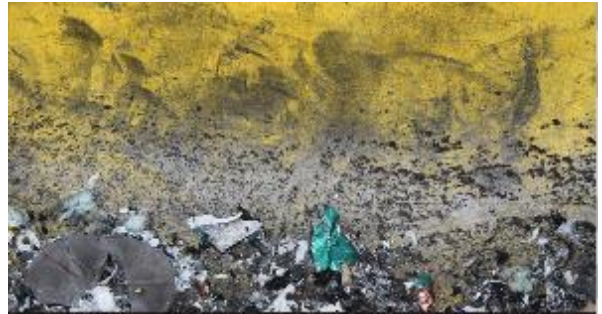
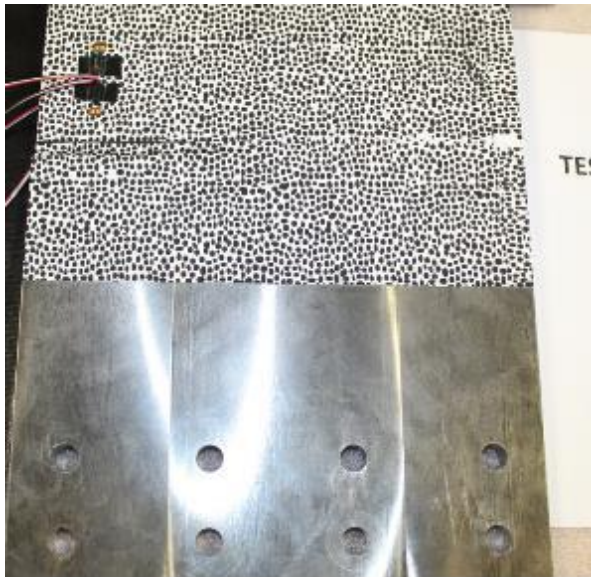
3.1.2.16. B50L7-011

| Test Results Summary | Velocity was reduced from 710kts because of battery deformation during acceleration. Battery impact removed an approximately 8'' high and >4'' wide crescent-shaped section of material from the leading edge. |

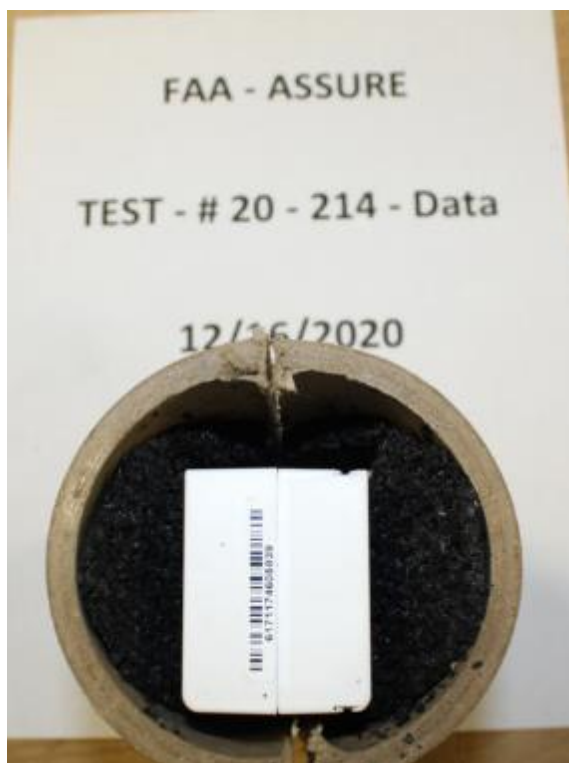
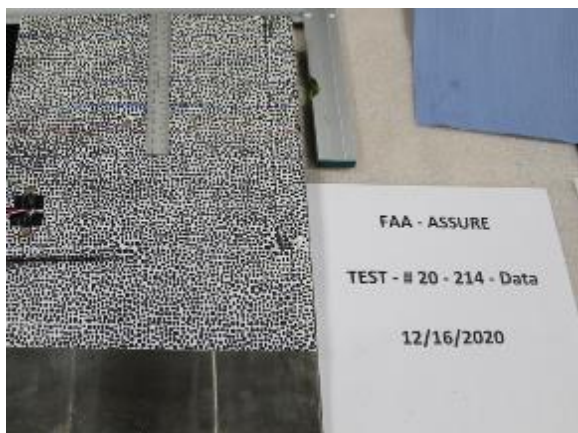
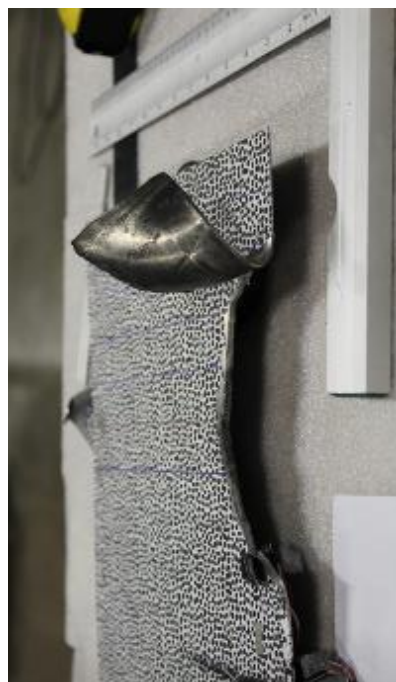
3.1.2.17. B50L7-012

Test Results Summary Velocity was reduced from 710kts because of battery deformation during acceleration. Battery impact removed an approximately 6'' high and >3'' wide crescent-shaped section of material from the leading edge.

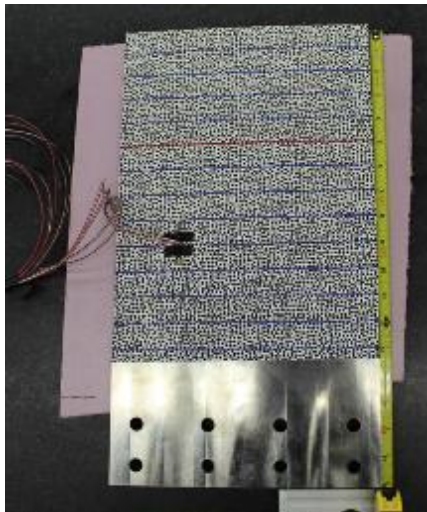
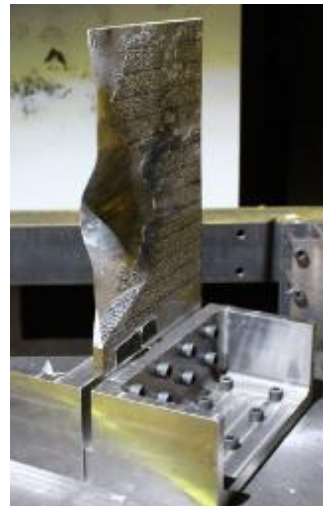
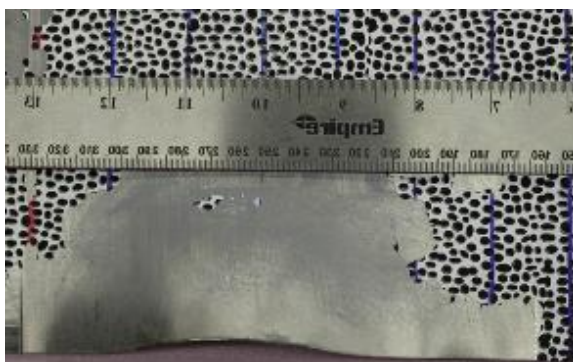
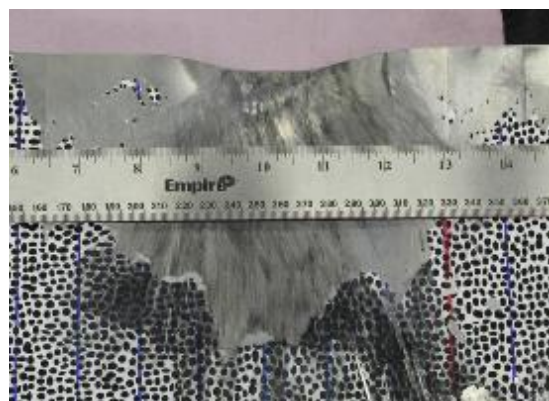
| Test Results Summary | The aircraft impact created an approximately 6'' bowed-out deformation in the leading edge of the blade. The impact did not appear to create any leading-edge fractures or tears. |

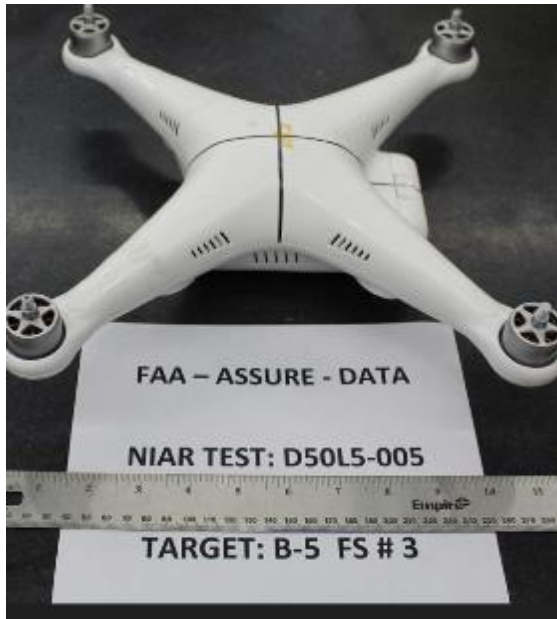
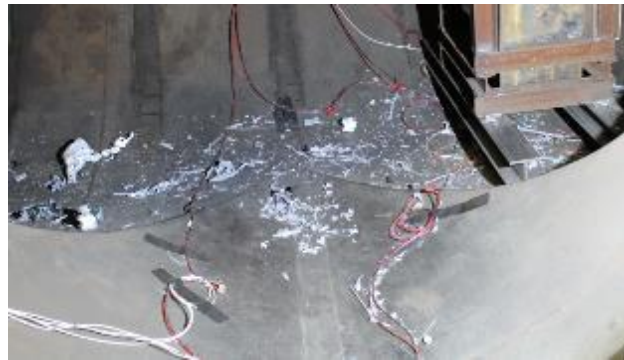
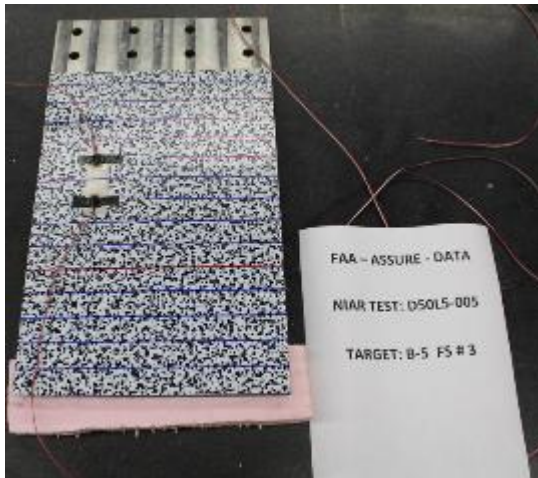
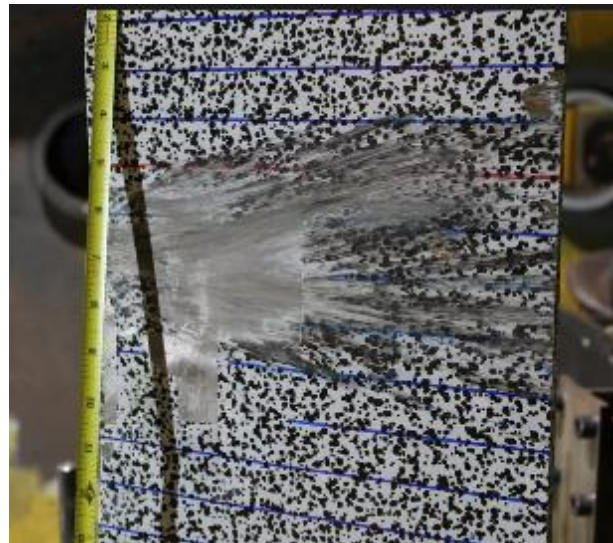
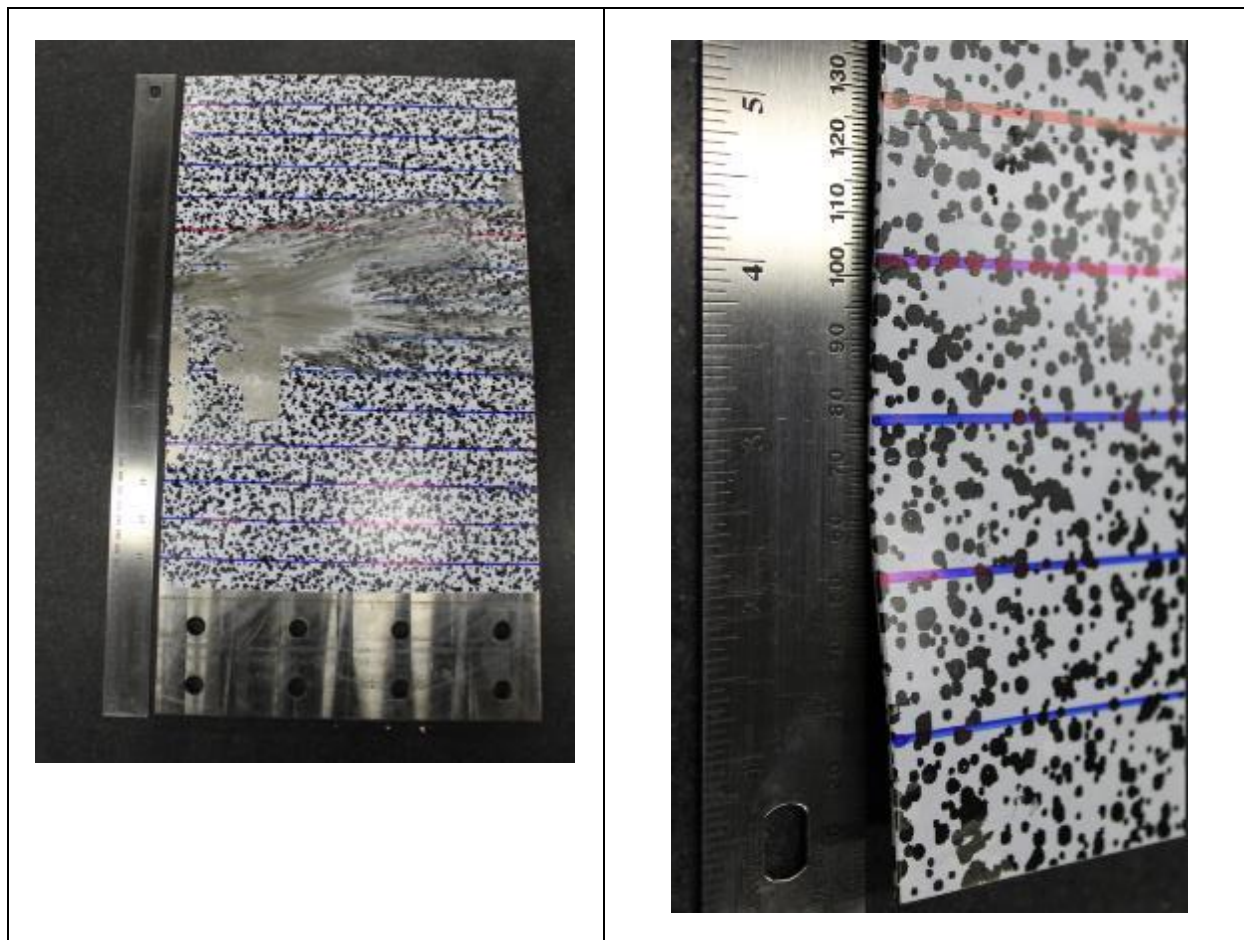
4.1.2.2. D50L5-005

| Test Results Summary | Left Side Digital Image Correlation System lighting did not trigger. Aircraft center body impact was right and aft of intended point on the leading edge, resulting in overall bending of the blade. |

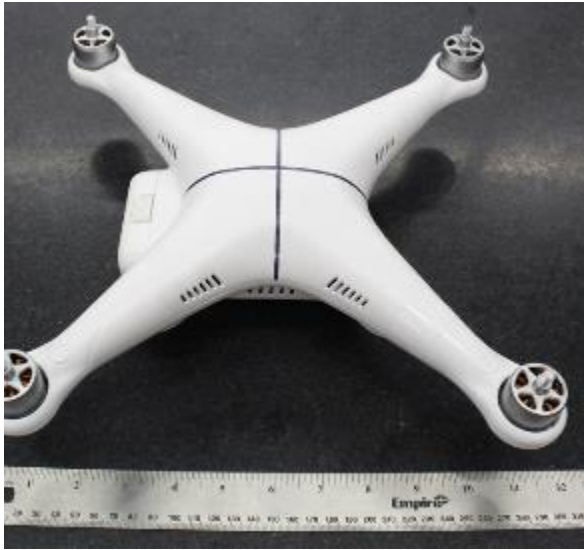
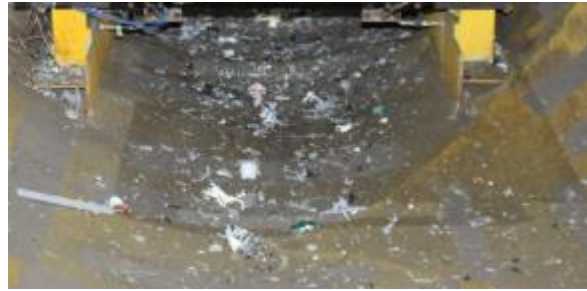
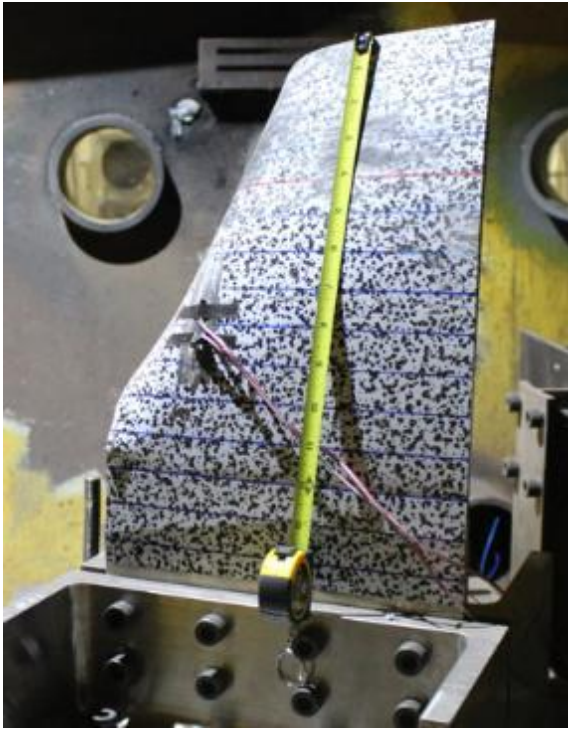
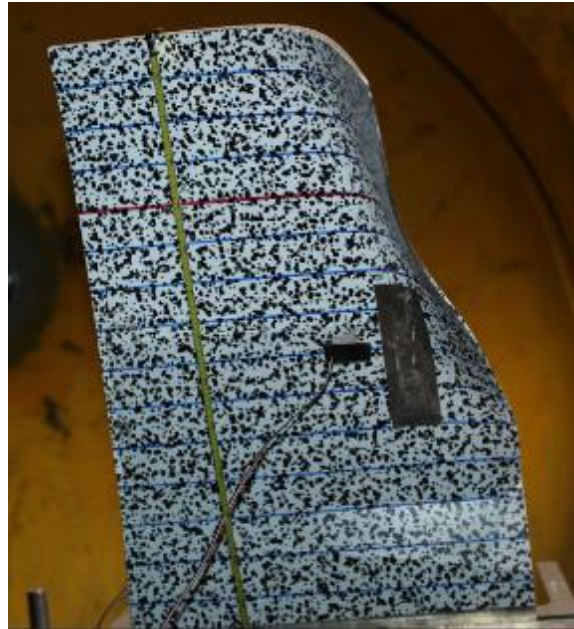
4.1.2.3. D80L7-002

| Test Results Summary | The impact resulted in a significant plastic deformation in which the blade was bent away from the impact. |

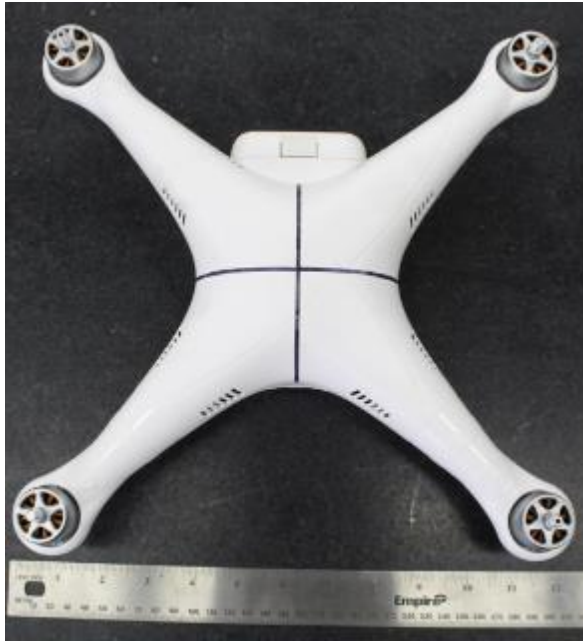
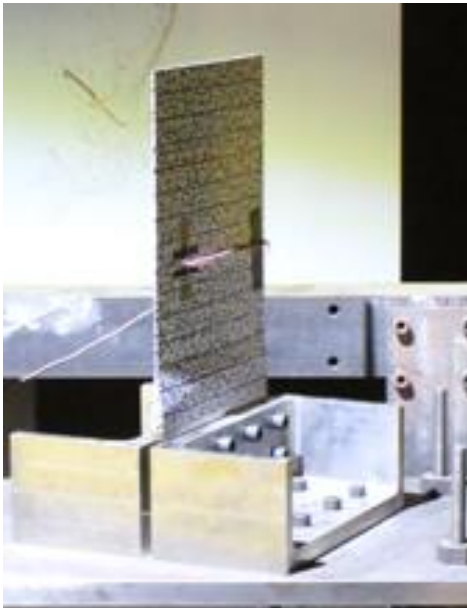
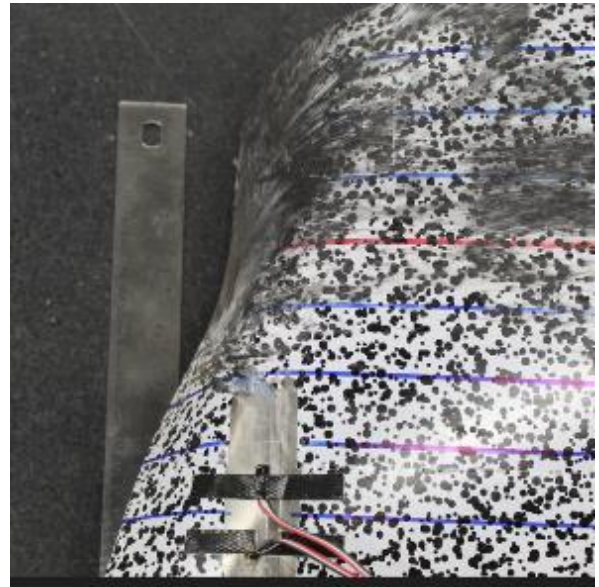
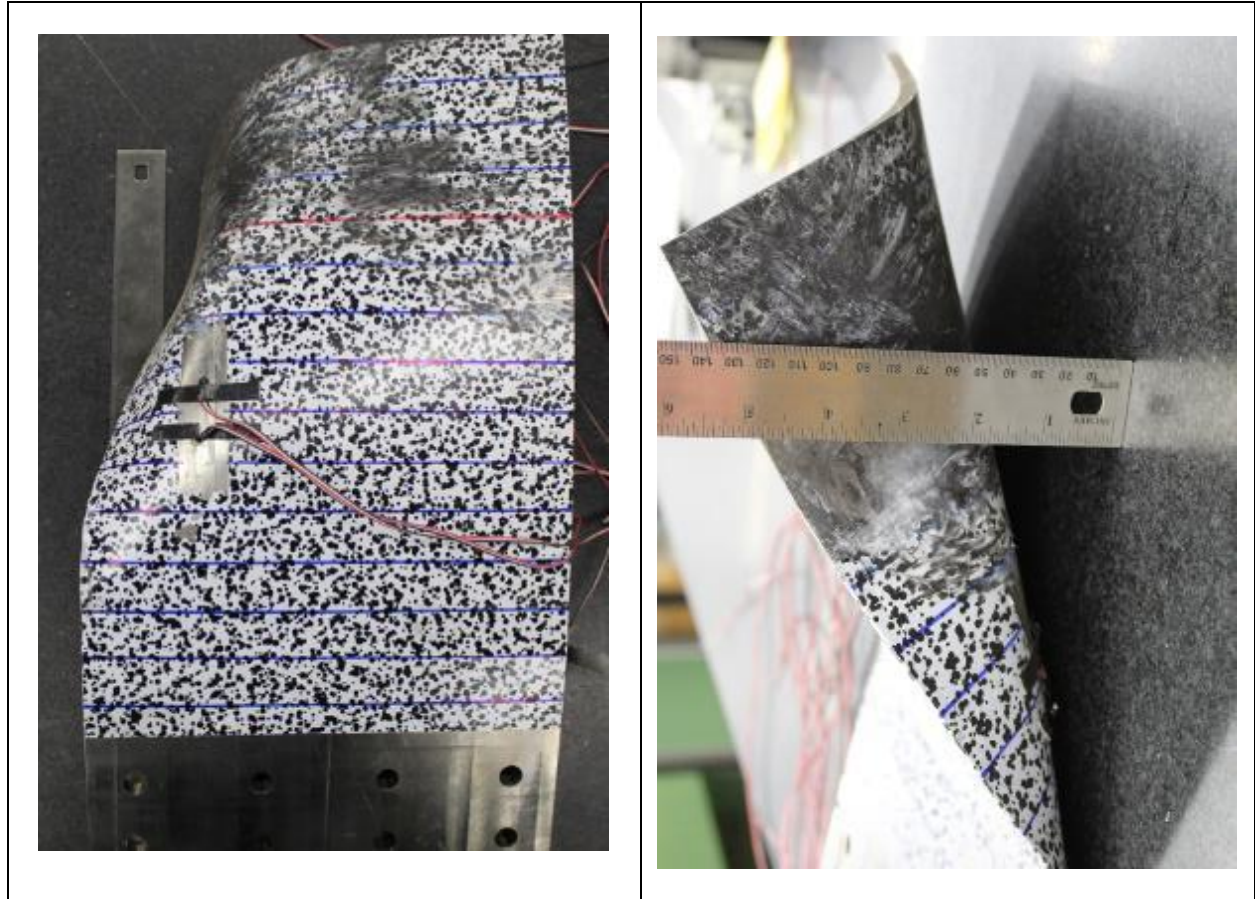
4.1.2.4. D80L7-001

| Test Results Summary | The impact resulted in a significant plastic deformation in which the blade was bent away from the impact. |

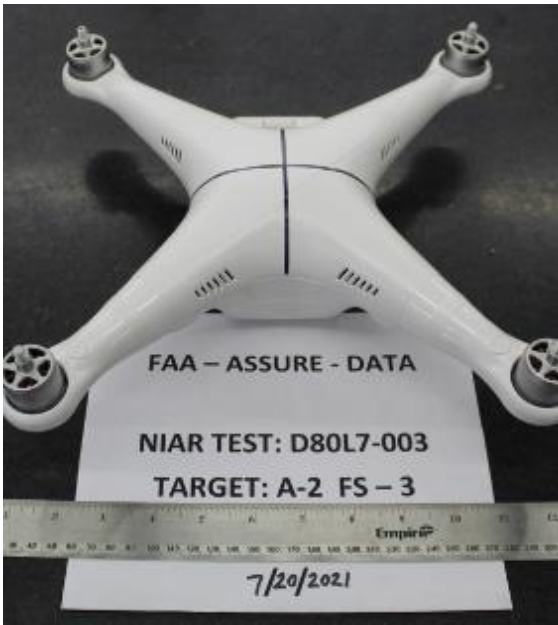
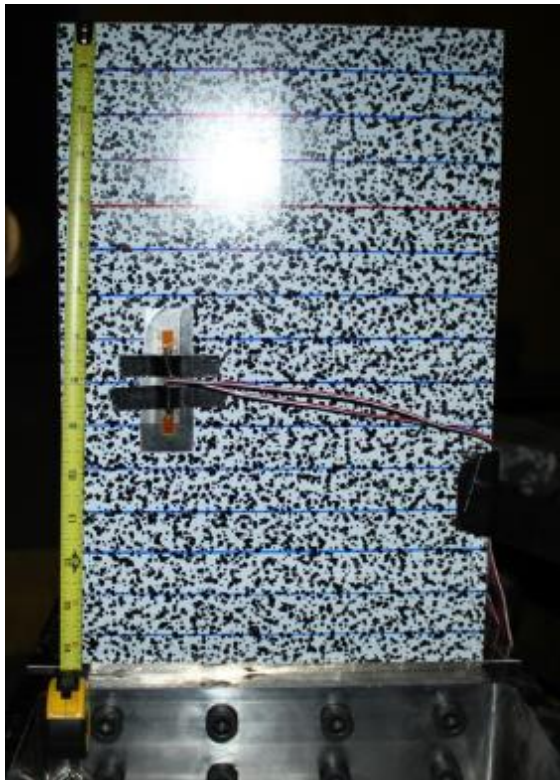
4.1.2.5. D80L7-003

| Test Results Summary The impact resulted in a significant plastic deformation in which the blade was bent away from the impact. |

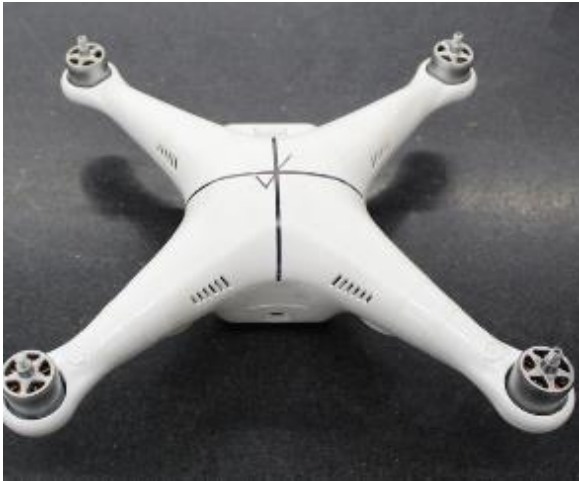
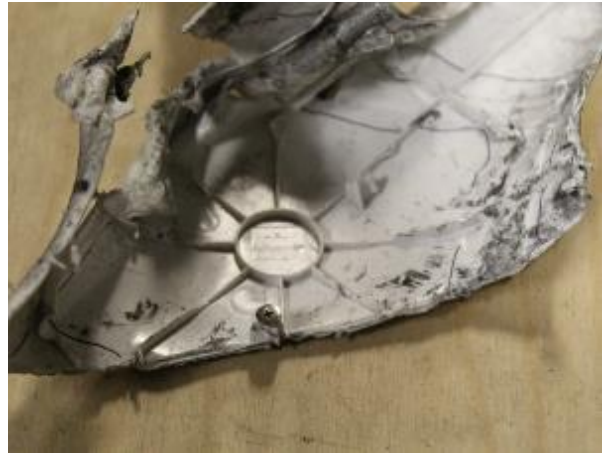
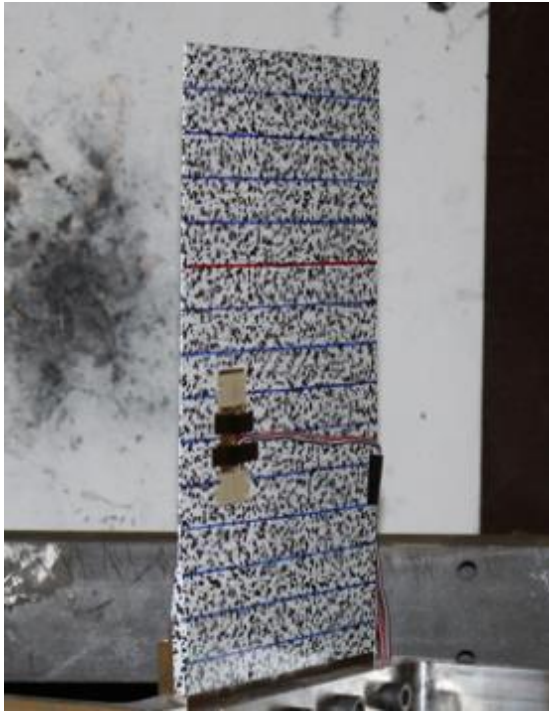
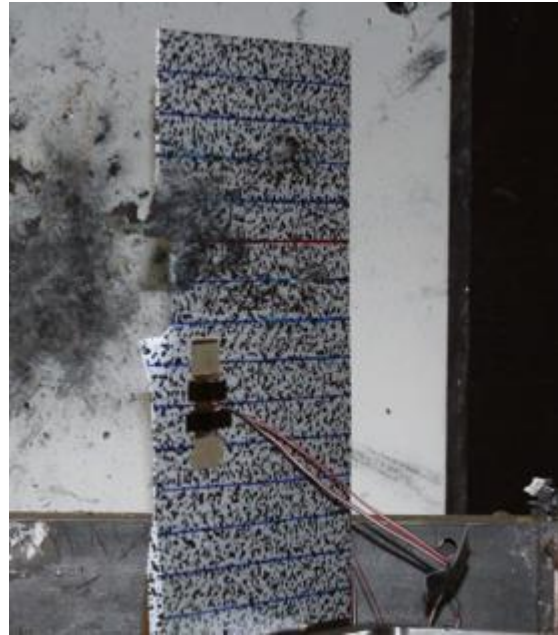
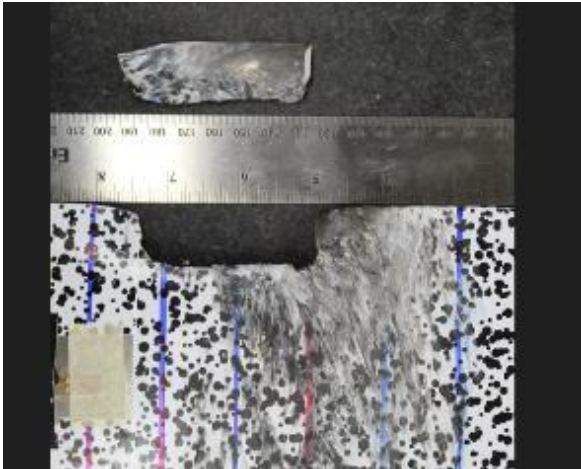
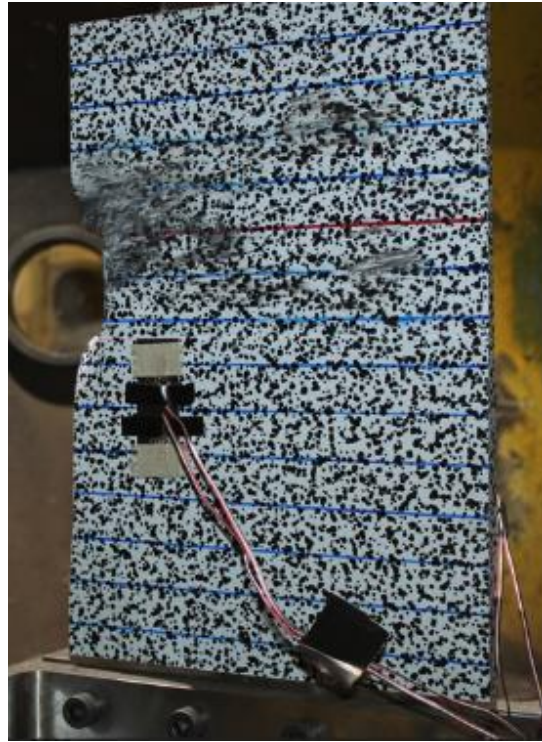
4.1.2.6. D50L5-006

| Test Results Summary | The impact resulted in separation of an approximately 2.5'' high and 1'' wide rectangular section from the leading edge of the blade. The aircraft was reduced to debris and battery dust. |
