DOT/FAA/AR-xx/xx

Volume VI – UAS Airborne Collision Severity Evaluation – 14 CFR Part 29 Rotorcraft

June 2022

Final Report

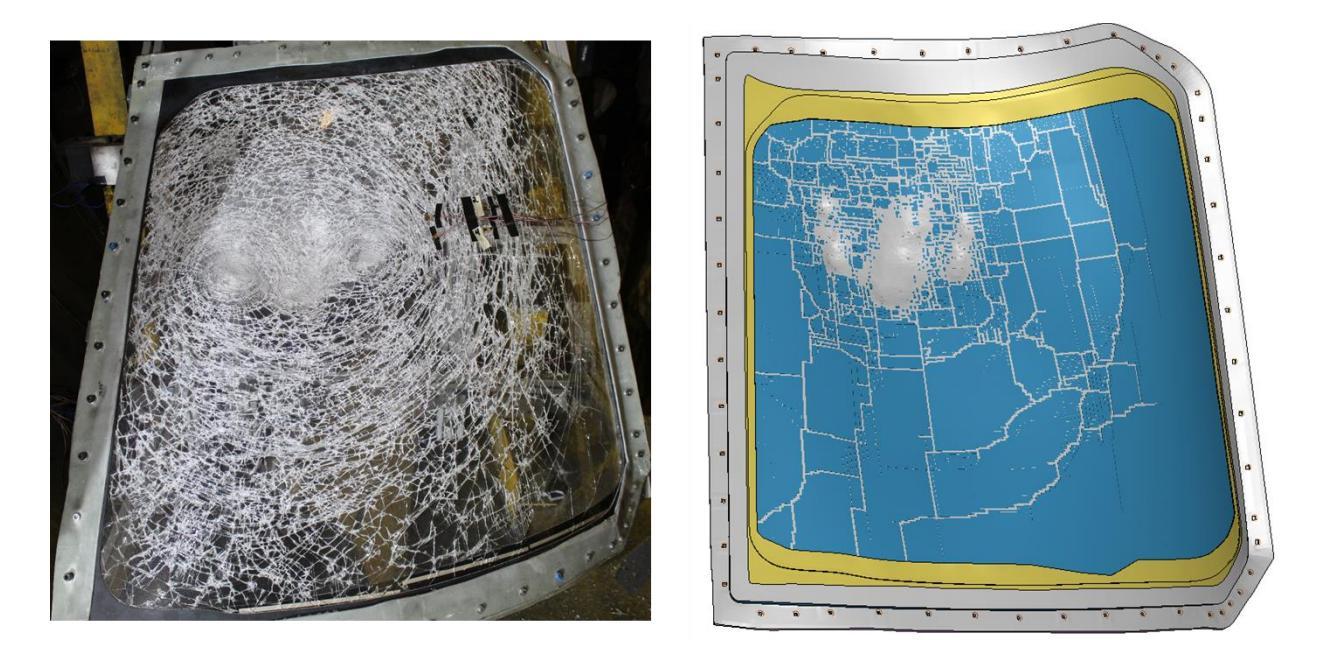
Figure 67. Windshield test at 175 knots – Damage comparison.

Figure 65 and Figure 66 compare the test and simulation results for both the isometric and top views, respectively. Figure 67 compares the windshield damage observed in the test article and the analysis results. Again, the test and analysis show a good correlation. The numerical model correlates the level of damage observed on the windshield during the test with significant cracking and shattering but without complete failure of the inner layer. The numerical results also show very similar UAS deformation to that observed in the test.

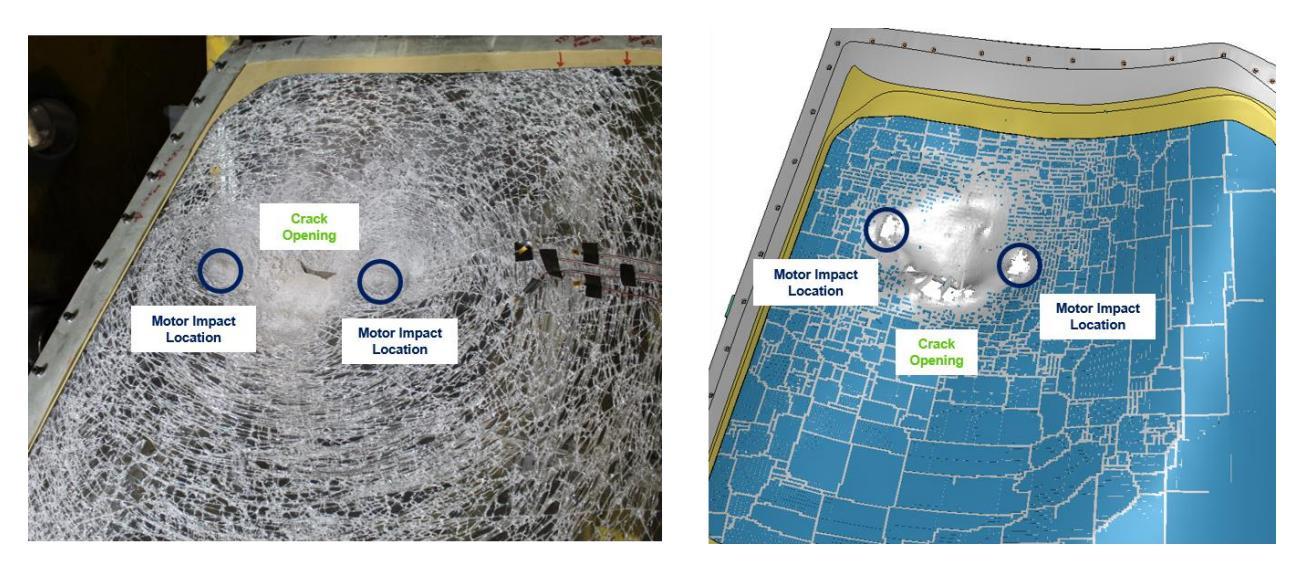
Figure 73. Windshield test at 300 knots – Damage comparison.

Figure 71 and Figure 72 present the comparison between the test and simulation results for both the isometric and top views, respectively. Figure 73 compares the windshield damage observed in the test article and the analysis results. The numerical model correlates with the kinematics and test results as with the previous test conditions. The model is capable of capturing the significant shattering and cracking observed on the windshield and the failure of the inner layer. The model can also capture the penetration of the UAS battery into the cockpit as observed during the physical test.

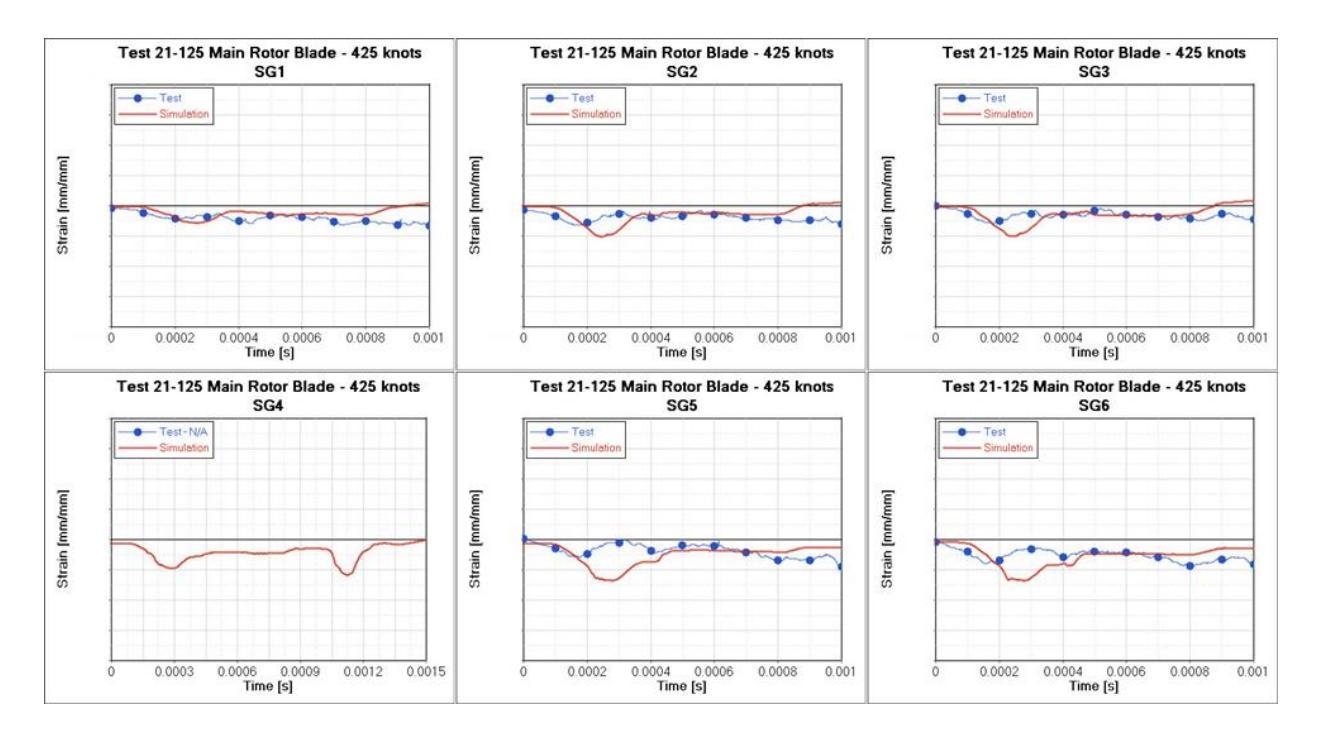
Figure 87. Test 21-125 SGs 1 to 6 simulation and test correlation

The strain gages data was compared with the simulation strain outputs. The simulation and test strain outputs show good correlation, indicating similar strain magnitude and behavior. Figure 87 compares the test strain gage data and the simulation. Strain gage 4 data was affected by the impact of the UAS; this data has not been included in the comparison. The values on the vertical axis are not shown for confidential reasons.

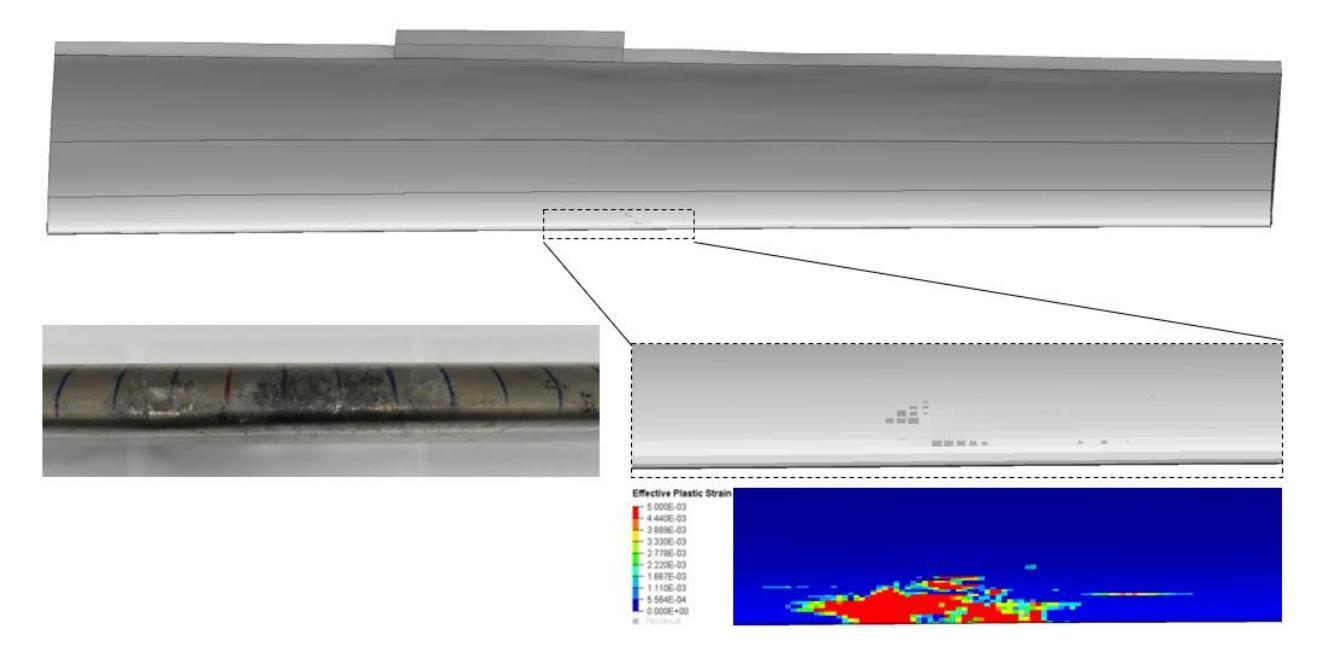
Figure 88. Test 21-125 blade leading edge damage.

The post-test examination of the test article revealed two areas of damage in the blade section: the leading edge and the inside of the blade. Figure 88 shows the dent on the test article's leading edge and the damage observed in the simulation. Although the FEM does not have a noticeable dent as in the test, the effective plastic strain contour indicates permanent deformation in the impact area.

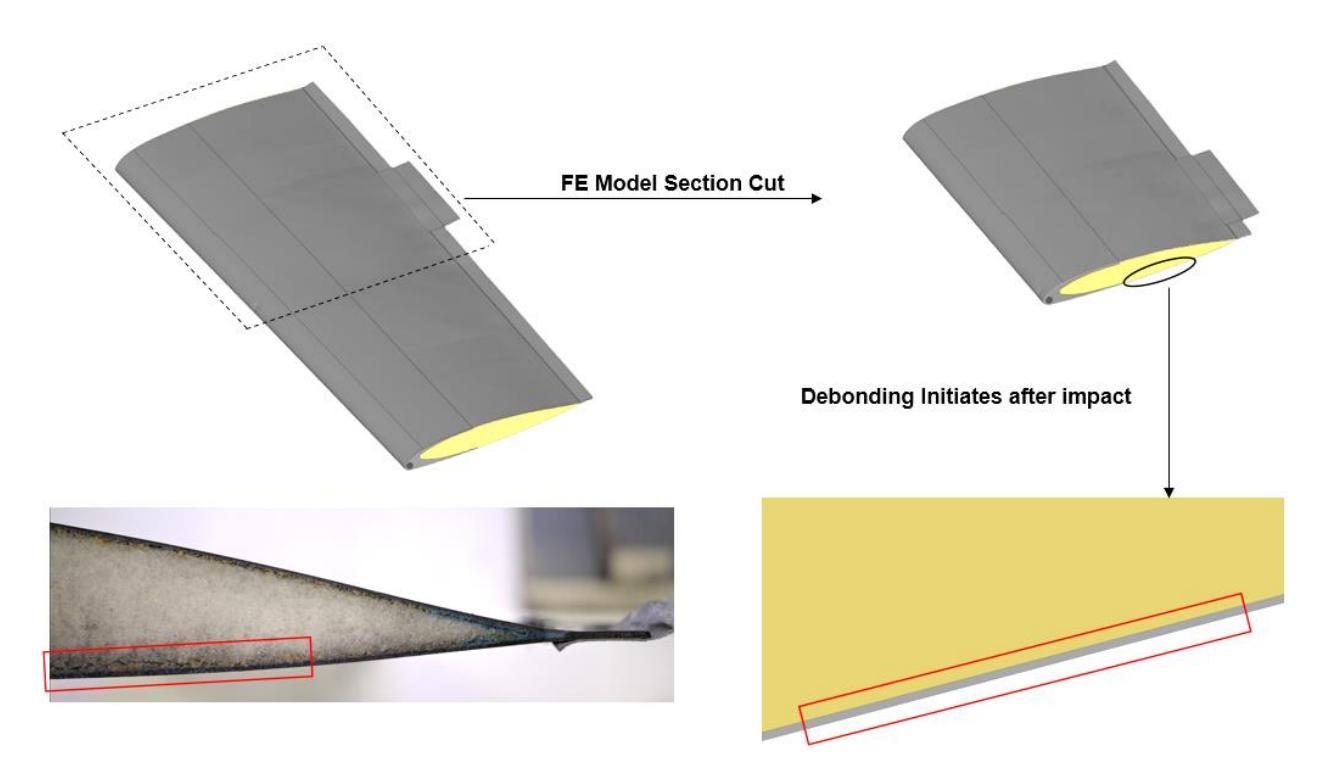
Figure 90. Test 21-125 blade skin debonding.

NIAR dissected the Test 21-125 blade section into three pieces to examine the damage inside the test specimen. Figure 89 shows the post-test blade dissection. The inboard direction points towards the blade root, whereas the outboard direction points towards the blade tip. Figure 90 presents the cross-section between cuts #1 and #2 in the outboard direction, indicating that the skin was debonded from the foam.

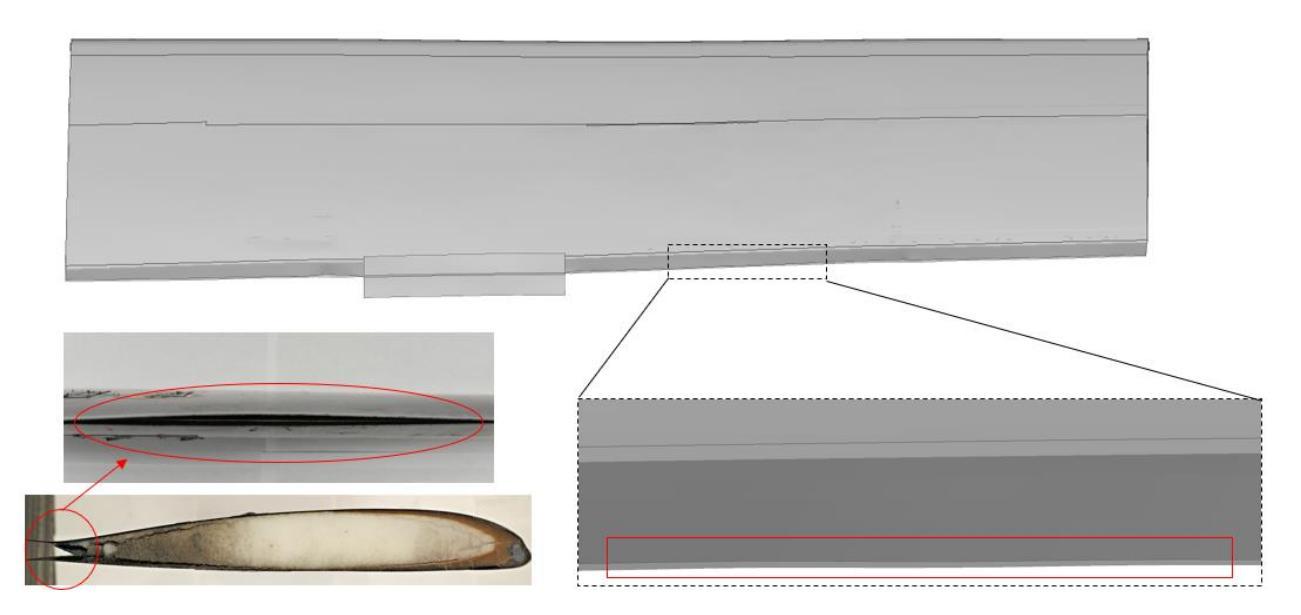
Figure 100. Test 21-126 trailing edge skin debonding.

NIAR dissected the Test 21-126 blade section into two pieces to examine the damage inside the test specimen. Figure 98 shows the post-test blade dissection. The inboard direction points towards the blade root, whereas the outboard direction points towards the blade tip. Figure 99 presents the cross-section between cuts #1 and #2 in the outboard direction, indicating that the skin was debonded from the foam in the test and the simulation. In addition, Figure 100 shows the trailing edge skin debonding, which was also captured by the simulation.

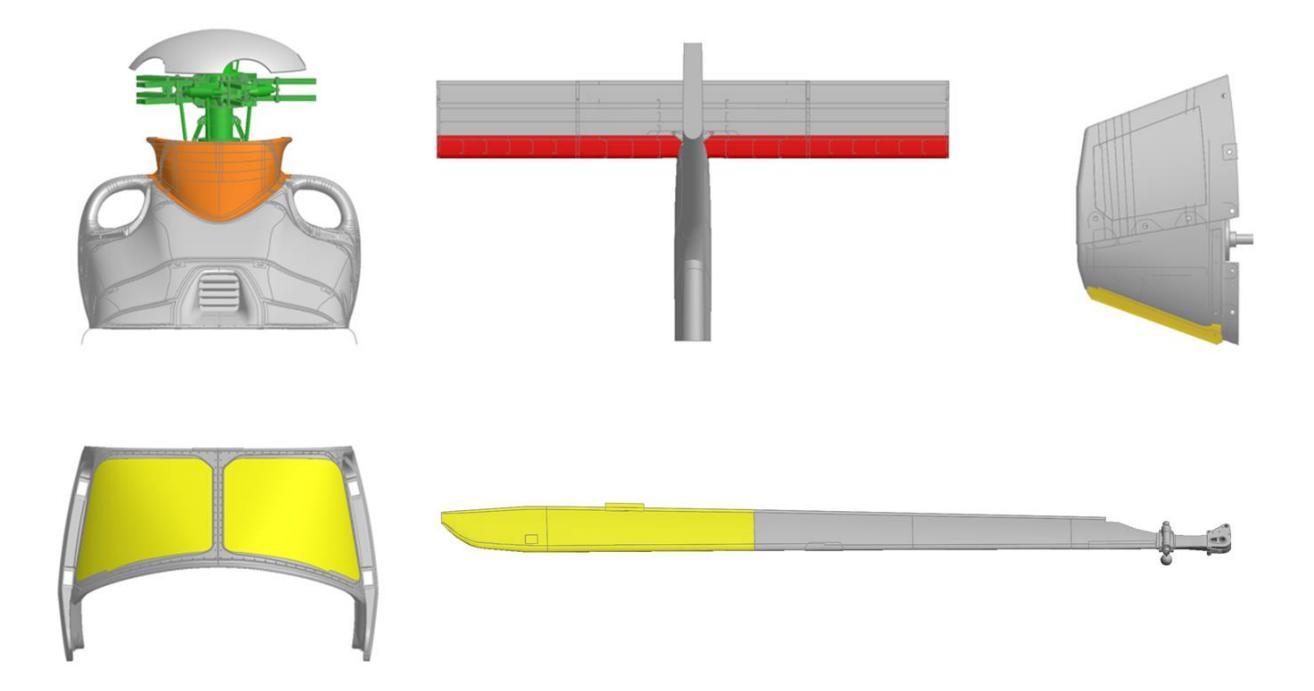
Figure 109. Summary of impact severity levels – Rotorcraft targets and quadcopter 2.7 lb. (RQ2.7).

This chapter presents the results of the airborne collision studies for the 2.7 lb. UAS quadcopter and the rotorcraft components. The target impact areas introduced in Chapter 5 are the front cowling, horizontal stabilizer, rear servo, windshield, and main rotor blade. Figure 109 illustrates the highest damage severity level observed on each target. In general, it can be noticed that the damage sustained by the rotorcraft component increases with the impact velocity. For example, the horizontal stabilizer shows level 4 damage at cruise speed. The front cowling location 1 impact at cruise speed shows level 3 damage to the cowling and level 1 to the rotor shaft structure (secondary impact). The rear servo, windshield, and blade cases have level 2 damage at cruise speed. Table 17 summarizes the damage severity level evaluation and fire risk assessment of the 2.7 lb. quadcopter impact cases.

Table 17 also includes the damage severity assessment of the tail rotor according to the findings from testing. As shown in APPENDIX B, the component level test results indicate the probability of a level 4 damage. Further work will be required in the future to conduct full-scale tests or simulation of the tail rotor.

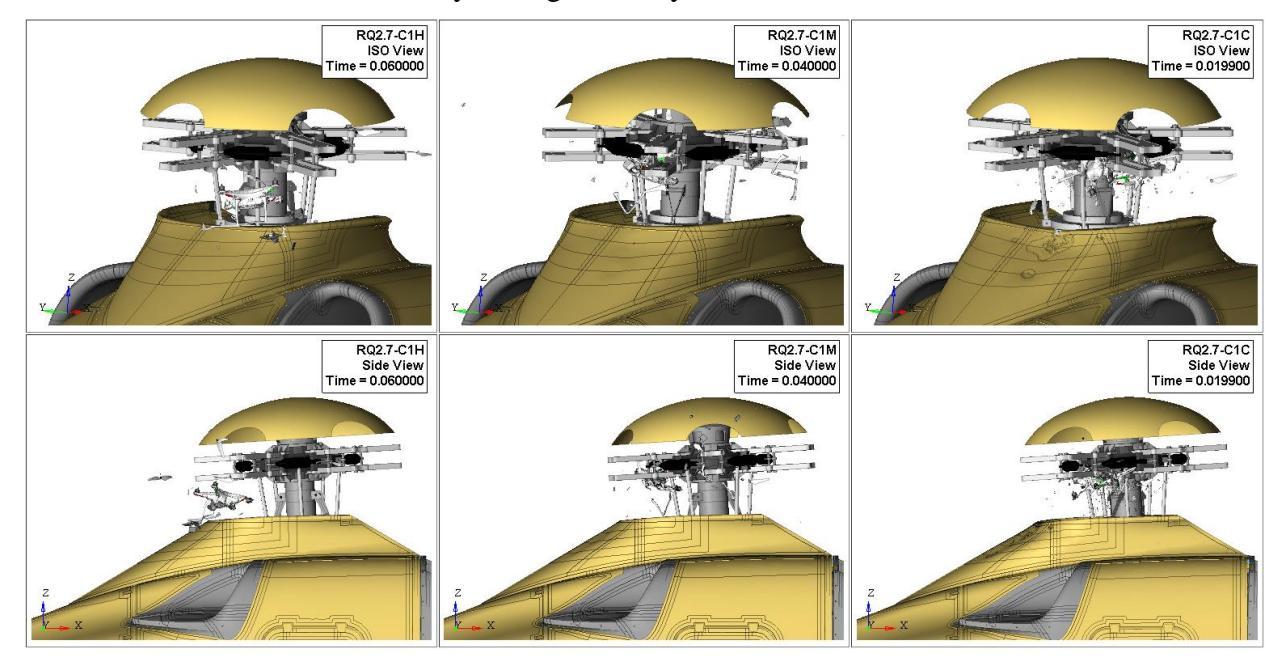
Figure 111. The final time of impact for RQ2.7-C1H, RQ2.7-C1M and RQ2.7-C1C (left to right).

Figure 111 presents the isometric and side views of the simulation's last instant for the three velocity iterations. Cases are presented from lowest (left) to highest velocity (right). The UAS was deflected towards the rotor shaft assembly after colliding with the cowling surface.

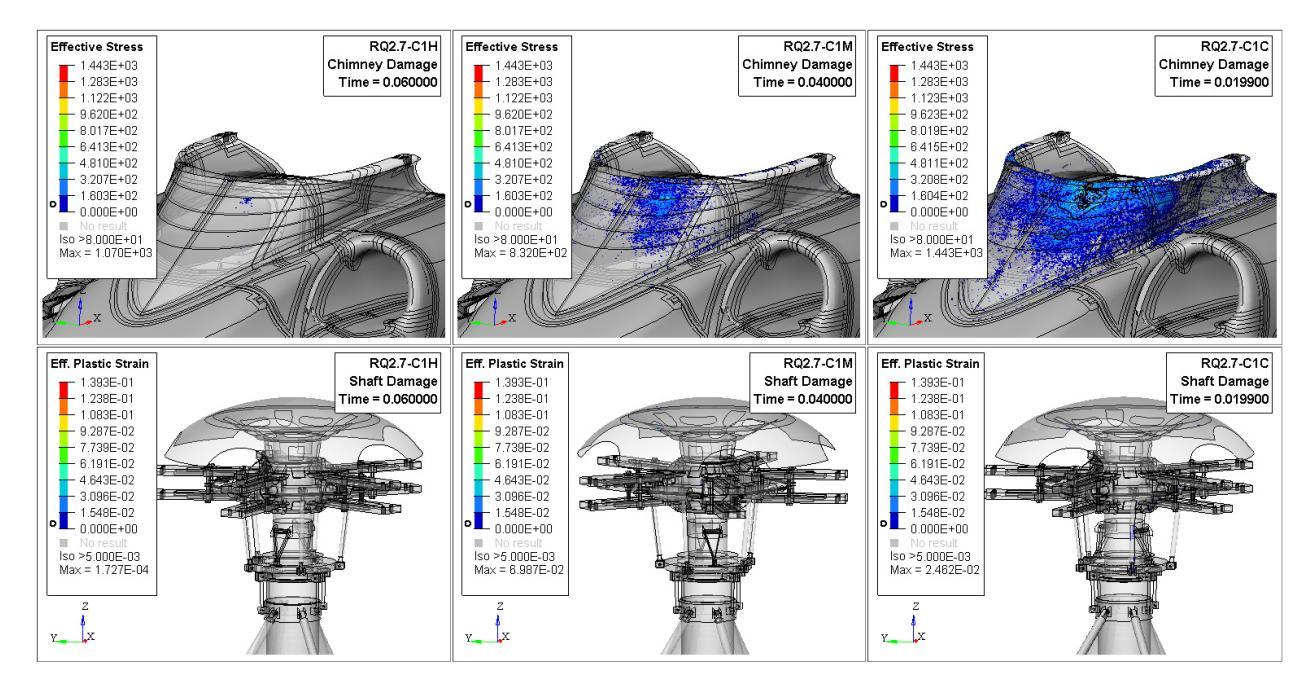
Figure 112. Chimney and rotor shaft damage for RQ2.7-C1H, RQ2.7-C1M and RQ2.7-C1C (left to right).

Figure 112 shows the damage observed on the chimney (upper images) and the rotor shaft assembly (lower images). The chimney sustains more damage as the impact velocity increases. RQ2.7-C1H shows no damage to the honeycomb structure. RQ2.7-C1M indicates damage to the honeycomb (core crushing) and no failure of the composite skin. RQ2.7-H1C captures damage to

the honeycomb and failure of the skin at the chimney's upper free edge. Thus, RQ2.7-C1H damage severity is level 1, RQ2.7-C1M of level 2, and RQ2.7-C1C of level 3.

The rotor shaft assembly presents no damage due to secondary impacts of the UAS debris. Therefore, the rotor shaft assembly damage severity was level 1 in all three cases.

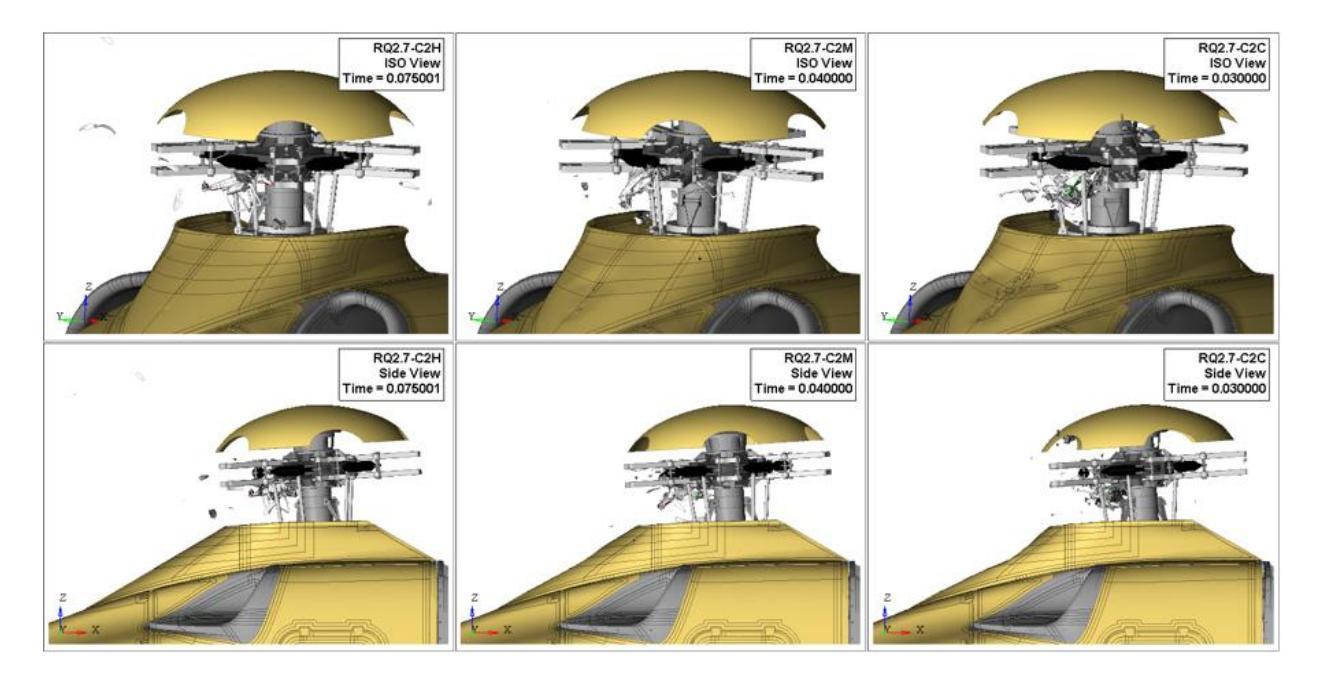
Figure 114. The final time of impact for RQ2.7-C2H, RQ2.7-C2M, and RQ2.7-C2C (left to right).

Figure 114 presents the isometric and side views of the simulation's last instant for the three velocity iterations. Cases are presented from lowest (left) to highest velocity (right). The UAS was deflected towards the rotor shaft assembly after colliding with the cowling surface.

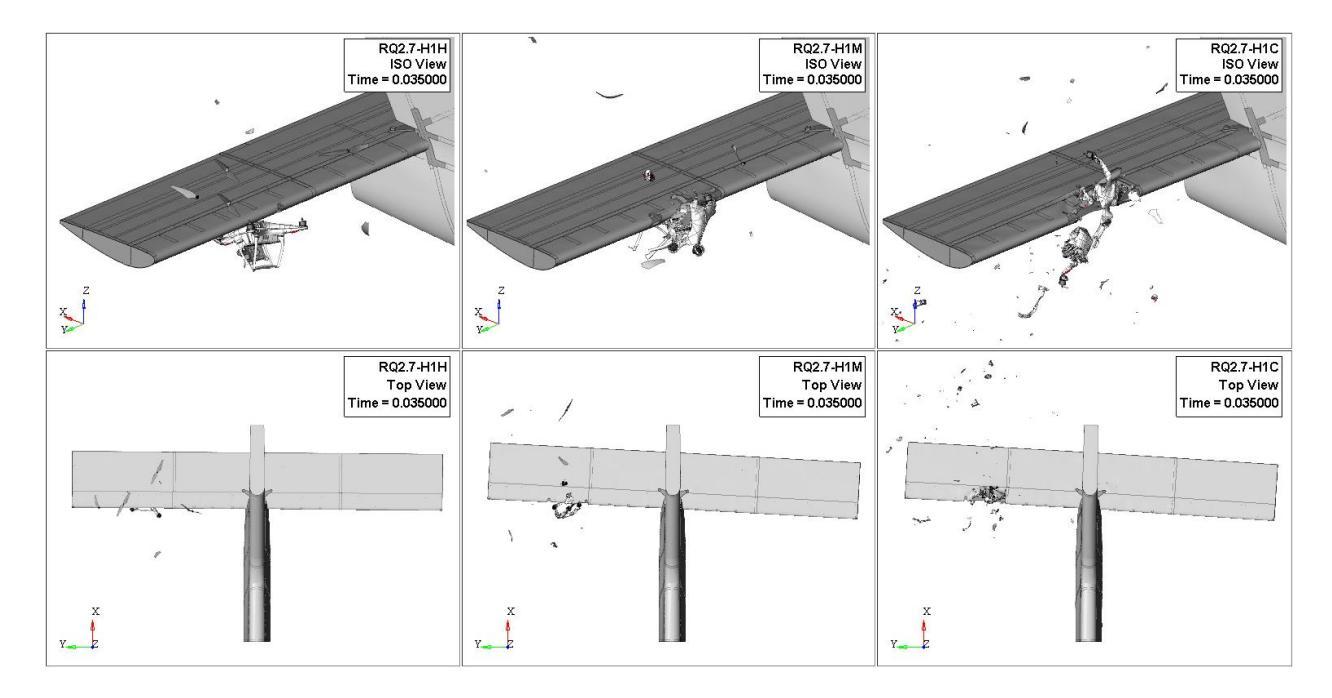
Figure 117. The final time of impact for RQ2.7-H1H, RQ2.7-H1M and RQ2.7-H1C (left to right).

Figure 117 shows the isometric and side views of the simulation's last instant for the three velocity iterations. Cases are presented from lowest (left) to highest velocity (right). In all three cases, the stabilizer rotates backward due to the UAS collision. The simulation also predicts the spring back motion of the stabilizer, which returned to its initial position after the impact.

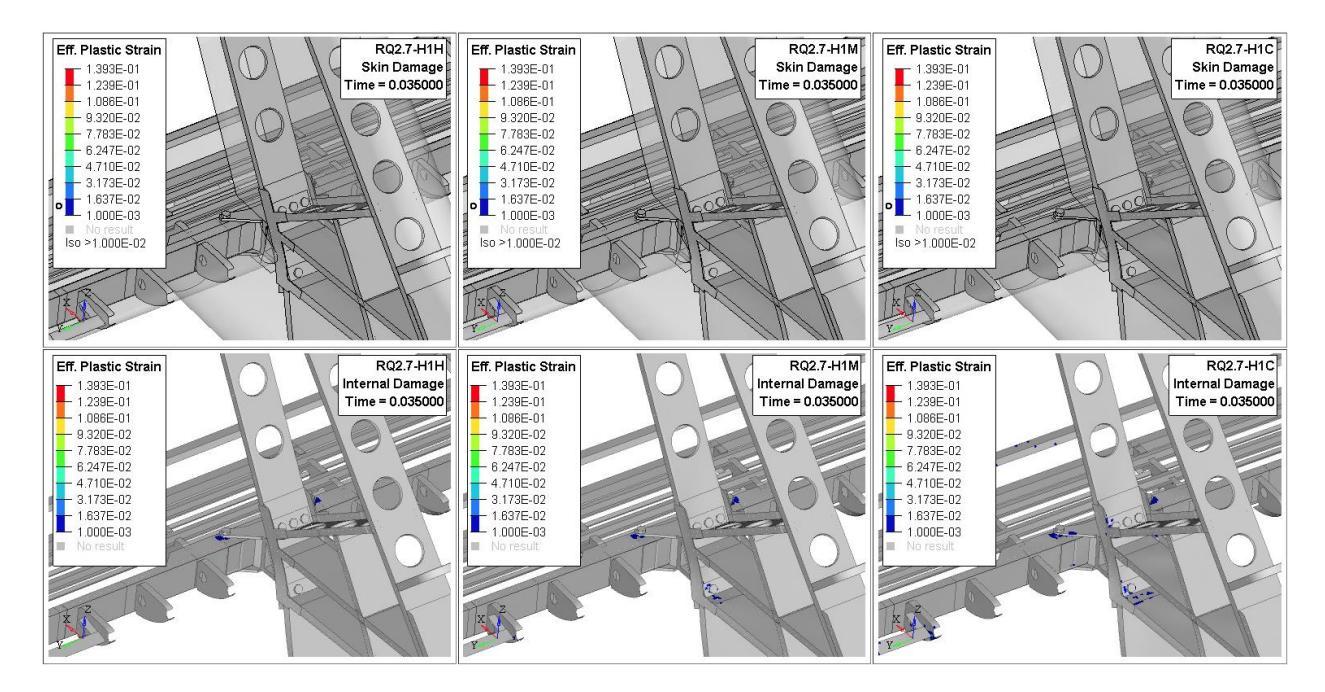
Figure 119. Skin and internal structures plastic strain at the tail root for RQ2.7-H1H, RQ2.7-H1M and RQ2.7-H1C (left to right).

In addition, due to the backward deflection of the horizontal stabilizer during the impact, some permanent deformation was observed in the root region of the horizontal stabilizer, where the airframe is connected to the rest of the tail. The deformation was located near the large bolts that secure the stabilizer's connection and increase with the velocity of the impact. Figure 119 depicts the effective plastic strain of the horizontal stabilizer's root region.

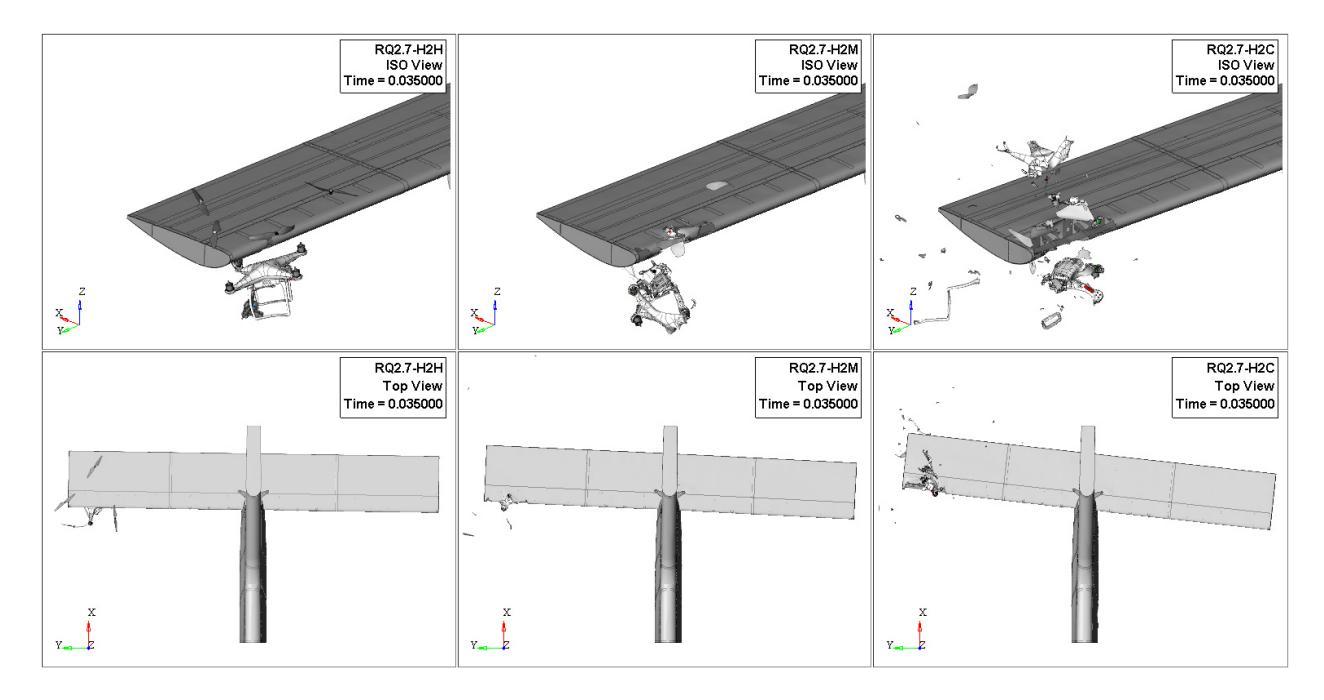
Figure 121. The final impact time for RQ2.7-H2H, RQ2.7-H2M, and RQ2.7-H2C (left to right).

Figure 121 shows the isometric and side views of the simulation's last instant for the three velocity iterations. Cases are presented from lowest (left) to highest velocity (right). In all three cases, the stabilizer rotates backward due to the UAS collision. The simulation also predicts the spring back motion of the stabilizer, which returned to its initial position after the impact.

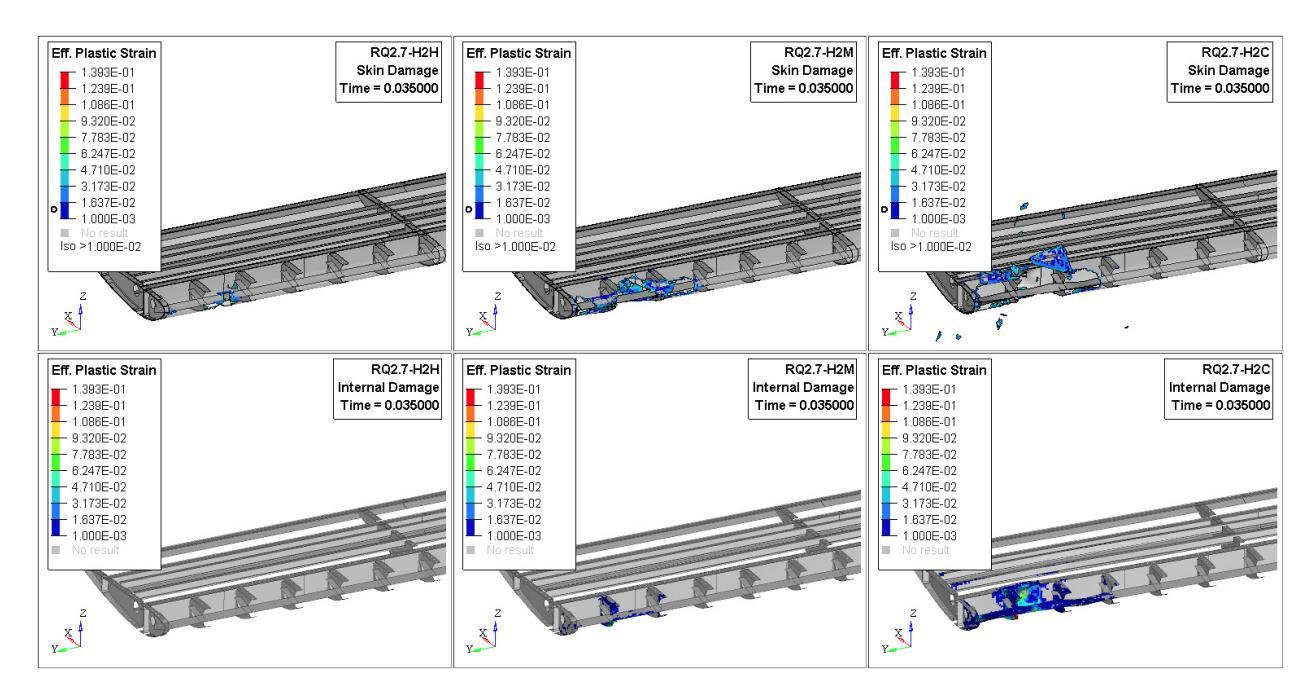
Figure 122. Skin and internal structures plastic strain for RQ2.7-H2H, RQ2.7-H2M, and RQ2.7-H2C (left to right).

Figure 122 shows the permanent deformation of the horizontal stabilizer's skin (upper images) and the internal components (lower images). The horizontal stabilizer assembly sustains more damage as the impact velocity increases. RQ2.7-H2H shows little damage to the skin and none to the internal components. RQ2.7-H2M presents rupture of the skin and permanent deformation of the closest nose ribs. RQ2.7-H2C has a larger opening of the leading edge skin and indicates permanent spar deformation, a primary structural member. Thus, RQ2.7-H2H has a damage severity of level 1, RQ2.7-H2M has a damage severity of level 3, and RQ2.7-H2C is classified as level 4.

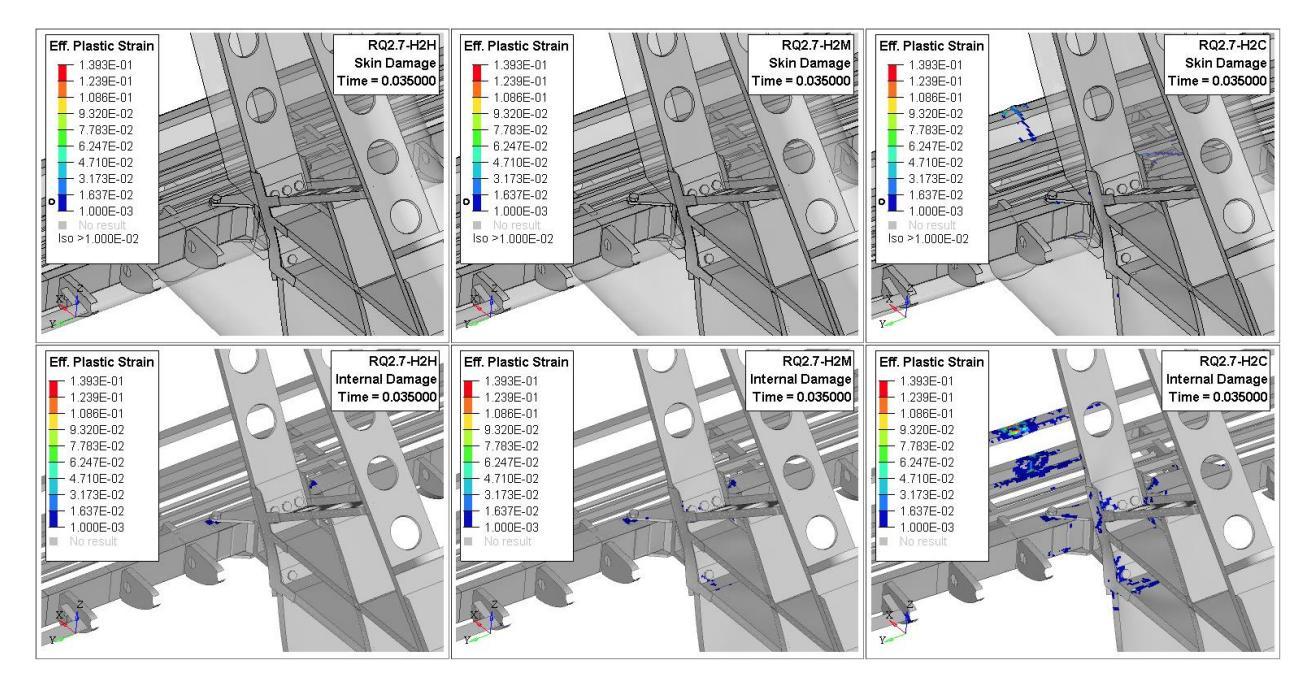
Figure 123. Skin and internal structures plastic strain at the tail root for RQ2.7-H2H, RQ2.7-H2M, and RQ2.7-H2C (left to right).

In addition, due to the backward deflection of the horizontal stabilizer during the impact, some permanent deformation was observed in the root region of the horizontal stabilizer, where the airframe is connected to the rest of the tail. The deformation was located near the large bolts that secure the stabilizer's connection and increase with the velocity of the impact. Figure 123 depicts the effective plastic strain of the horizontal stabilizer's root region.

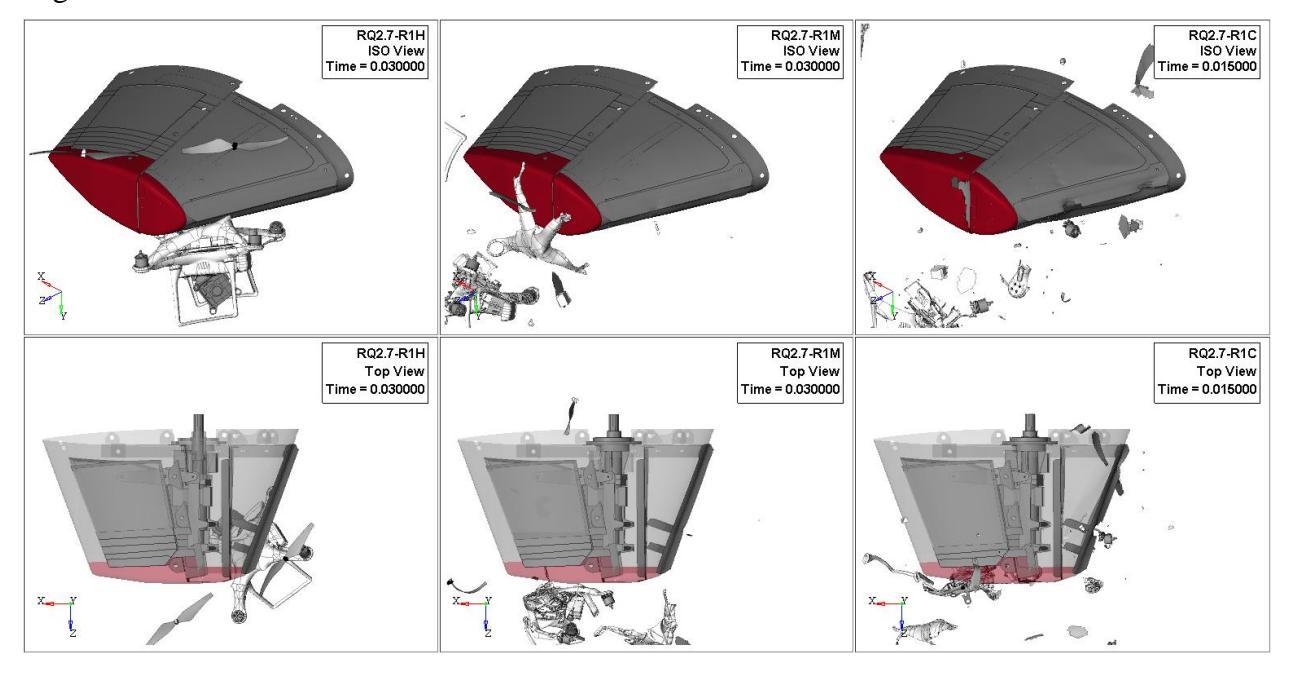
Figure 125. The final time of impact for RQ2.7-R1H, RQ2.7-R1M and RQ2.7-R1C (left to right).

Figure 125 shows the isometric and side views of the simulation's last instant for the three velocity iterations. Again, cases are presented from lowest (left) to highest velocity (right). Again, the rear servo could sustain the impact with the quadcopter, and no indications of failure of the leading edge skin were observed.

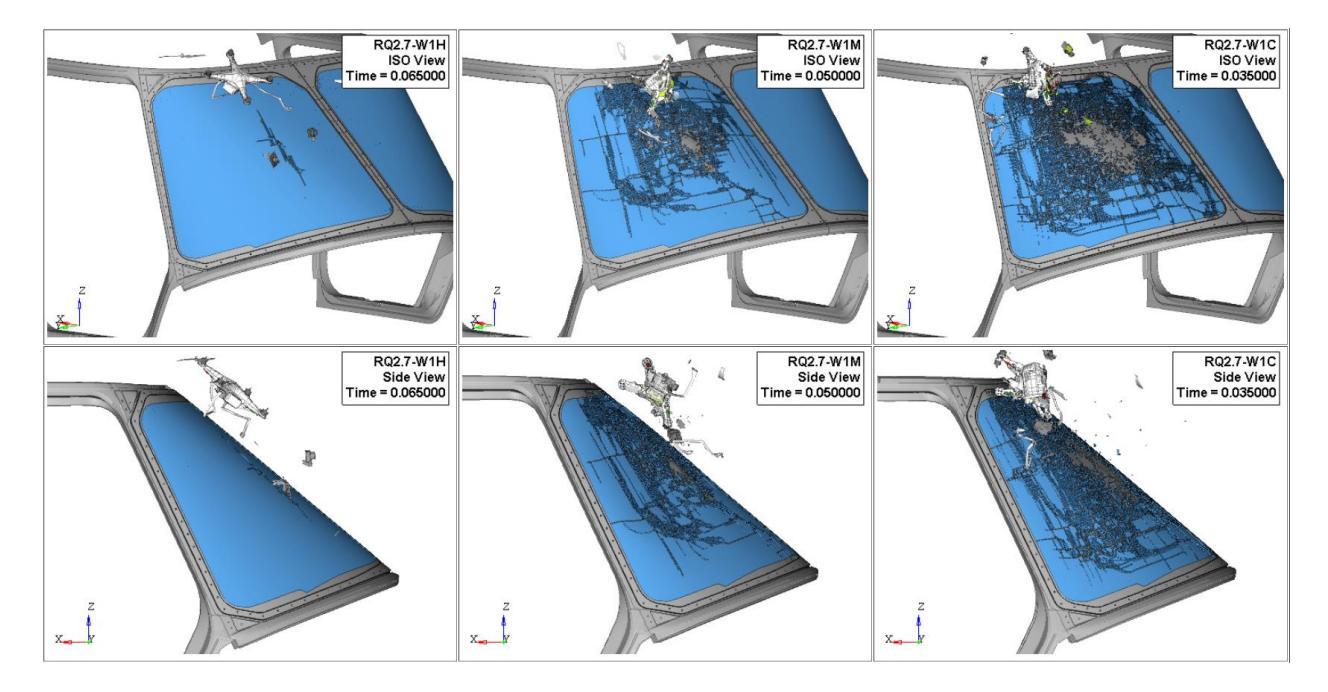
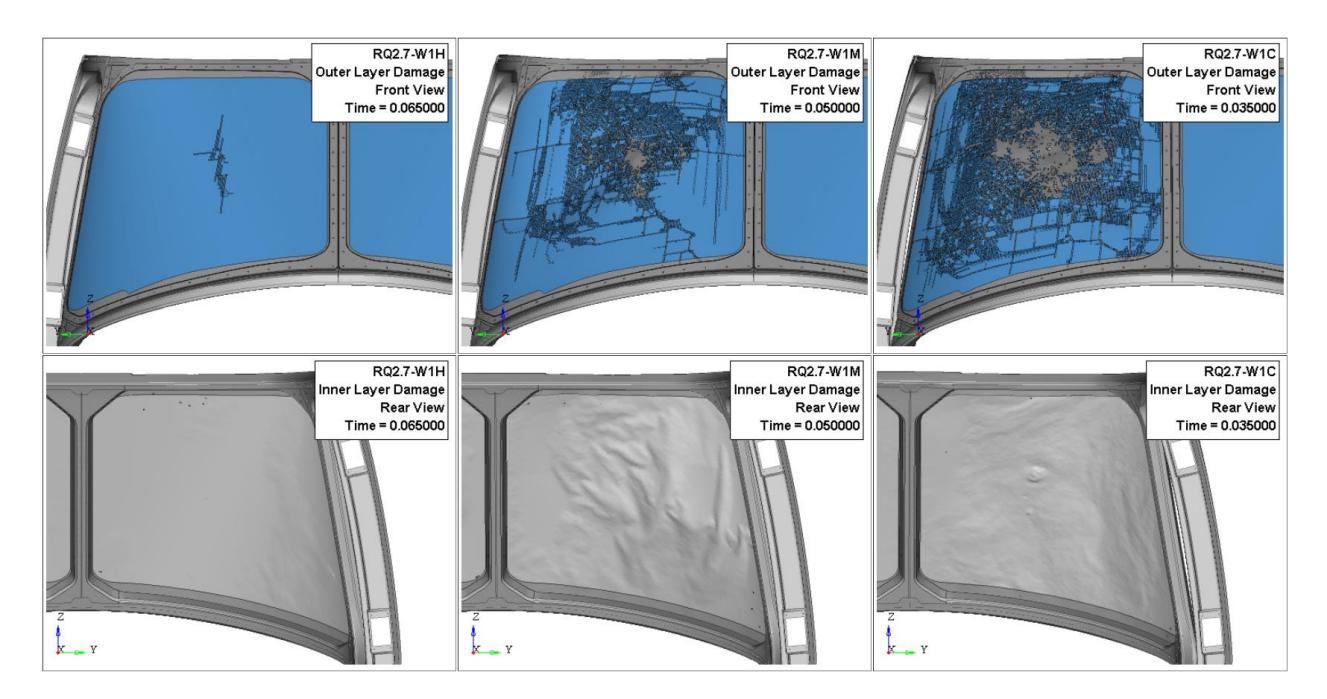
Figure 128. The final time of impact for RQ2.7-W1H, RQ2.7-W1M and RQ2.7-W1C (left to right) – Isometric and side views.

Figure 128 shows the isometric and side views of the simulation's last instant for the three velocity iterations. Figure 129 presents the front and rear windshield view of the simulation's last frame. The images present the lowest (left) cases to the highest velocity (right). The rear view indicates that none of the UAS components penetrated the windshield.

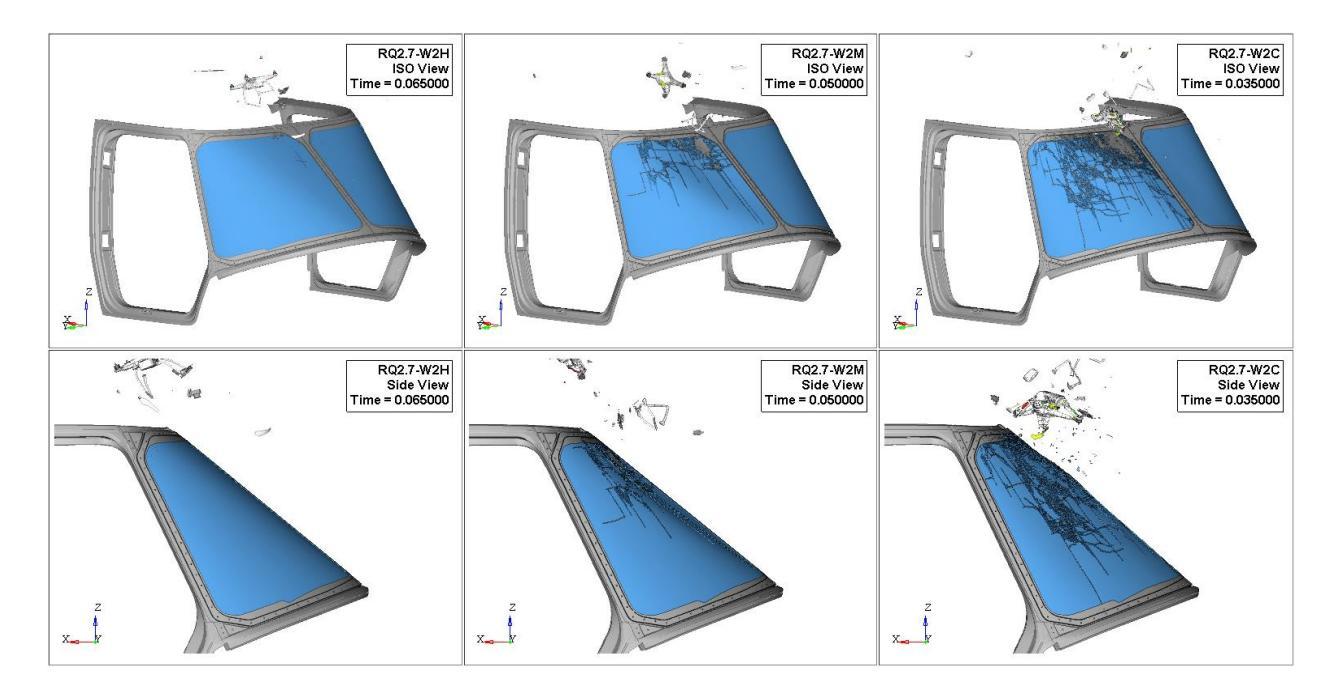
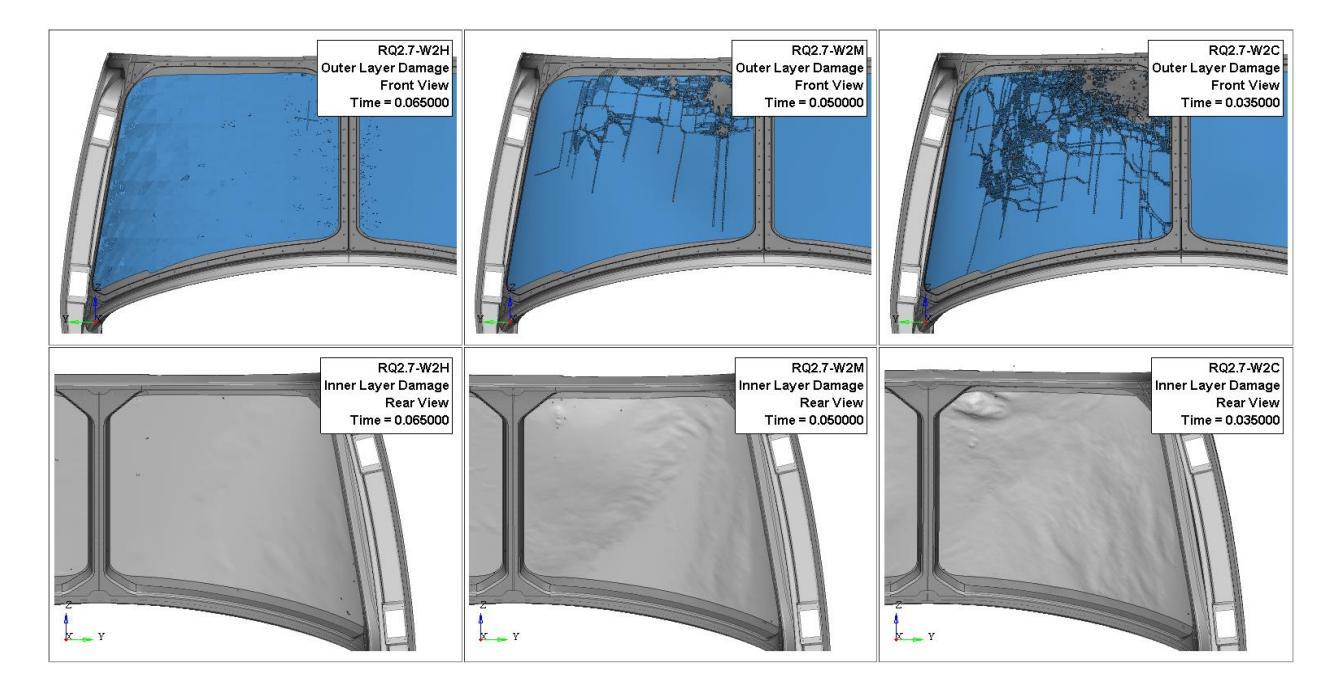
Figure 132. The final time of impact for RQ2.7-W2H, RQ2.7-W2M, and RQ2.7-W2C (left to right) – Isometric and side views.

Figure 132 shows the isometric and side views of the simulation's last instant for the three velocity iterations. Figure 133 presents the front and rear windshield view of the simulation's last frame. The images present the lowest (left) cases to the highest velocity (right). The rear view indicates that none of the UAS components penetrated the windshield.

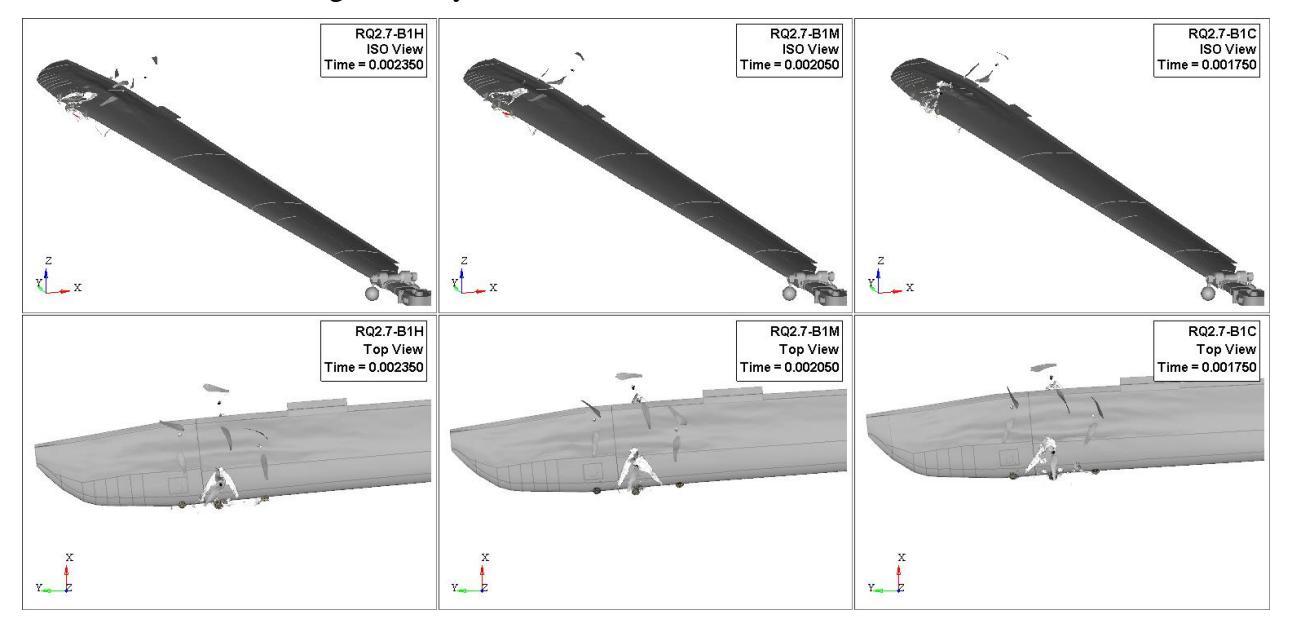
Figure 136. The final time of impact for RQ2.7-B1H, RQ2.7-B1M and RQ2.7-B1C (left to right).

Figure 136 presents the isometric and top views of the simulation's last instant for the three velocity iterations. Cases are presented from lowest (left) to highest velocity (right). The UAS was sliced and broken into pieces during the collision with the blade's leading edge.

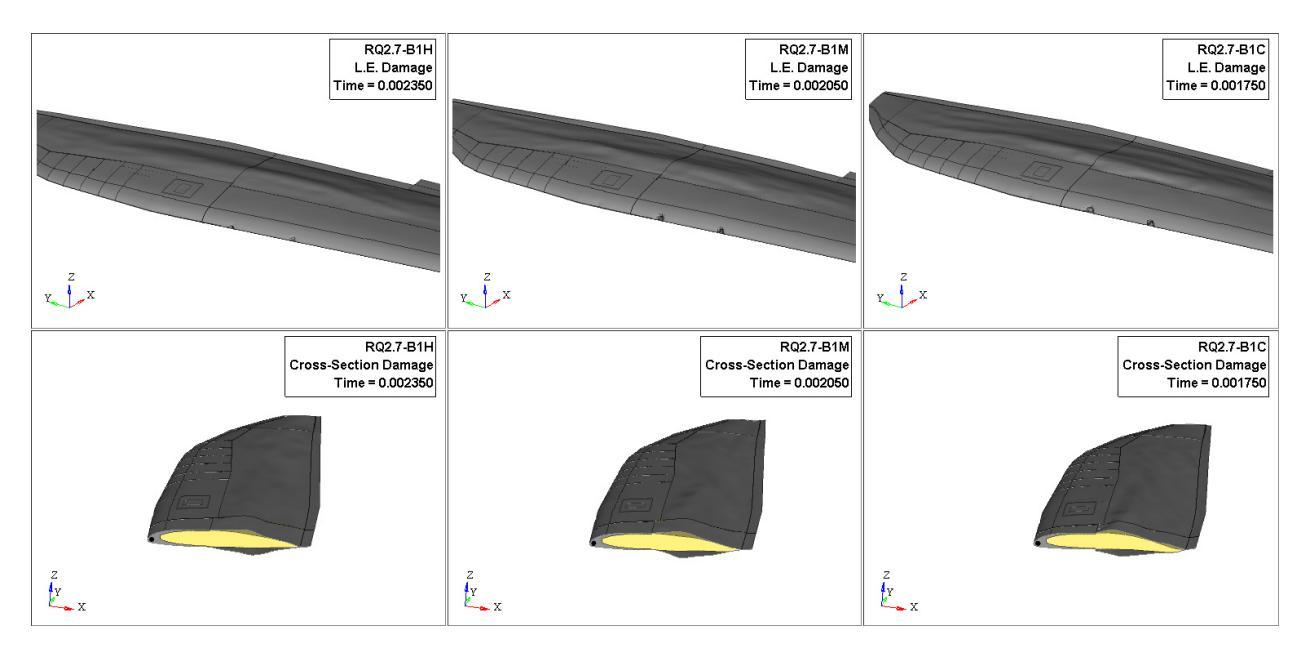
Figure 137. Leading-edge and cross-section damage for RQ2.7-B1H, RQ2.7-B1M and RQ2.7-B1C (left to right).

Figure 137 shows the damage observed on the blade leading edge (upper images) and the blade cross-section at the impact location (lower images). RQ2.7-B1H shows the minimal damage to the leading edge and debonding of the skin close to the trailing edge. RQ2.7-B1M and RQ2.7-B1C present deeper leading edge indentations that indicate more damage to the leading edge as the impact velocity increases. Moreover, skin debonding was noticed in the Medium and Cruise cases. It is important to note that the skin debonding was observed in the physical tests presented in Chapter 4.4. The large-scale simulation cases capture this behavior in agreement with the test

results; however, due to the limitations of the FE model to capture this type of interface interaction after the initiation of the skin separation, the size and propagation of the skin separation must be treated as a conservative approach. Thus, based on the damage severity described in Table 15, all three cases have a damage severity of level 2.
