DOT/FAA/AR-xx/xx

Volume VI – UAS Airborne Collision Severity Evaluation – 14 CFR Part 29 Rotorcraft

June 2022

Final Report

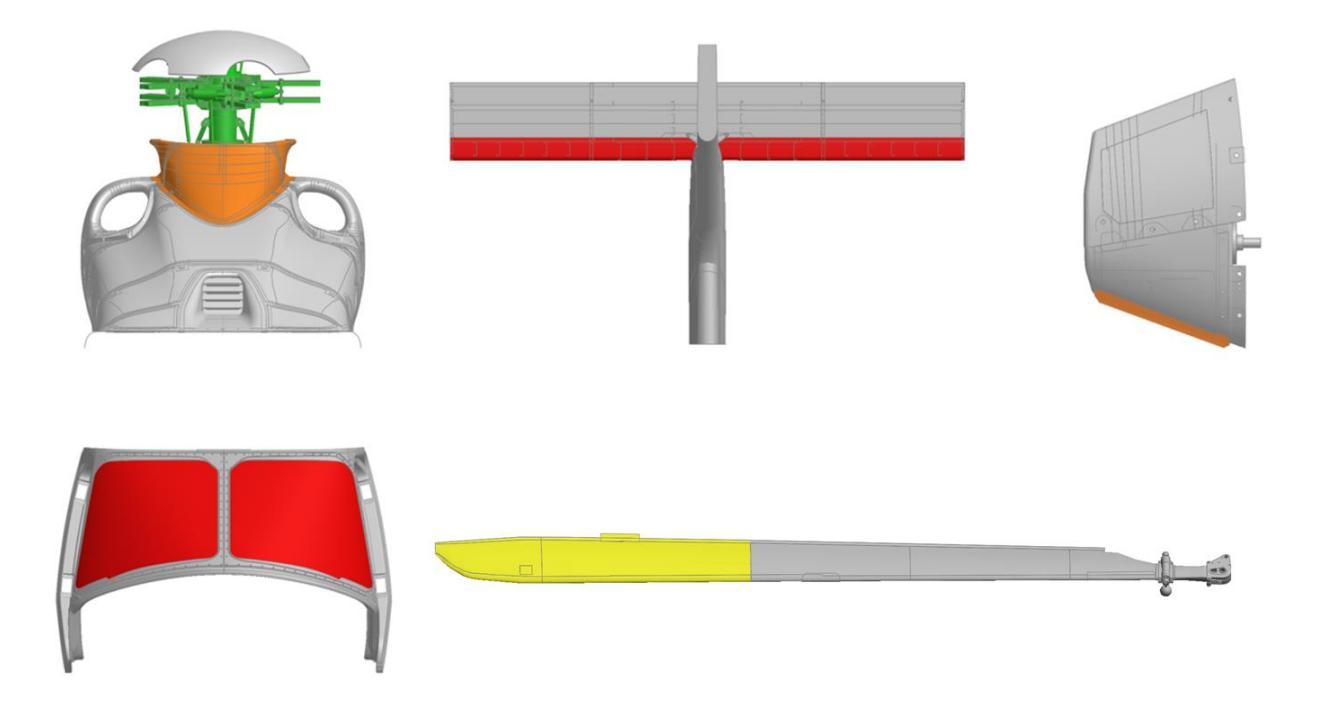
Figure 138. Summary of impact severity levels – Rotorcraft targets and fixed-wing 4.0 lb. (RF4.0).

This chapter presents the results of the airborne collision studies for the 4.0 lb. UAS fixed-wing and the rotorcraft components. The target impact areas introduced in Chapter 5 are the front cowling, horizontal stabilizer, rear servo, windshield, and main rotor blade. Figure 138 illustrates the highest damage severity level observed on each target. In general, it can be noticed that the damage sustained by the rotorcraft component increases with the impact velocity. For example, the horizontal stabilizer and windshield cases captured level 4 damage at cruise speed. The front cowling location 1 impact at cruise speed shows level 3 damage to the cowling and level 1 to the rotor shaft structure (secondary impact). The rear servo and the blade cases have level 2 damage at cruise speed. Table 18 summarizes the damage severity level evaluation and fire risk assessment of the 4.0 lb. fixed-wing impact cases.

Table 18 also includes the damage severity assessment of the tail rotor according to the findings from testing. As shown in APPENDIX B, the component level test results indicate the probability of a level 4 damage. Further work will be required in the future to conduct full-scale tests or simulation of the tail rotor.

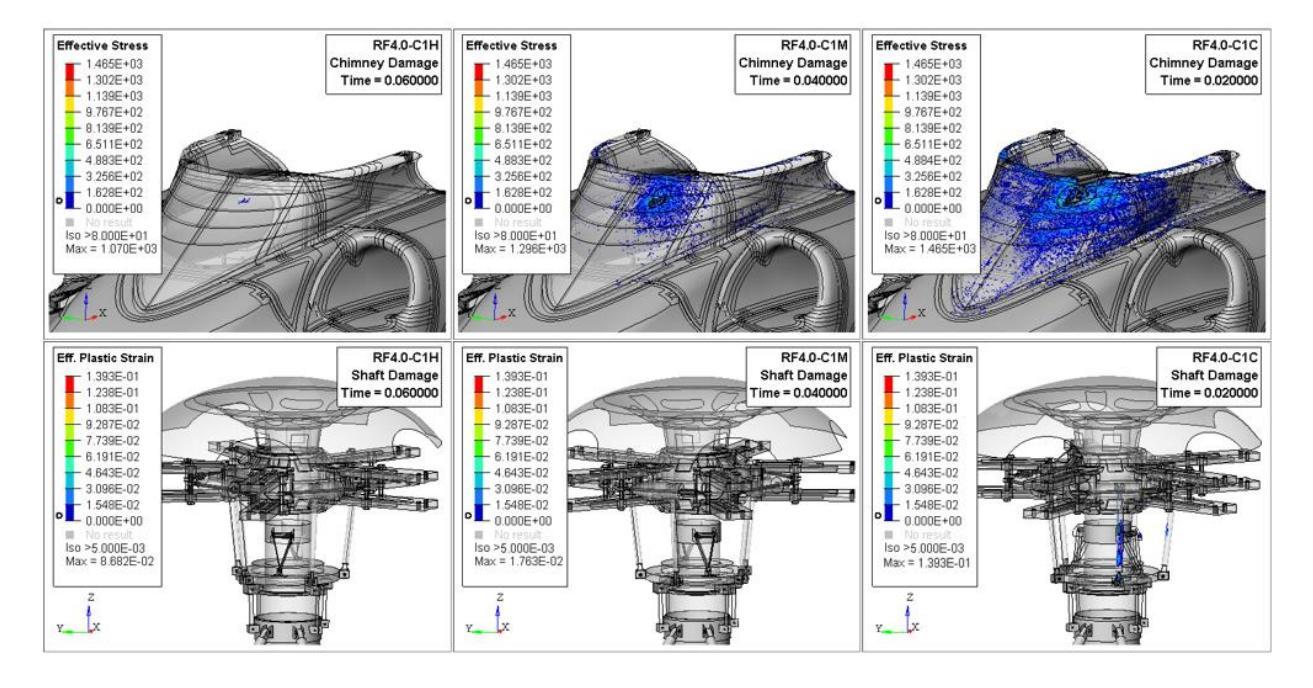
Figure 141. Chimney and rotor shaft damage for RF4.0-C1H, RF4.0-C1M and RF4.0-C1C (left to right).

Figure 141 shows the damage observed on the chimney (upper images) and the rotor shaft assembly (lower images). The chimney sustains more damage as the impact velocity increases. RF4.0-C1H shows no damage to the honeycomb structure (core crushing). RF4.0-C1M indicates damage to the honeycomb and no failure of the composite skin. RF4.0-H1C captures damage to the honeycomb and failure of the skin at the chimney's upper free edge. Thus, RF4.0-C1H and RF4.0-C1M have damage severity of level 2 and RF4.0-C1C of level 3.

Regarding the rotor shaft's secondary impact, RF4.0-C1C shows little permanent deformation to one of the rotor pitch links. Therefore, the secondary impact damage severity to the rotor was classified as level 1 for RF4.0-C1H and RF4.0-C1M, and level 2 for RF4.0-C1C

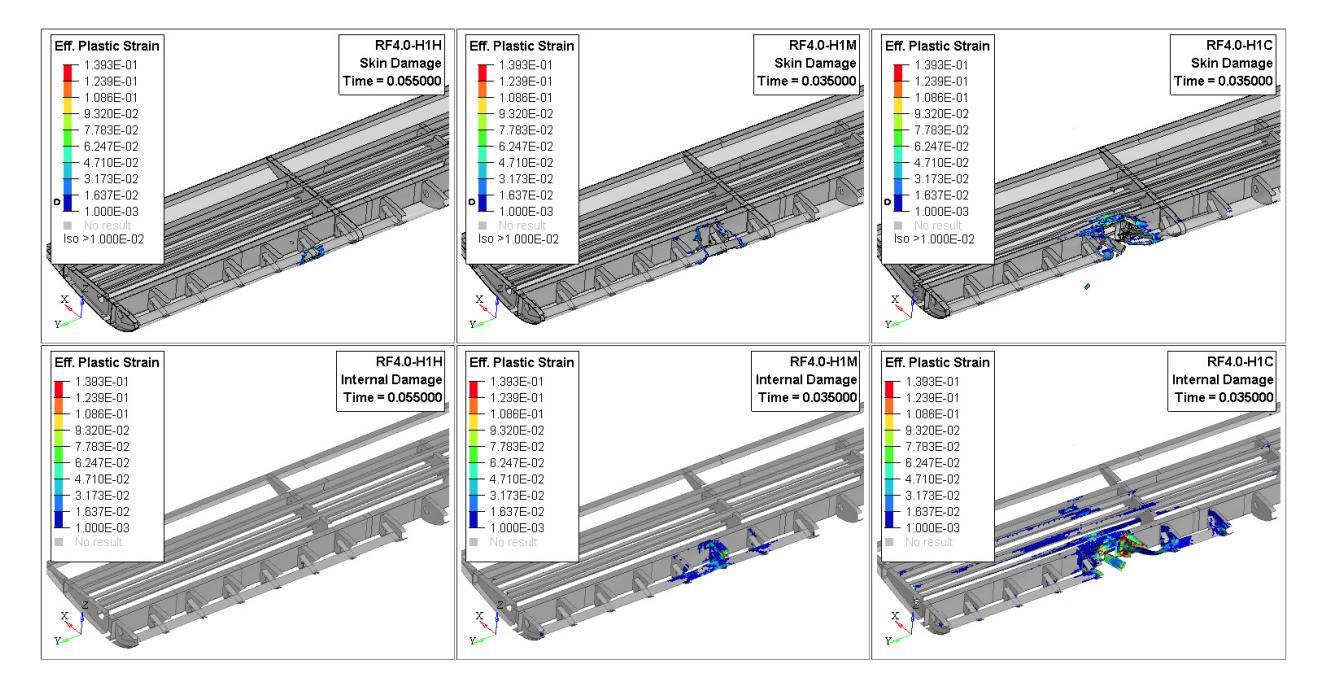
Figure 147. Skin and internal structures plastic strain for RF4.0-H1H, RF4.0-H1M and RF4.0-H1C (left to right).

Figure 146 shows the permanent deformation of the horizontal stabilizer's skin (upper images) and the internal components (lower images). The horizontal stabilizer assembly sustains more damage as the impact velocity increases. RF4.0-H1H shows little damage to the skin and none to the internal components. RF4.0-H1M presents rupture of the skin and permanent deformation at the closest nose rib. RF4.0-H1C has a larger opening of the leading edge skin and shows a hole on the main spar's web, a primary structural member. Thus, RF4.0-H1H has a damage severity of level 2, RF4.0-H1M has a damage severity of level 3, and RF4.0-H1C is classified as level 4. Due to the penetration of the UAS battery into the airframe, there is risk of fire for RF4.0-H1C.

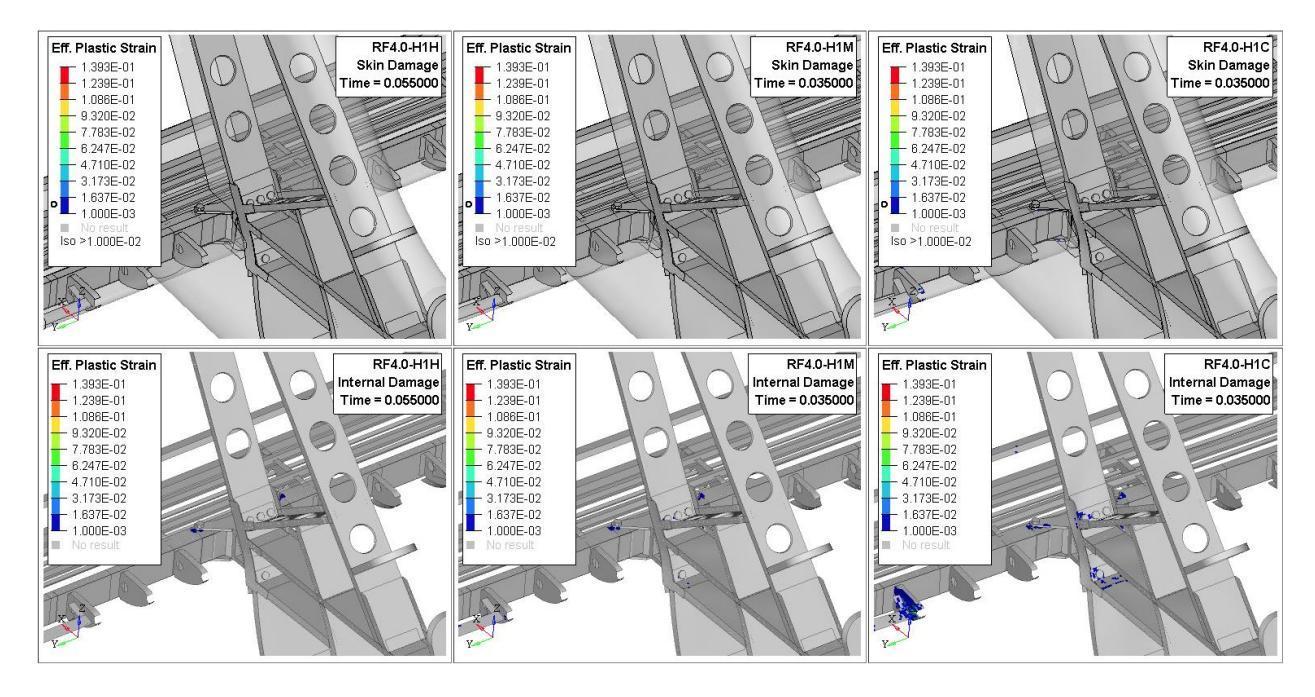
Figure 148. Skin and internal structures plastic strain at the tail root for RF4.0-H1H, RF4.0-H1M and RF4.0-H1C (left to right).

In addition, due to the backward deflection of the horizontal stabilizer during the impact, permanent deformation was observed in the root region of the horizontal stabilizer, where the airframe is connected to the rest of the tail. The deformation was located near the large bolts that secure the stabilizer's connection and increase with the velocity of the impact. Figure 148 depicts the effective plastic strain of the horizontal stabilizer's root region.

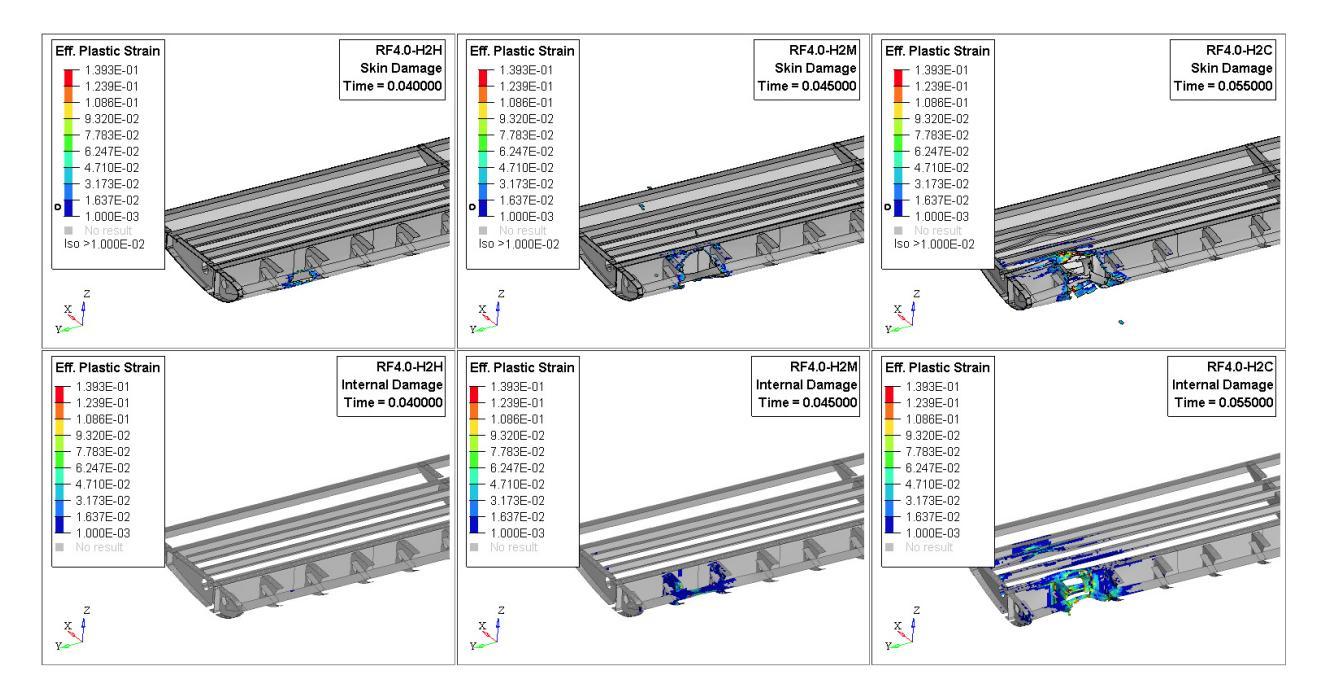
Figure 151. Skin and internal structures plastic strain for RF4.0-H2H, RF4.0-H2M, and RF4.0-H2C (left to right).

Figure 151 shows the permanent deformation of the horizontal stabilizer's skin (upper images) and the internal components (lower images). The horizontal stabilizer assembly sustains more damage as the impact velocity increases. RF4.0-H2H shows a small perforation of the leading edge skin and no damage to the internal components. RF4.0-H2M presents rupture of the skin and permanent deformation of the closest nose ribs. RF4.0-H2C has a large opening of the leading edge skin, permanent deformation to the spar, and failure of the spar's web, a primary structural member. Thus, RF4.0-H2H has a damage severity of level 2, RF4.0-H2M has a damage severity of level 3, and RF4.0-H2C is classified as level 4. Due to the penetration of the UAS battery into the airframe, there is risk of fire for RF4.0-H2C.

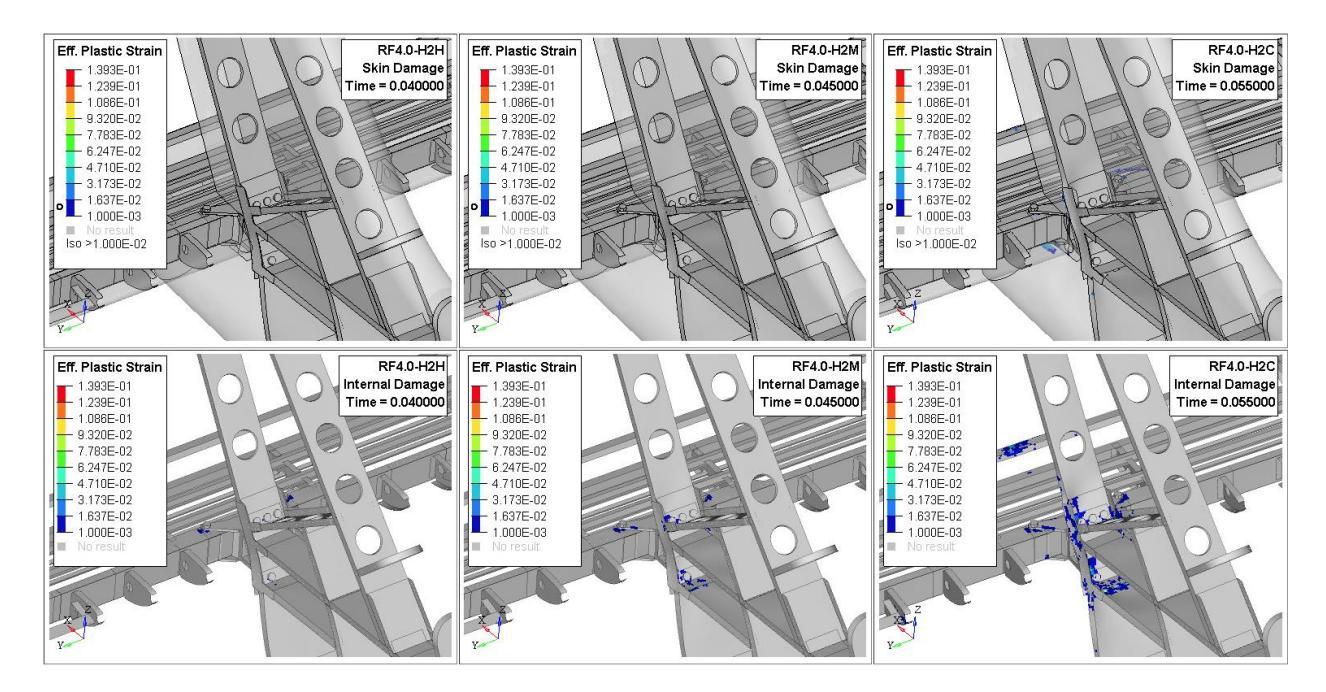
Figure 152. Skin and internal structures plastic strain at the tail root for RF4.0-H2H, RF4.0-H2M, and RF4.0-H2C (left to right).

In addition, due to the backward deflection of the horizontal stabilizer during the impact, some permanent deformation was observed in the root region of the horizontal stabilizer, where the airframe is connected to the rest of the tail. The deformation was located near the large bolts that secure the stabilizer's connection and increase with the velocity of the impact. The cruise velocity impact contains the most permanent deformation in this area. Figure 152 depicts the effective plastic strain of the horizontal stabilizer's root region.

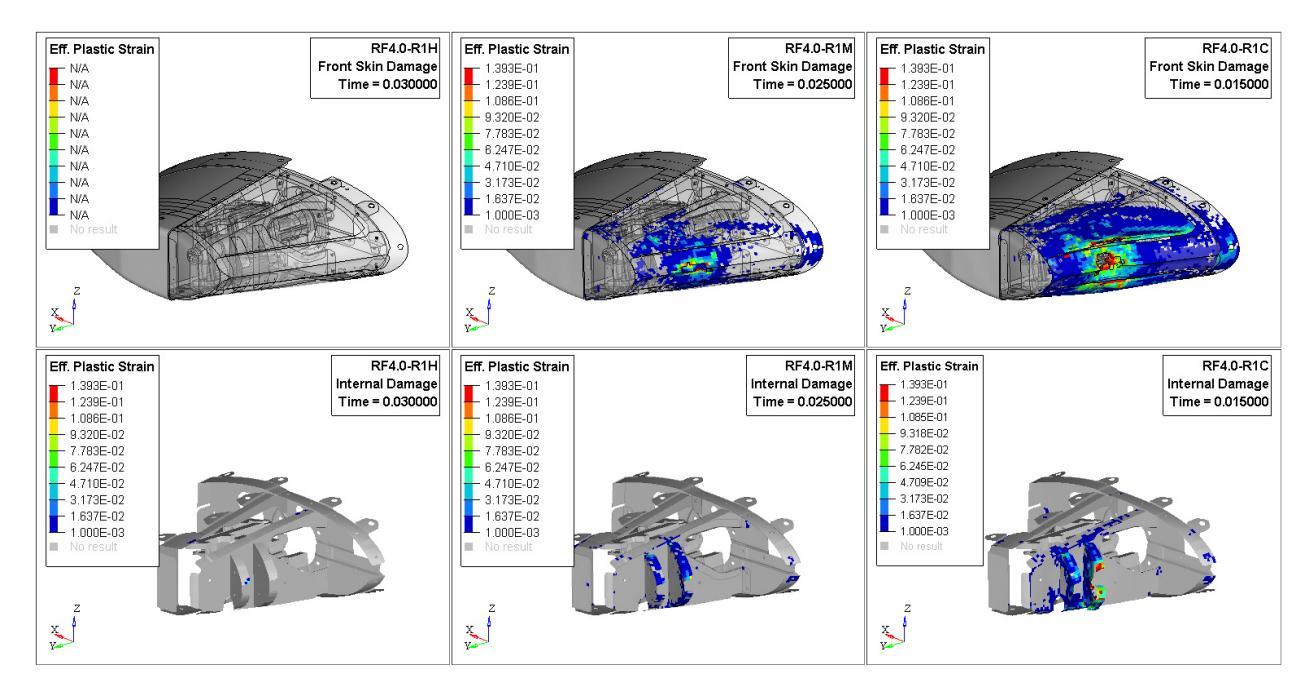
Figure 156. Skin and internal structures plastic strain for RF4.0-R1H, RF4.0-R1M and RF4.0-R1C (left to right).

Figure 156 shows the damage to the servo skin (upper images) and the internal structure (lower images). RF4.0-R1H shows no permanent deformation of the skin and internal structure. Likewise, RF4.0-R1M indicates little permanent deformation to the skin and internal structure. However, RF4.0-R1C presents large skin permanent deformation and localized damage to the nose ribs. Thus, RF4.0-H1H has a damage severity of level 1, RF4.0-H1M achieved level 2, and RF4.0-H1C reached level 3.

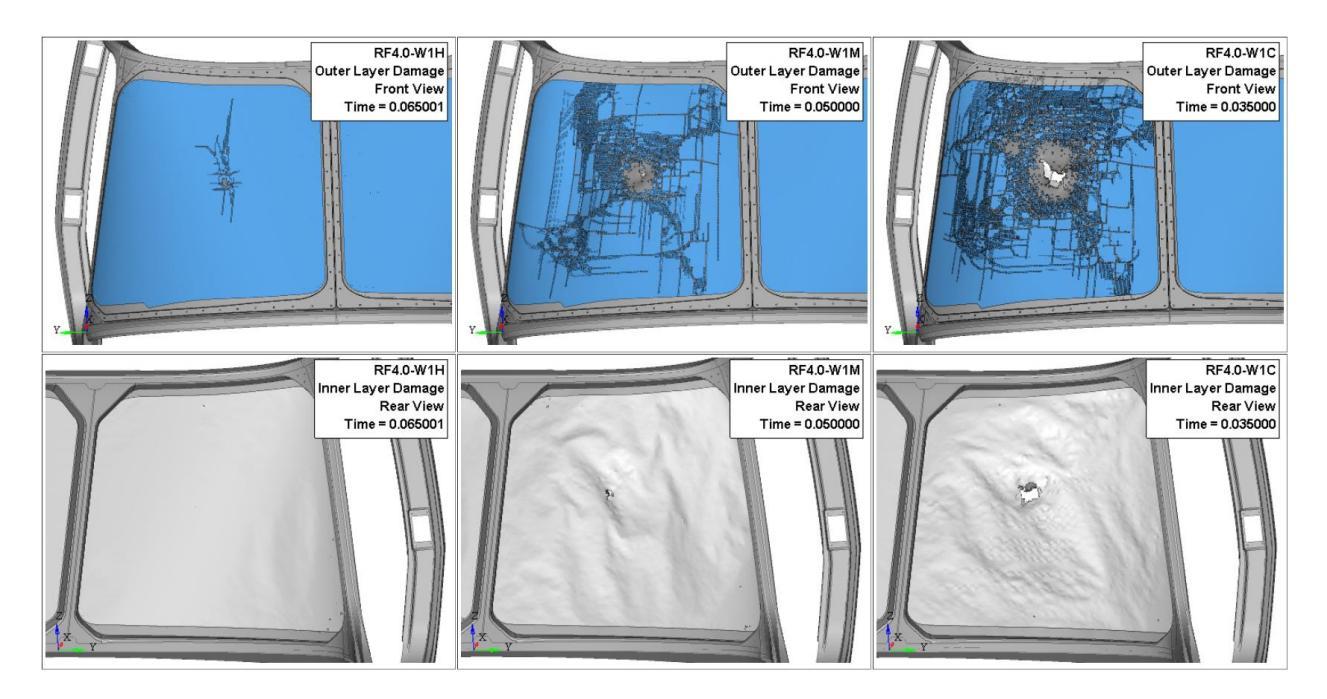
Figure 159. The final time of impact for RF4.0-W1H, RF4.0-W1M and RF4.0-W1C (left to right) – Front and rear views.

Figure 158 shows the isometric and side views of the simulation's last instant for the three velocity iterations. Figure 159 presents the front and rear windshield view of the simulation's last frame. The images present the lowest (left) cases to the highest velocity (right). The rear view indicates that the UAS perforated the windscreen at cruise velocity.

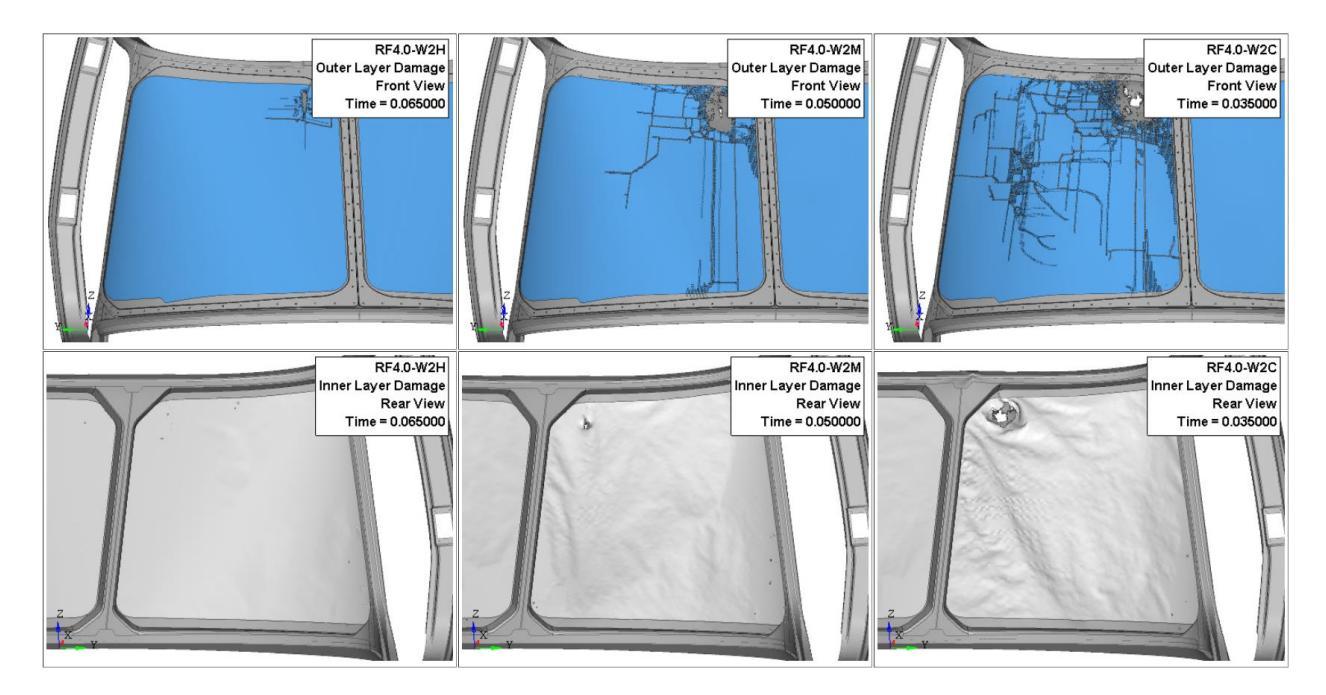
Figure 163. The final time of impact for RF4.0-W2H, RF4.0-W2M, and RF4.0-W2C (left to right) – Front and rear views.

Figure 162 shows the isometric and side views of the simulation's last instant for the three velocity iterations. Figure 163 presents the front and rear windshield view of the simulation's last frame. The images present the lowest (left) cases to the highest velocity (right). The rear view indicates that the UAS perforated the windscreen at cruise velocity.

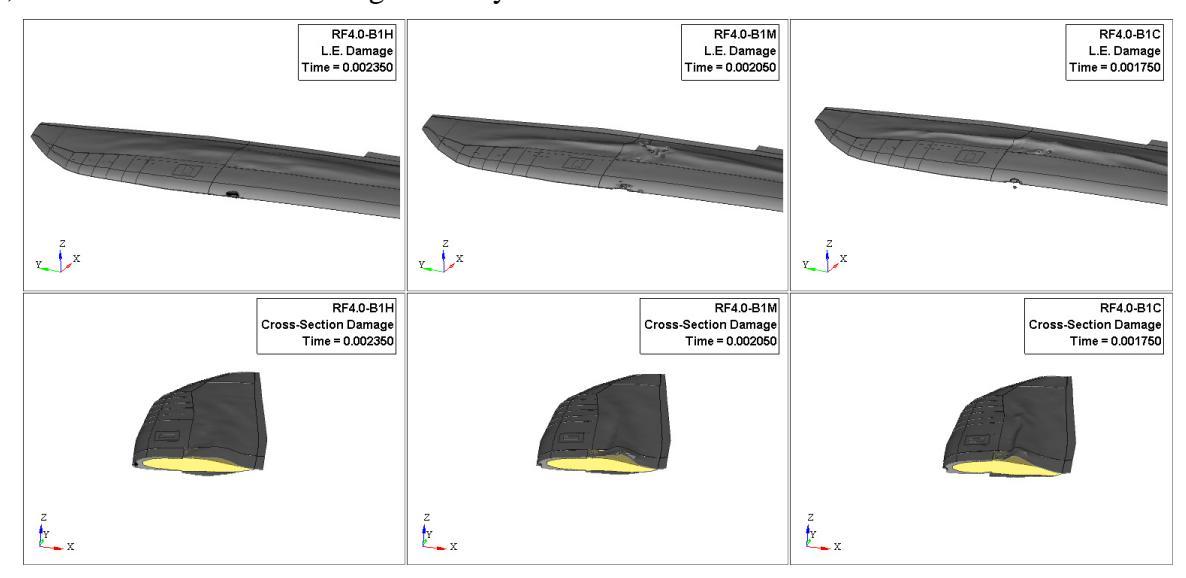
Figure 167. Leading-edge and cross-section damage for RF4.0-B1H, RF4.0-B1M and RF4.0-B1C (left to right).

Figure 167 shows the damage observed on the blade leading edge (upper images) and the impact location cross-sections (lower images). RF4.0-B1H shows a medium-sized dent to the leading edge, while RF4.0-B1M and RF4.0-B1C present deeper dents, indicating larger damage as the impact velocity increases. All three cases have localized debonding between the skin and foam interface. It is important to note that the skin debonding was observed in the physical tests presented in Chapter 4.4. The large-scale simulation cases capture this behavior in agreement with the test results; however, due to the limitations of the FE model to capture this type of interface interaction after the initiation of the skin separation, the size and propagation of the skin separation must be treated as a conservative approach. Thus, based on the damage severity described in Table 15, all three cases have a damage severity of level 2.

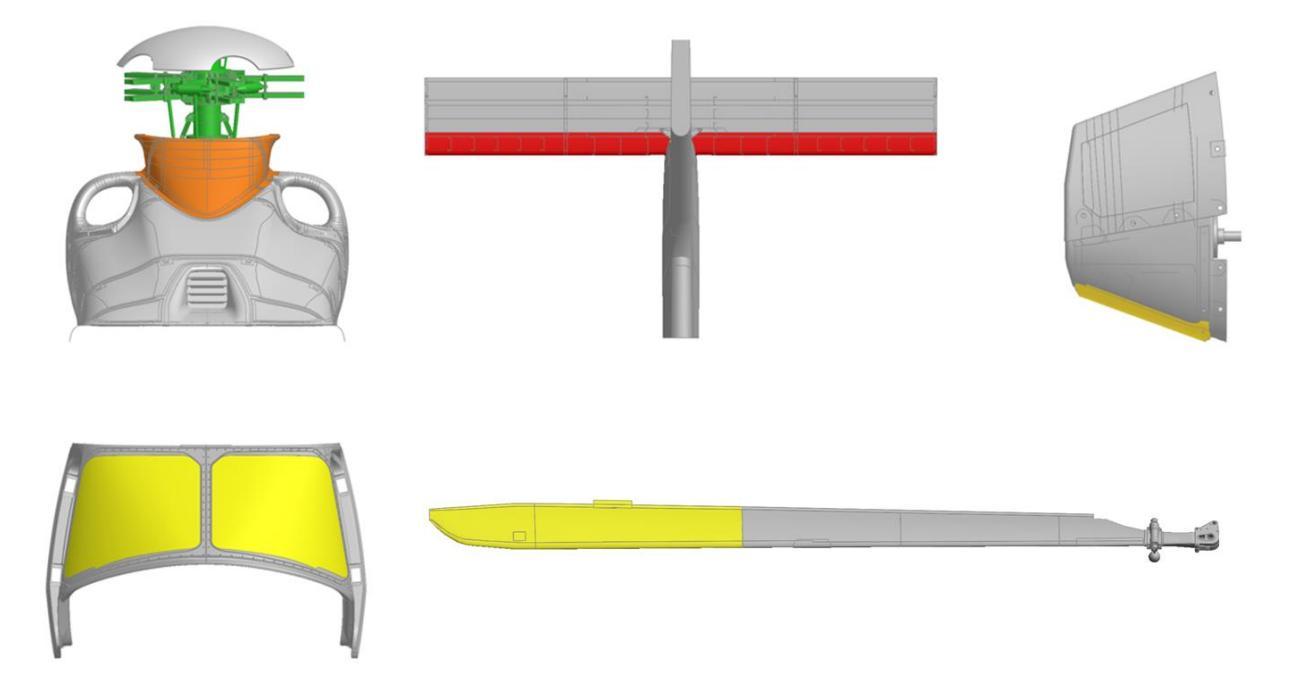
Figure 168. Summary of impact severity levels – Rotorcraft targets and quadcopter 2.7 lb. (RQ2.7).

The results of the 48 impact scenarios, which correspond to the 2.7 lb. quadcopter and 4.0 lb. fixedwing, are summarized in Table 20 and Table 21, respectively. In addition, Figure 168 and Figure 169 illustrate the highest severity level observed on each target's impact location for the 2.7 lb. quadcopter and 4.0 lb. fixed-wing cases, respectively. As the results indicate, the following parameters affect the severity classification of the impact event:

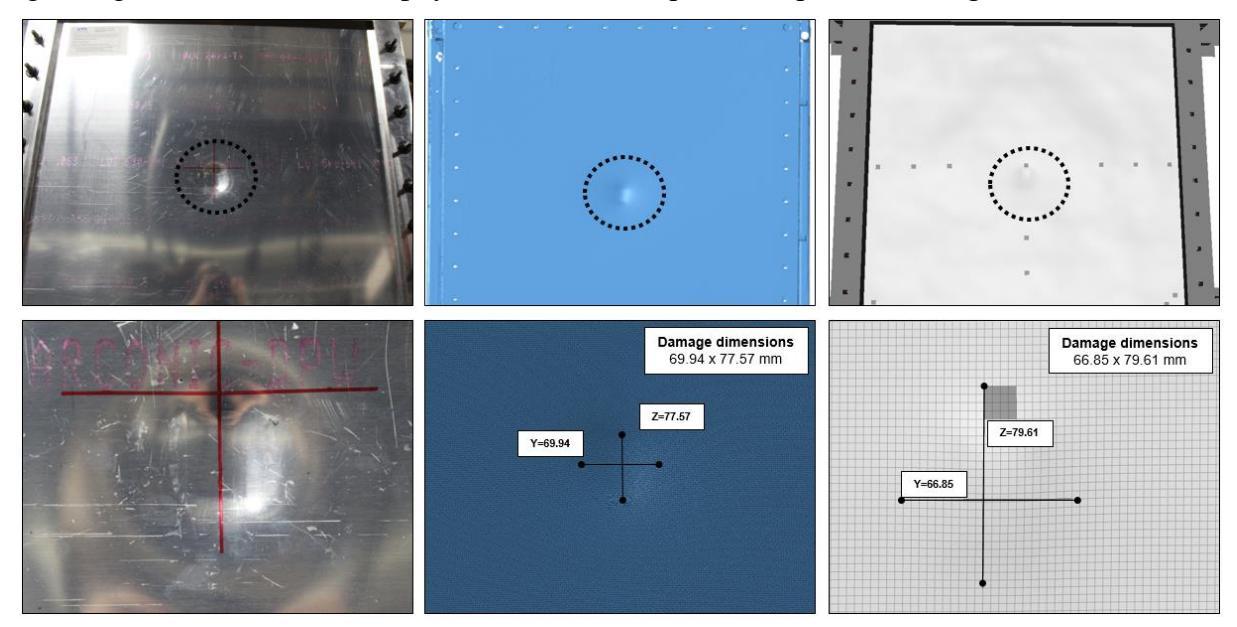
The physical panel was scanned after the test to compare the dimensions of the damaged area. Figure 251 compares the panel's damaged area dimensions for the test and simulation. Again, there is good agreement between the physical test and the predicted panel's damaged area.

Figure 251. Comparison of the final damage of the panel for the test (left), scan (middle), and simulation (right) for the battery A impact on 0.063" aluminum panel at 62.18 m/s (120.87 knots).
Figure 252 compares the physical and simulation projectile damage. The battery case broke into pieces for both physical test and simulation, and the cells were damaged but stayed attached. The quadcopter battery indented the aluminum panel, but it did not penetrate through it. The battery indicated a "Fire Risk" during the physical test.

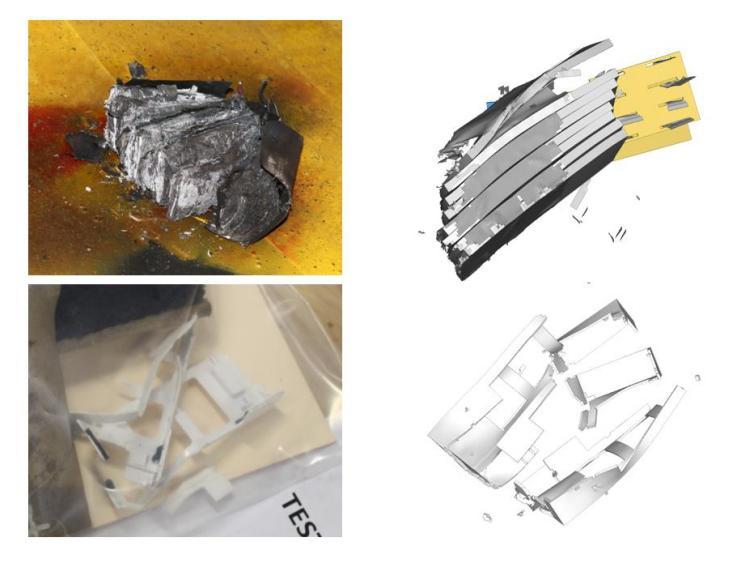
Figure 252. Comparison of the test (left) and simulation (right) projectile damage for battery A impact on 0.063" aluminum panel at 62.18 m/s (120.87 knots).

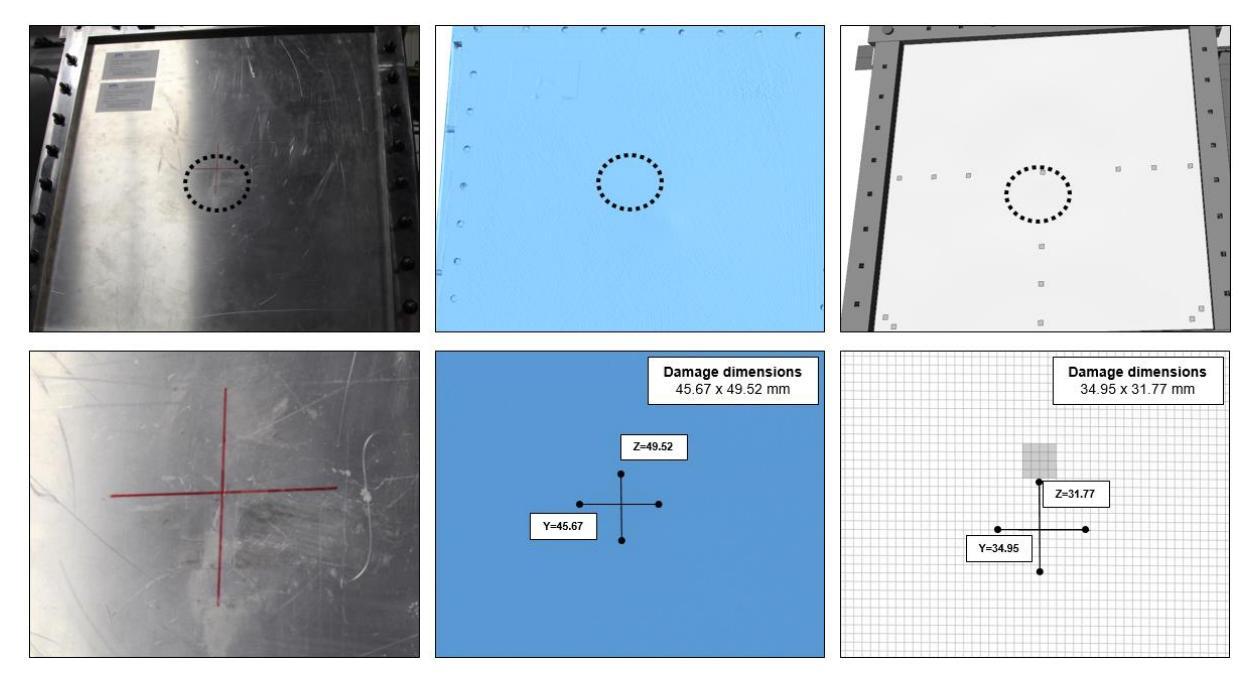
The physical panel was scanned after the test to compare the dimensions of the damaged area. Figure 261 compares the panel's damaged area dimensions for the test and simulation. For this case, the simulation predicts a smaller area holding plastic deformation. However, the overall shape is captured.

Figure 261. Comparison of the final damage of the panel for the test (left), scan (middle), and simulation (right) for battery A impact on 0.25" aluminum panel at 59.68 m/s (116.0 knots).

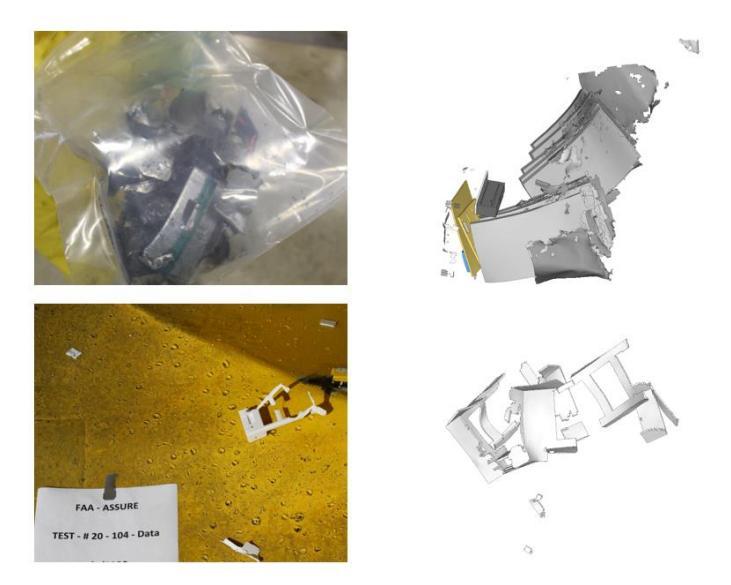
Figure 262 compares the physical and simulation projectile damage. The battery case split into fragments for both the physical test and simulation and the battery cells separated into several pieces, some of which showed a "Fire Risk" in the physical test. The battery left a small indentation on the panel but did not penetrate it.

Figure 262. Comparison of the test (left) and simulation (right) projectile damage for battery A impact on 0.25" aluminum panel at 59.68 m/s (116.0 knots).

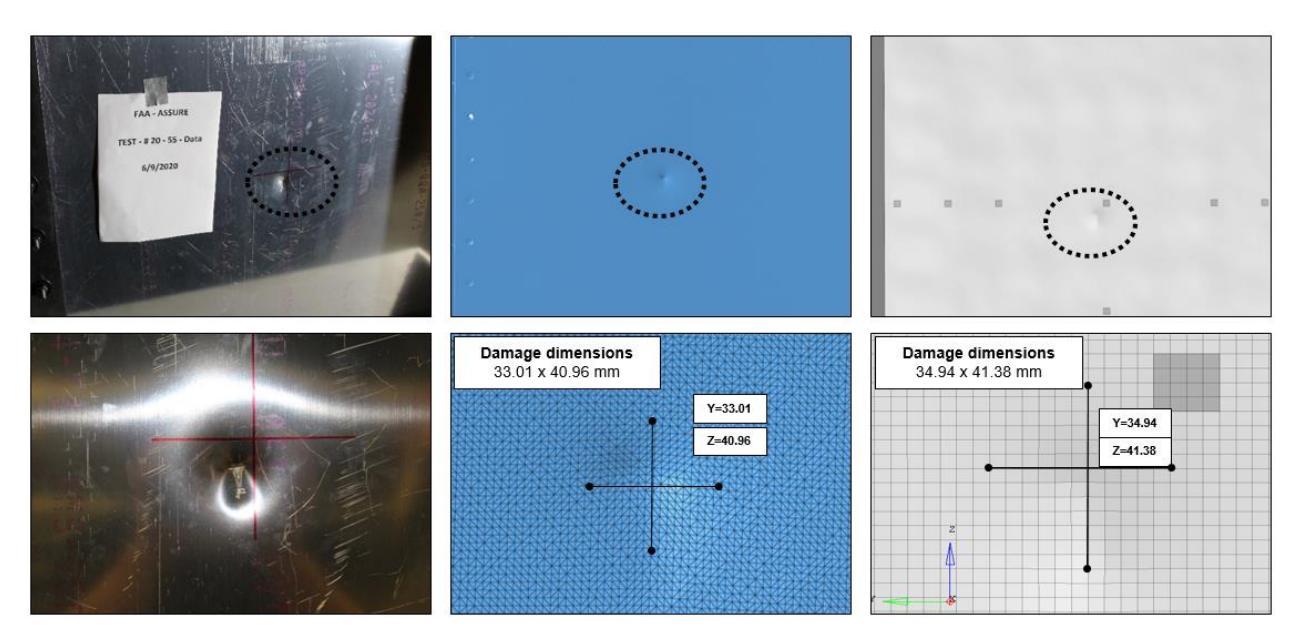
The physical panel was scanned after the test to compare the dimensions of the damaged area. Figure 271 compares the panel's damaged area dimensions for the test and simulation. Again, there is good agreement between the physical test and the predicted panel's damaged area.

Figure 271. Comparison of the final damage of the panel for the test (left), scan (middle), and simulation (right) for motor A impact on 0.063" aluminum panel at 63.79 m/s (124 knots).

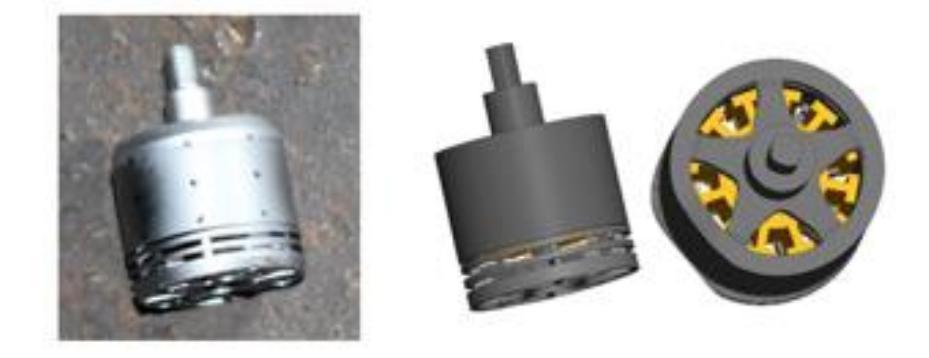
Figure 272 compares the physical and simulation projectile damage. For both physical tests and simulation, the motor sustained minor damage.

Figure 272. Comparison of the test (left) and simulation (right) projectile damage for motor A impact on 0.063" aluminum panel at 63.79 m/s (124 knots).

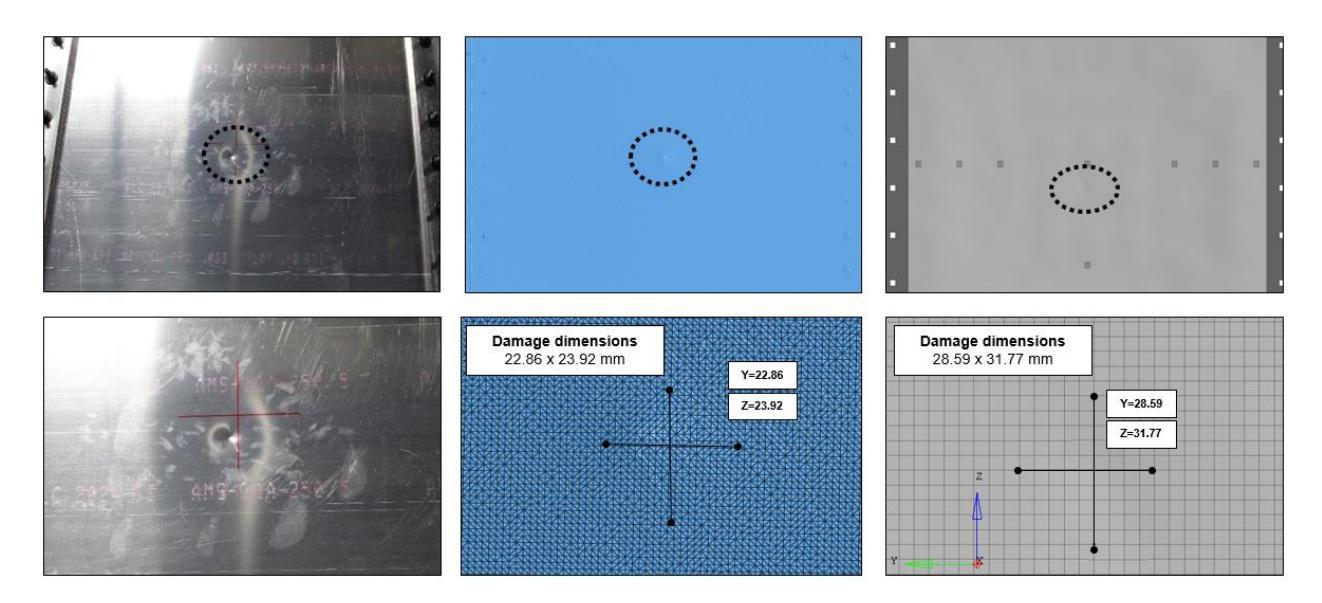
The physical panel was scanned after the test to compare the dimensions of the damaged area. Figure 281 compares the panel's damaged area dimensions for the test and simulation. Again, there is good agreement between the physical test and the predicted panel's damaged area.

Figure 281. Comparison of the final damage of the panel for the test (left), scan (middle), and simulation (right) for motor A impact on 0.063" aluminum panel at 29.32 m/s (57.0 knots).

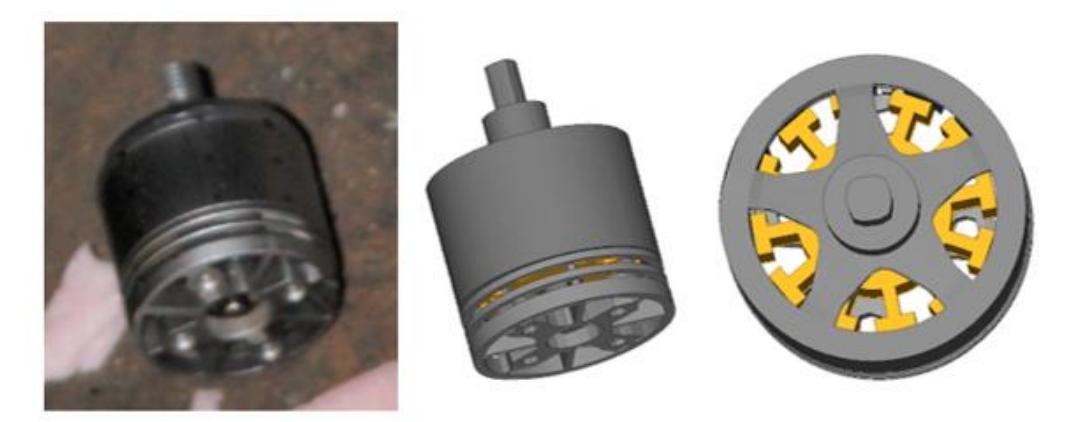
Figure 282 compares the physical and simulation projectile damage. For both physical tests and simulation, the motor sustained minor damage.

Figure 282. Comparison of the test (left) and simulation (right) projectile damage for motor A impact on 0.063" aluminum panel at 29.32 m/s (57.0 knots).

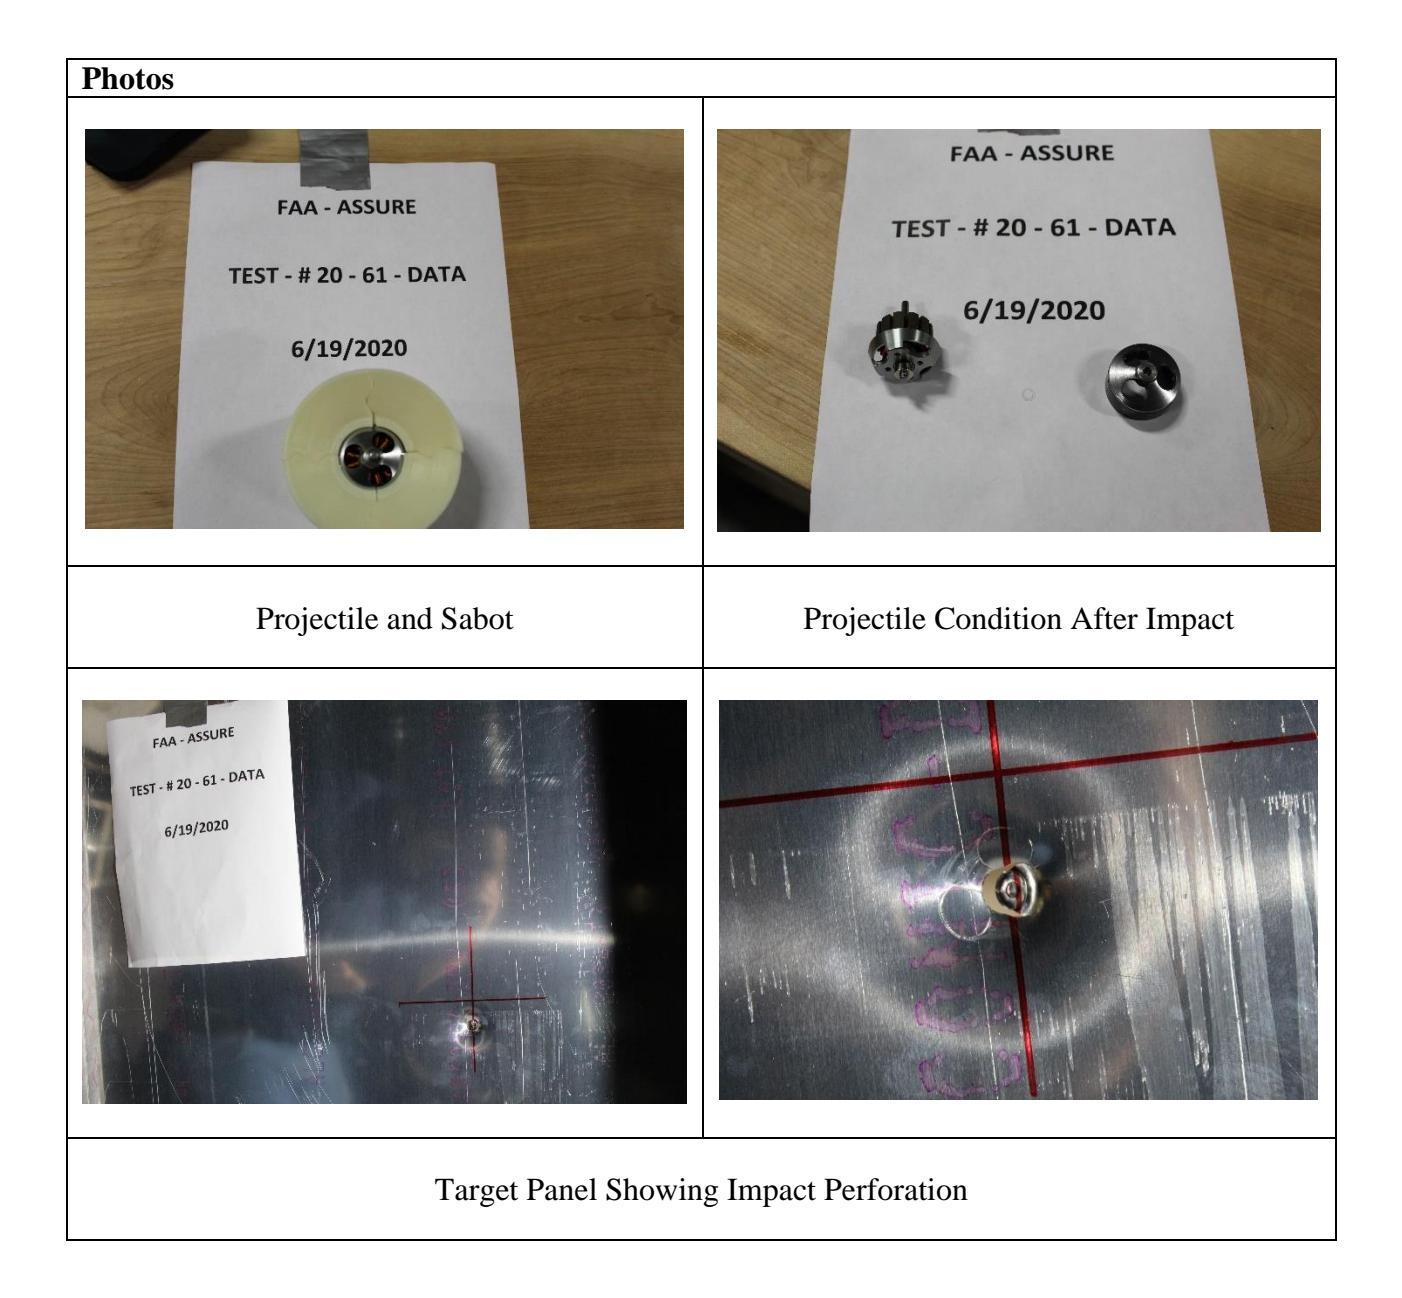
Motor B impacted the target in the nominal velocity range and correct orientation (motor shaft normal to the panel surface). During the test the motor pierced the aluminum panel, but did not go fully through the panel. The motor broke into two pieces.

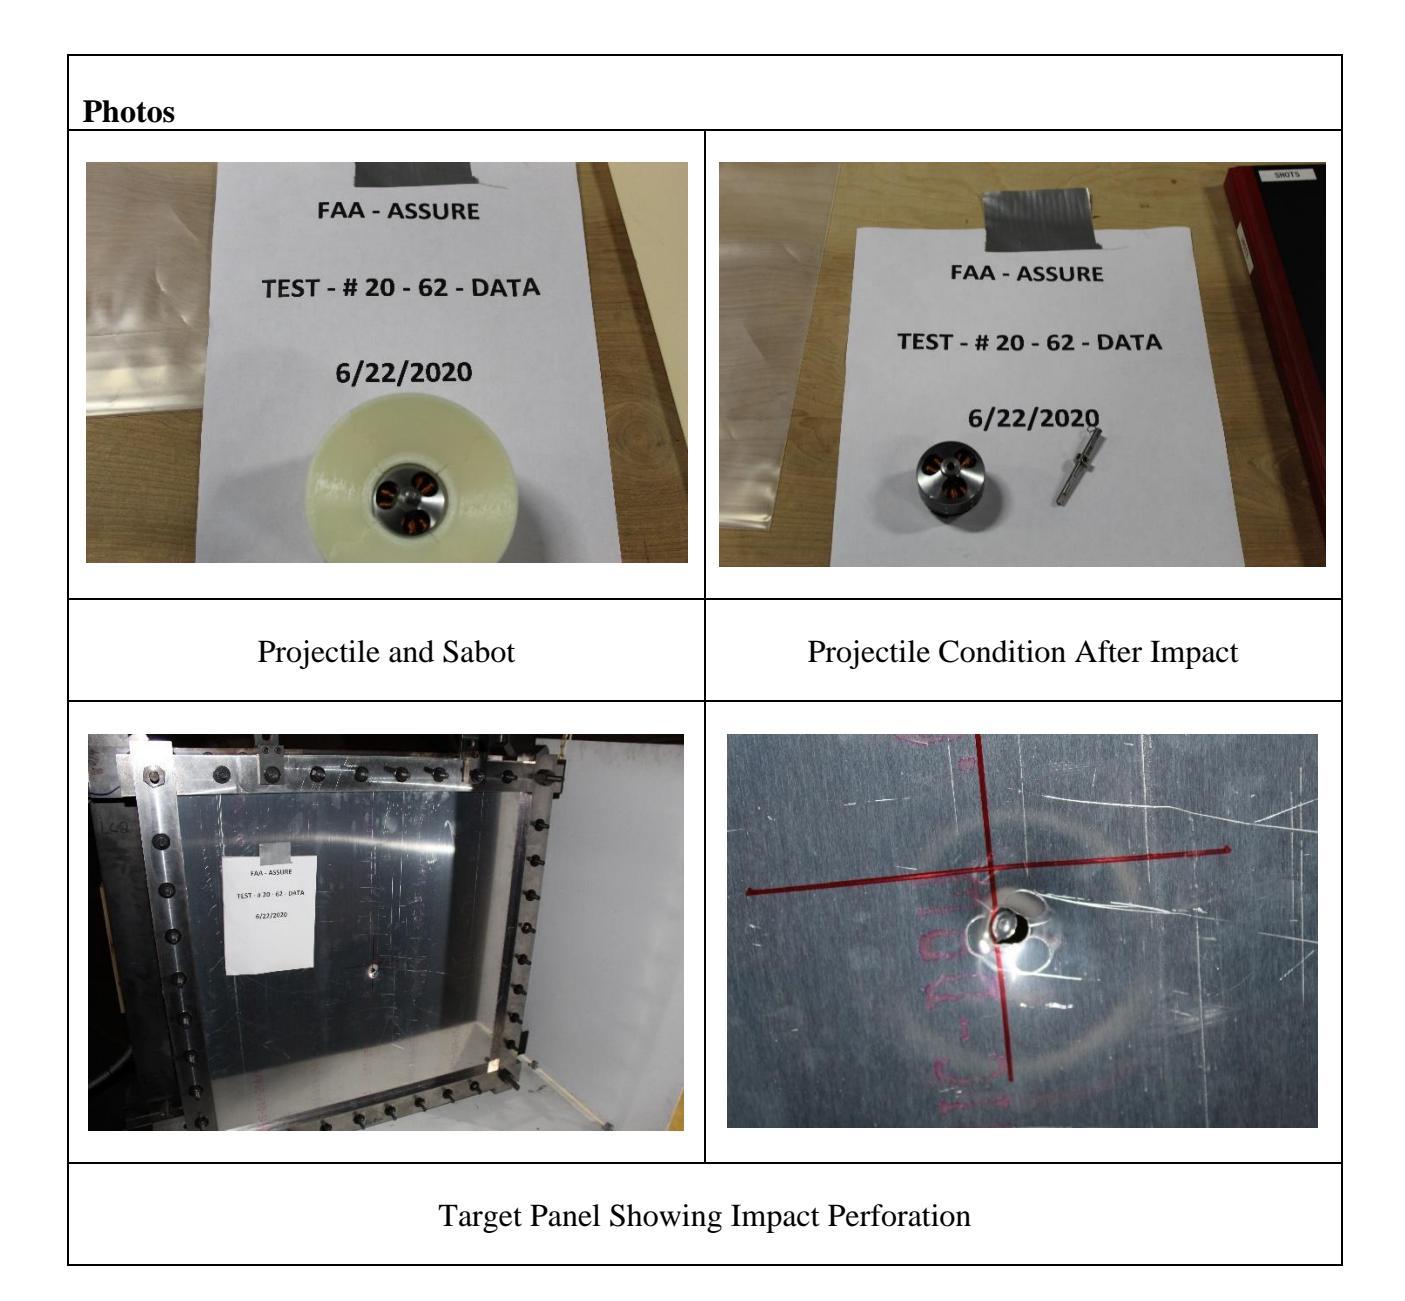
B.3.1.2.46 TEST 23-2

Motor B impacted the target in the nominal velocity range and correct orientation (motor shaft normal to the panel surface). During the test the motor pierced the aluminum panel without going through the panel. The motor broke into two pieces.
