DOT/FAA/AR-xx/xx

Volume VI – UAS Airborne Collision Severity Evaluation – 14 CFR Part 29 Rotorcraft

June 2022

Final Report

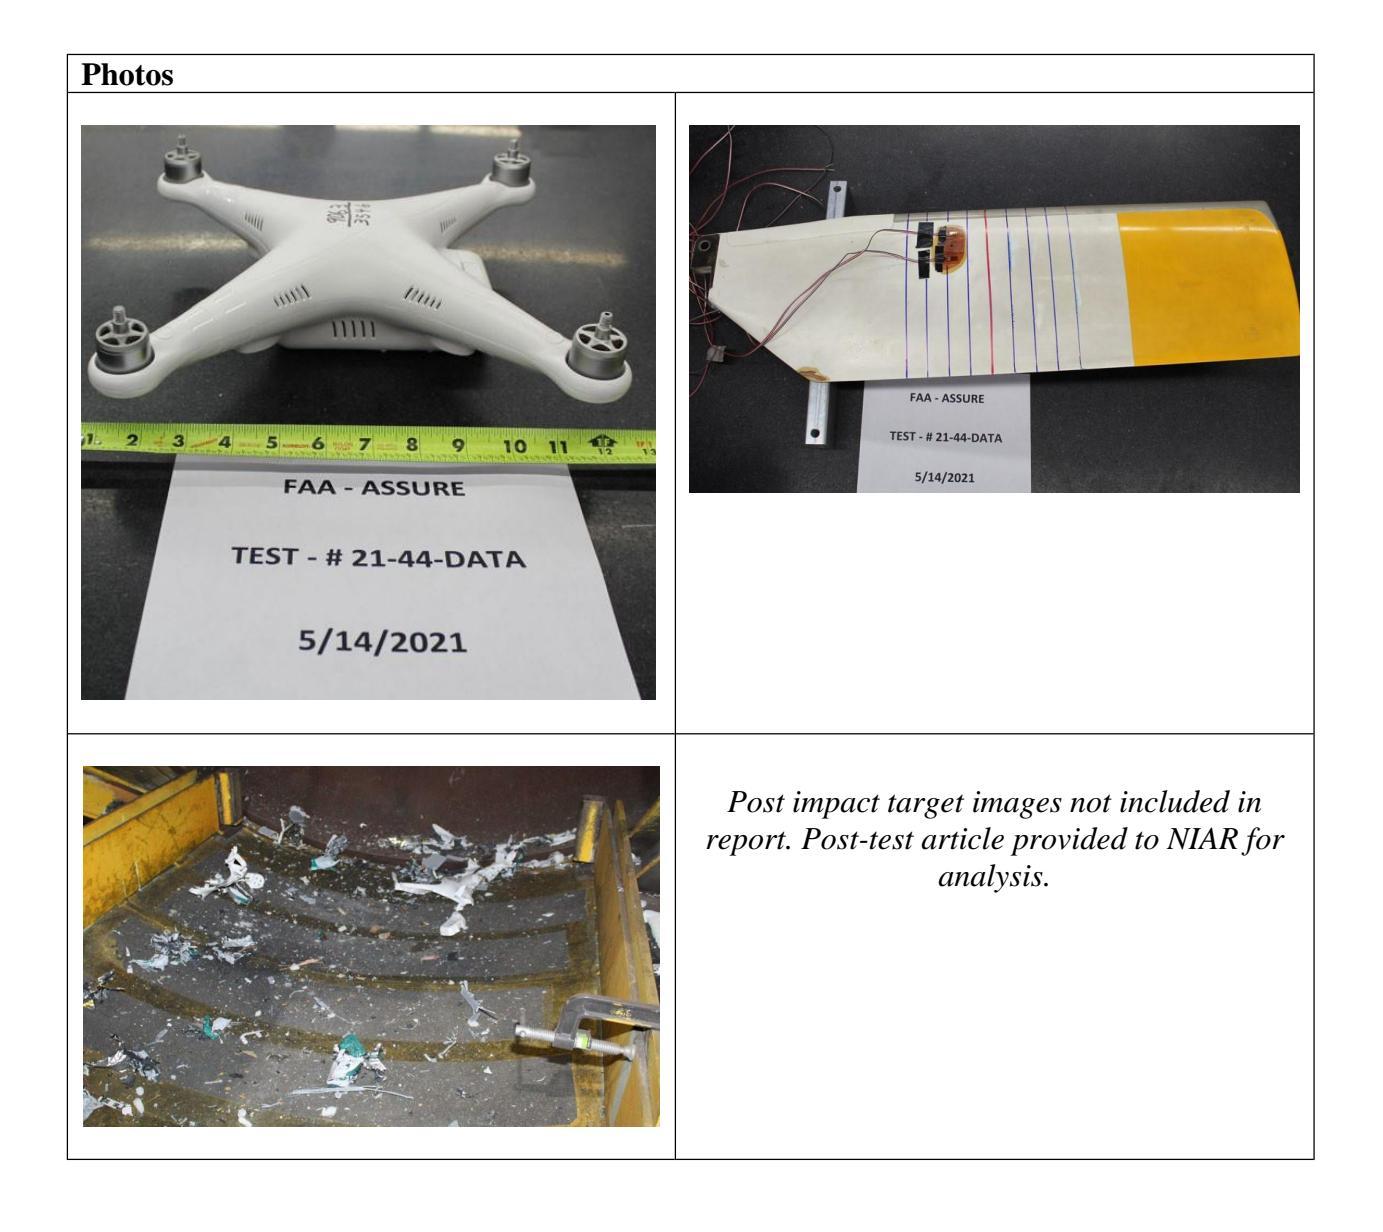
The tail rotor blade was structurally compromised by the sUAS impact.

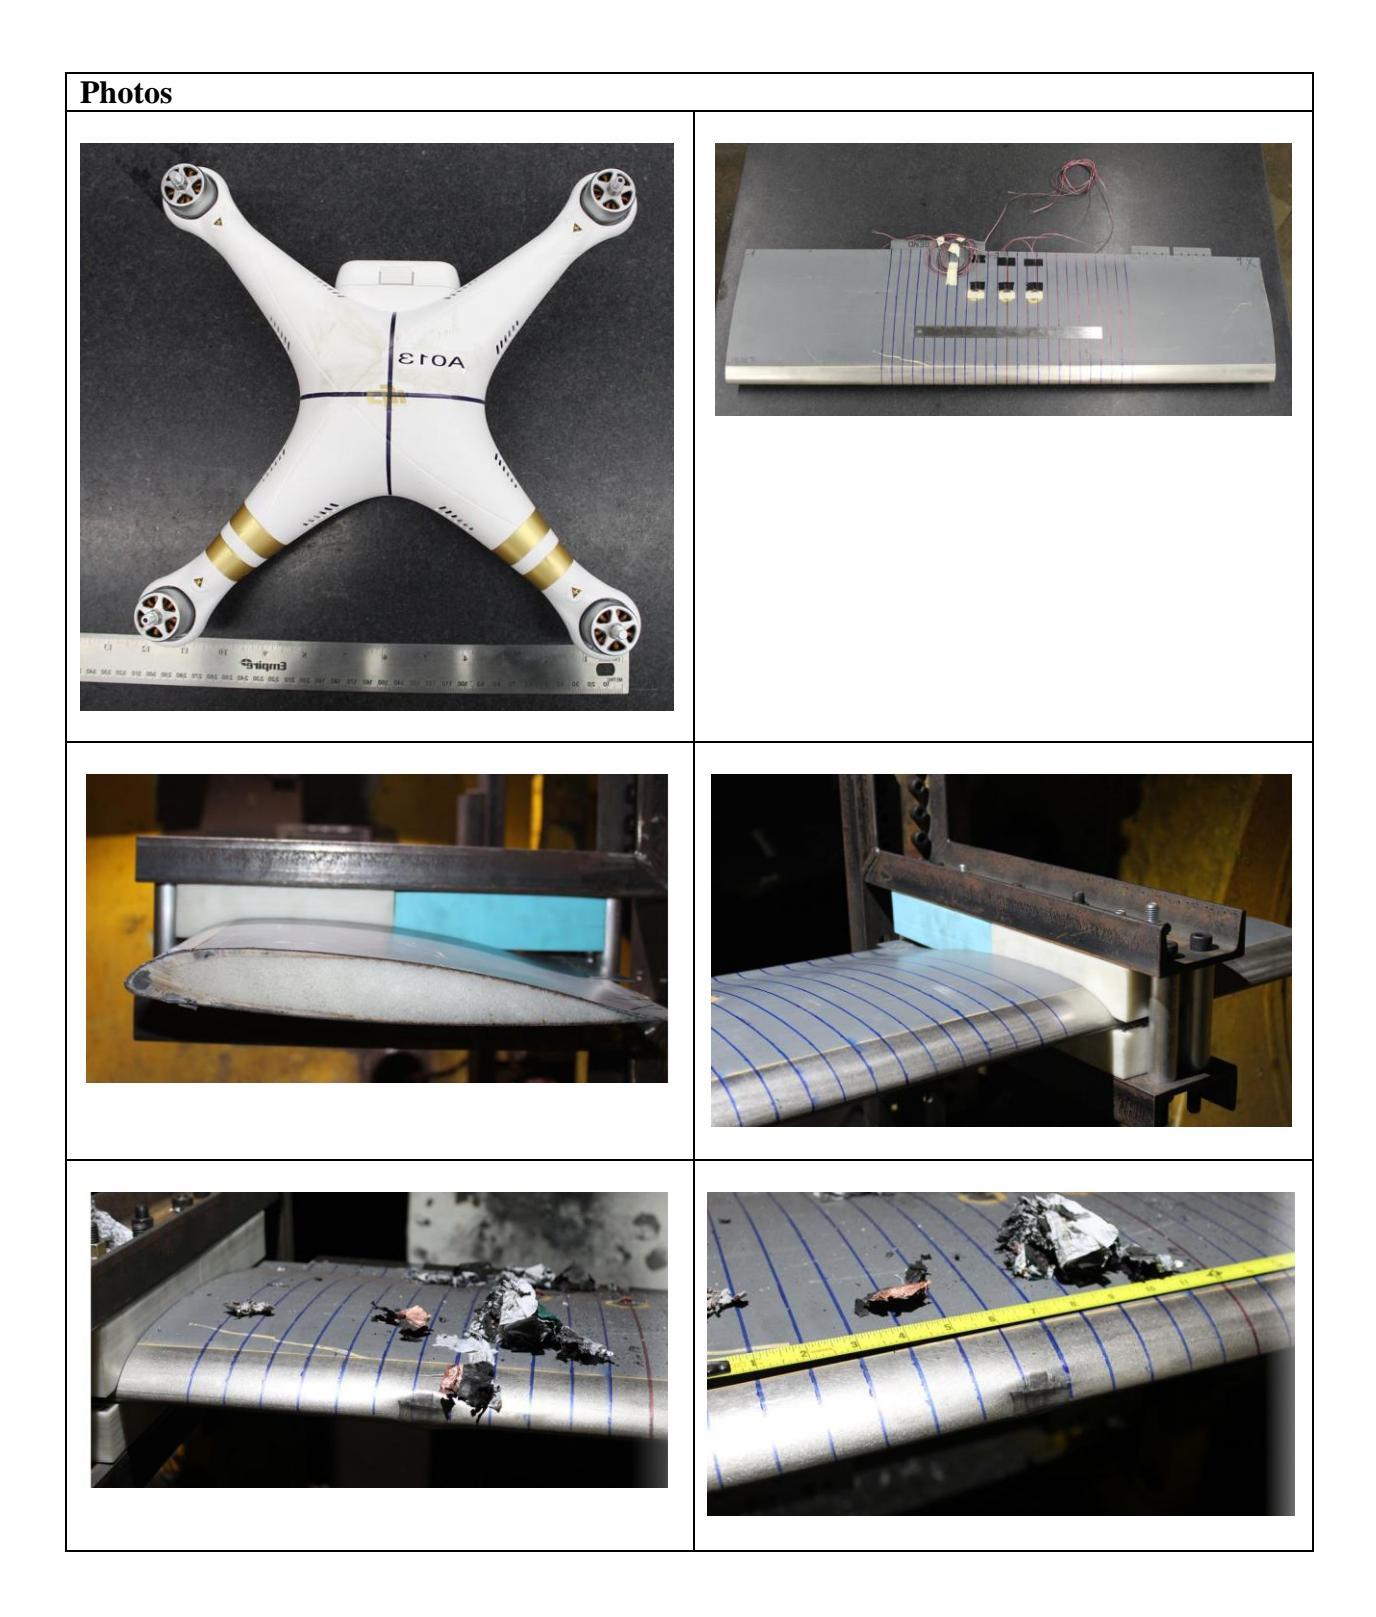
B.4.1.2.2 TEST 2-1 MAIN ROTOR BLADE

The sUAS dropped below the intended target line and only one motor impacted the blade leading edge. The motor that impacted the blade broke off of the sUAS and left a dent in the leading edge of the blade. The motor impact crushed the leading edge of the composite spare and deformed the metal rod in the leading edge of the spar. The impact created chordwise fractures in the composite spar. The motor was crushed to approximately half of its pre-impact width/diameter during the impact.

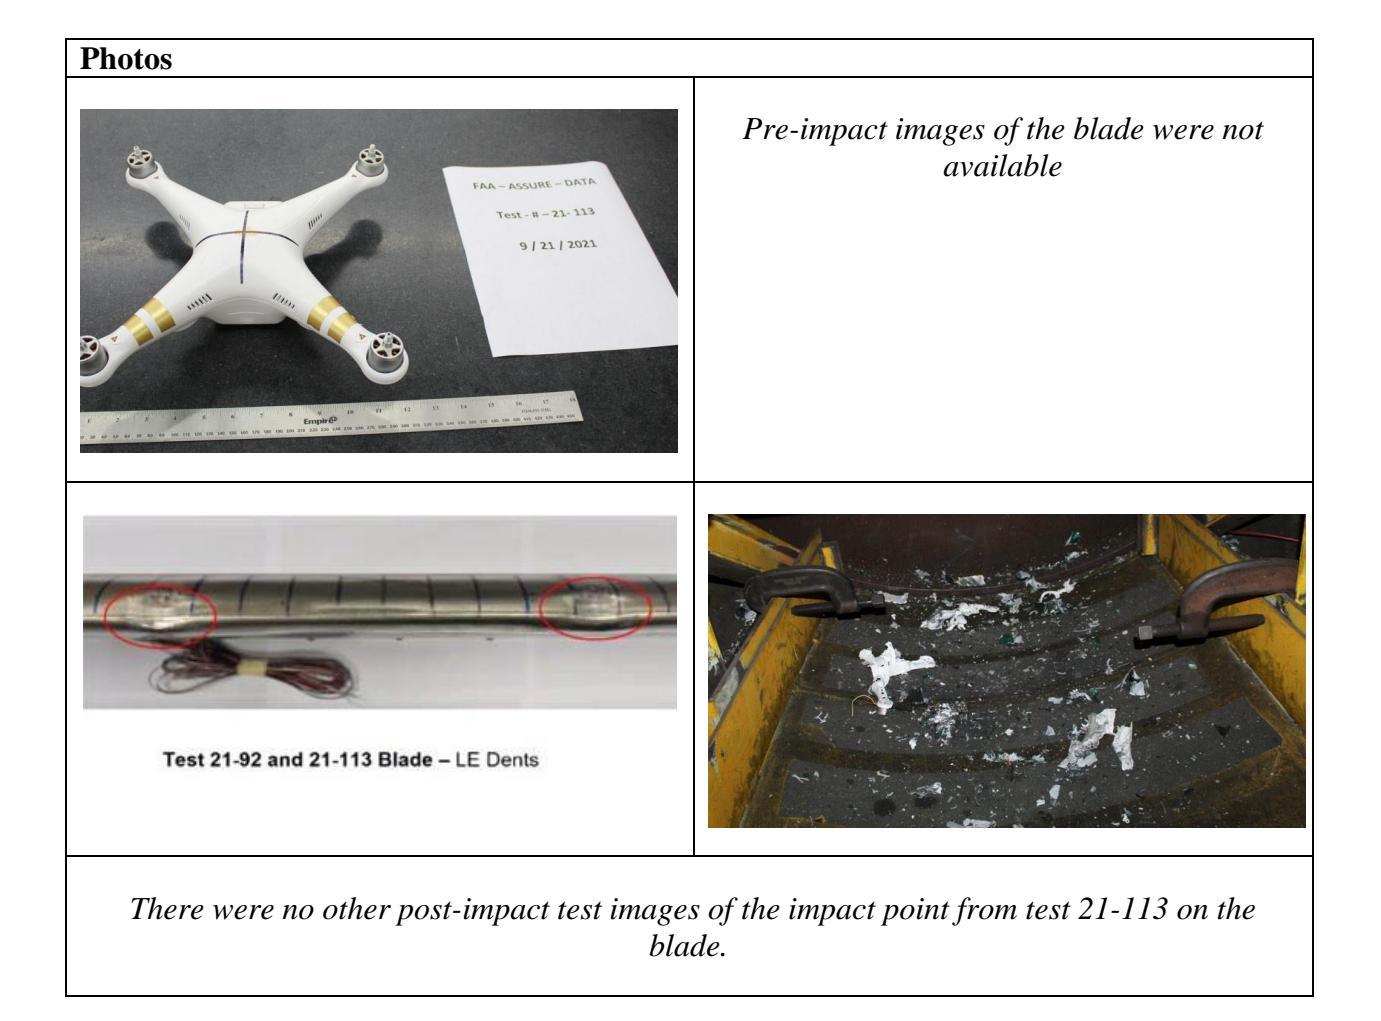
B.4.1.2.3 TEST 2-2 MAIN ROTOR BLADE

The sUAS trajectory was low such that only one motor impact the main rotor blade leading edge. This impact created a second indentation on the blade because there was already a motor impact on the blade leading edge from Test 2-1. After the test was completed, NIAR sectioned the blade at the impact point and observed that the leading edge of the composite spar was crushed, the leading-edge metal rod was deformed and the impact resulted in numerous chordwise fractures within the composite spar structure. There was debonding between the composite spar and the inner foam core of the main rotor blade. The sUAS was destroyed following its impact with the range backstop. Because this blade was sectioned after two impact tests were conducted using it as the target, it is not possible to correlate all damage to specific tests.

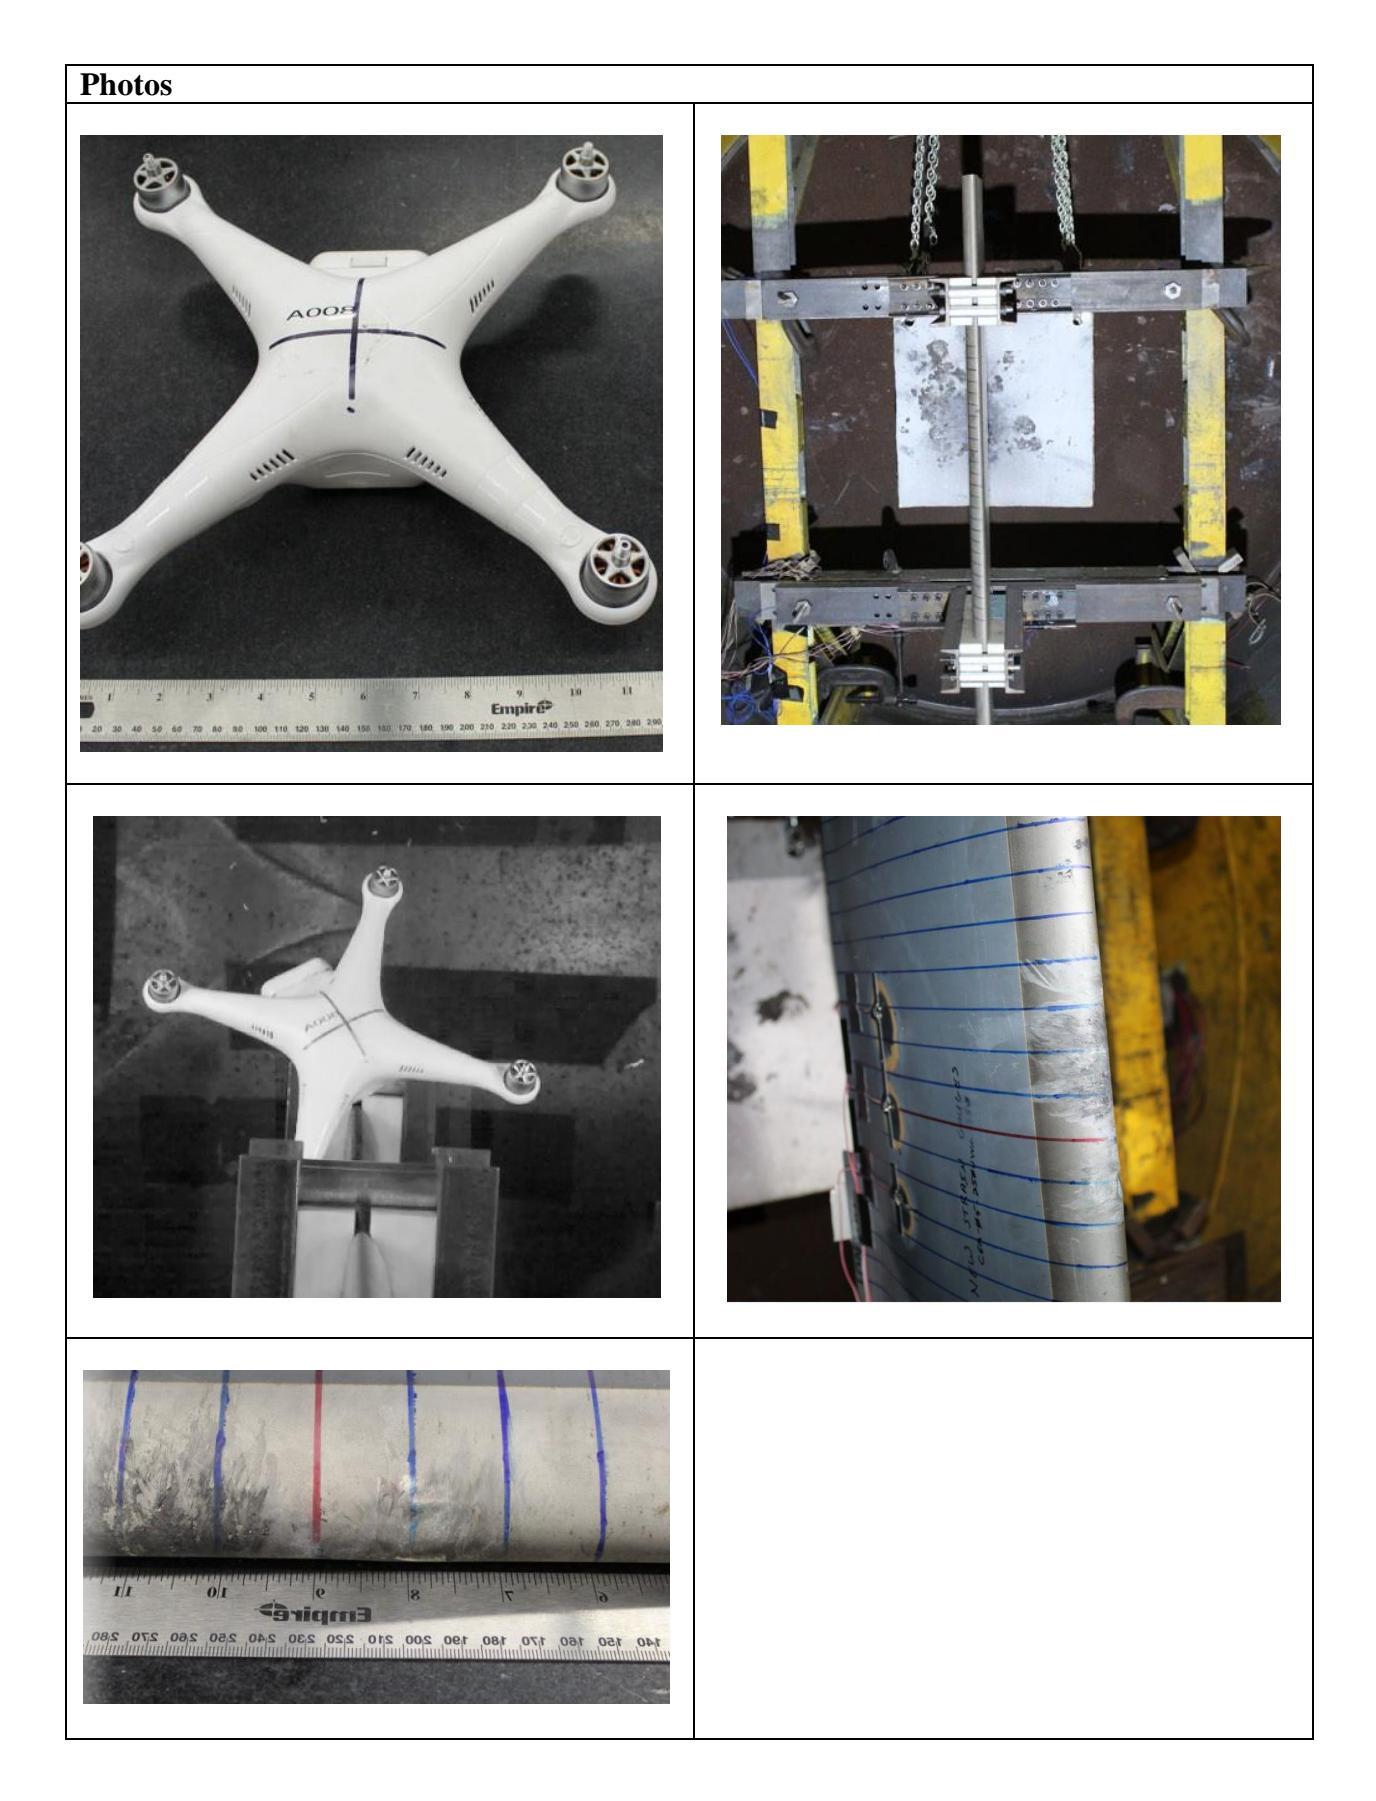
B.4.1.2.3 TEST 2-3 MAIN ROTOR BLADE

Aircraft yaw angle was large based on a poor sabot separation. The sUAS impacted with part of the battery and center body and one motor. There were minor dents in the blade leading edge from the motor impact. The sUAS was completely destroyed and the battery did not pose a "Fire Risk" after the impact.

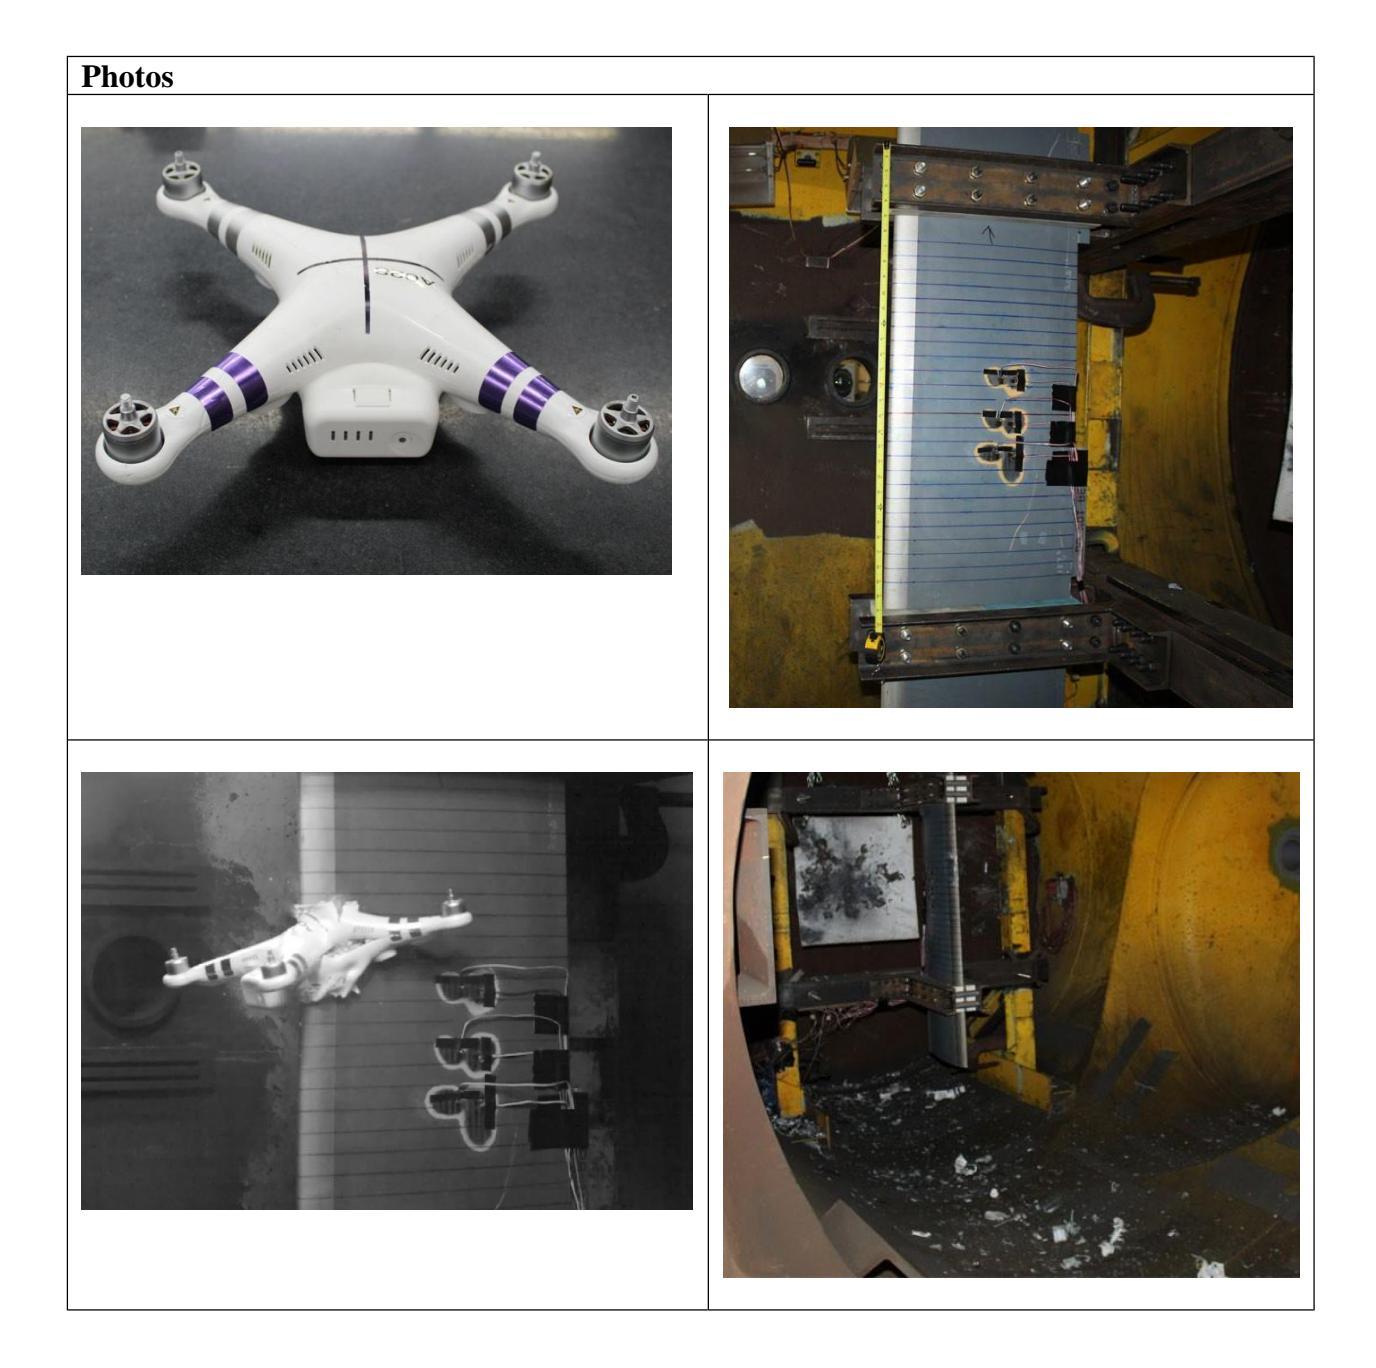
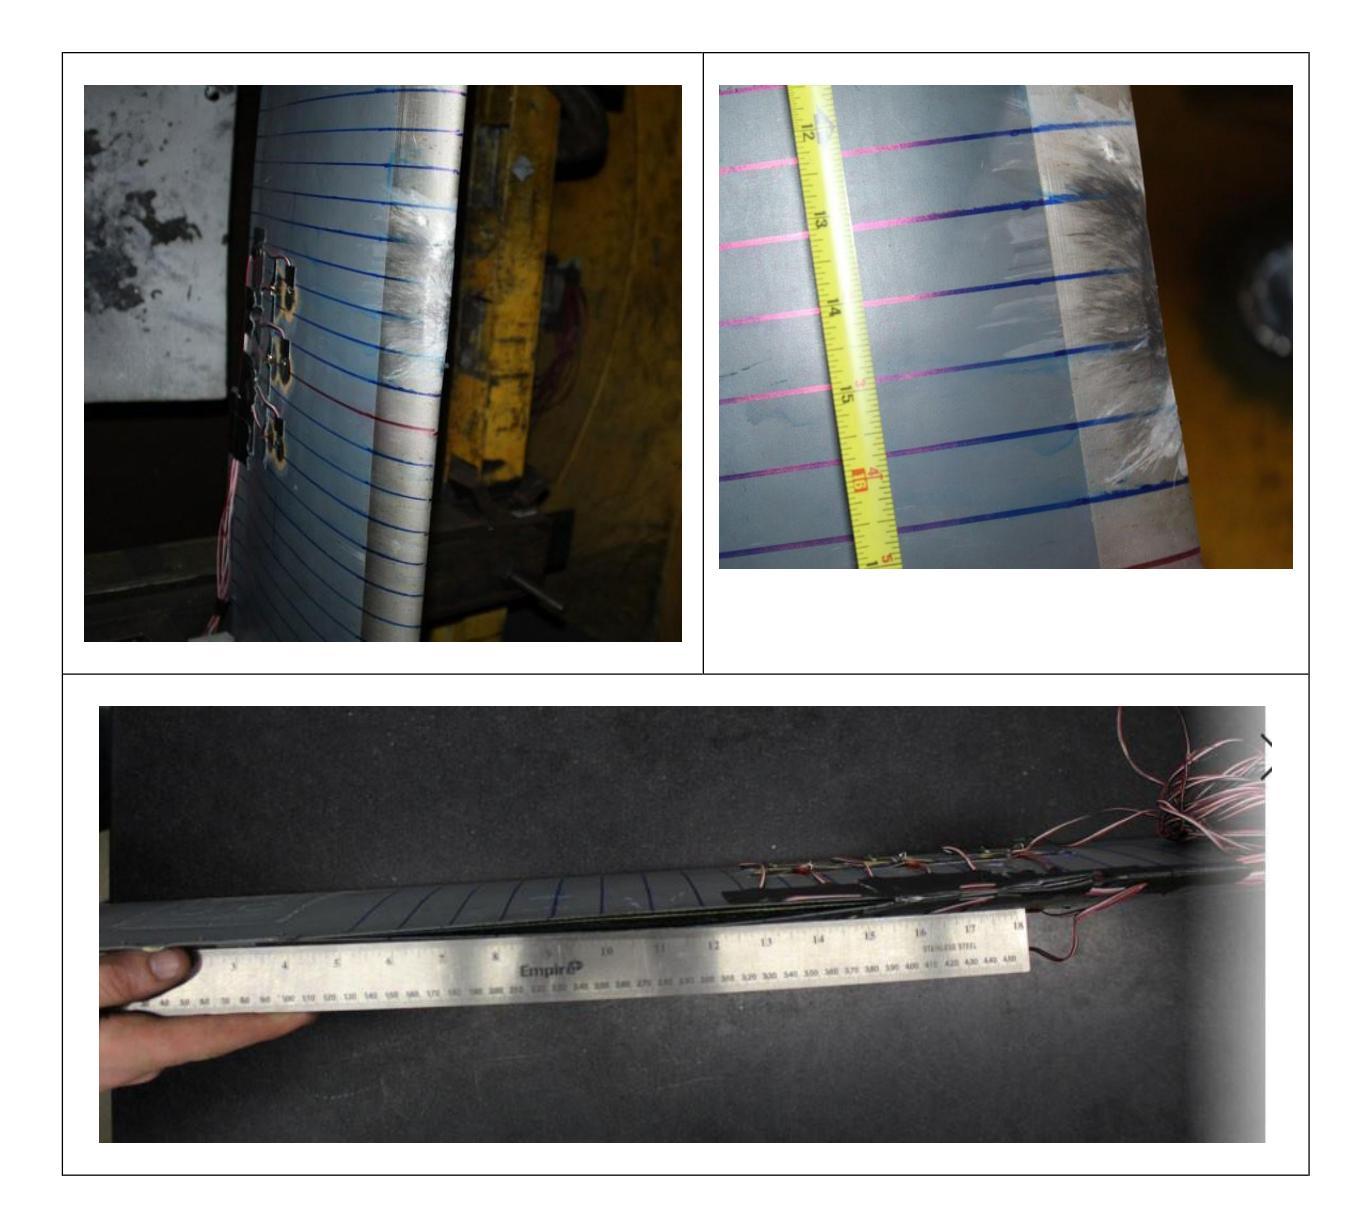
B.4.1.2.4 TEST 2-4 MAIN ROTOR BLADE

The DJI Phantom 3 impacted with roll, pitch and yaw angles within limits and the center body/battery was the only portion of the aircraft that impacted the rotor blade leading edge. The blade flexed during the impact, but only sustained minor leading-edge dents. NIAR's post-impact blade dissection showed that the metallic leading-edge strip debonded from the blade lower surface skin during the impact. The upper and lower surfaces of the blade debonded from the internal foam core. The sUAS impact also caused the trailing edge skin to split open and leave a gap between the upper and lower surface skin on the section directly aft of the leading edge impact area. The sUAS was destroyed and there was no "Fire Risk" based on how the impact destroyed the battery cells.

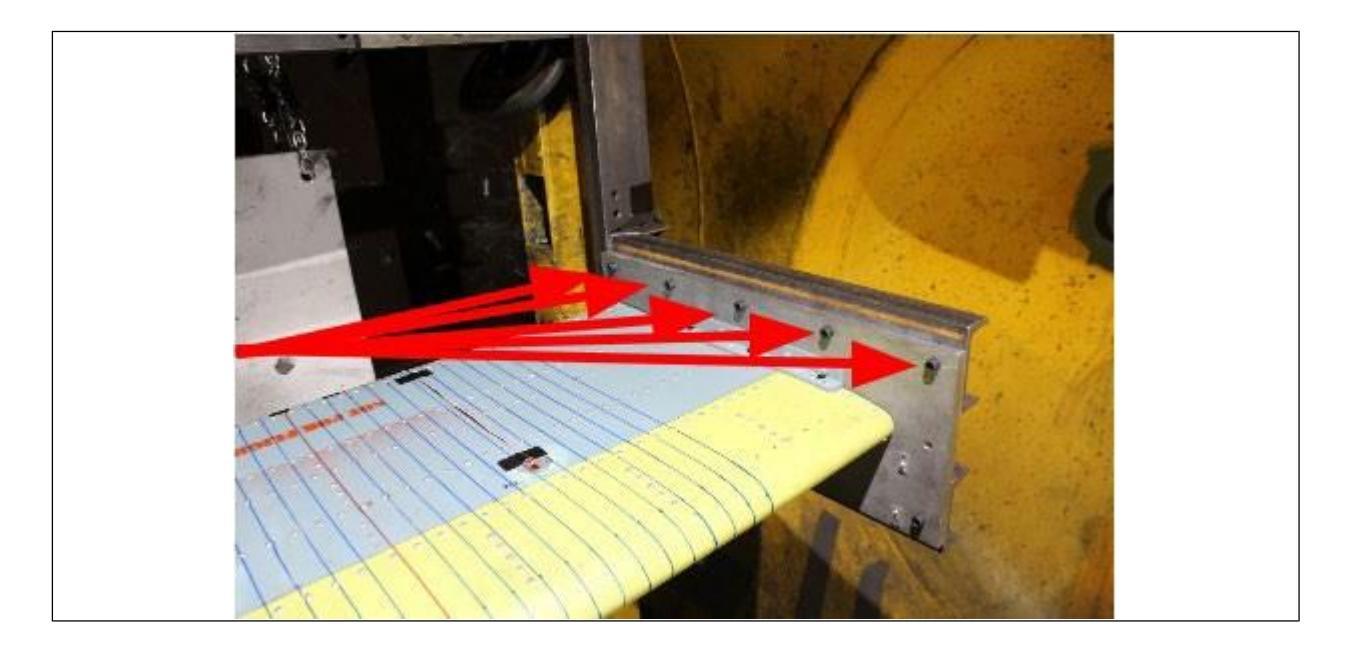
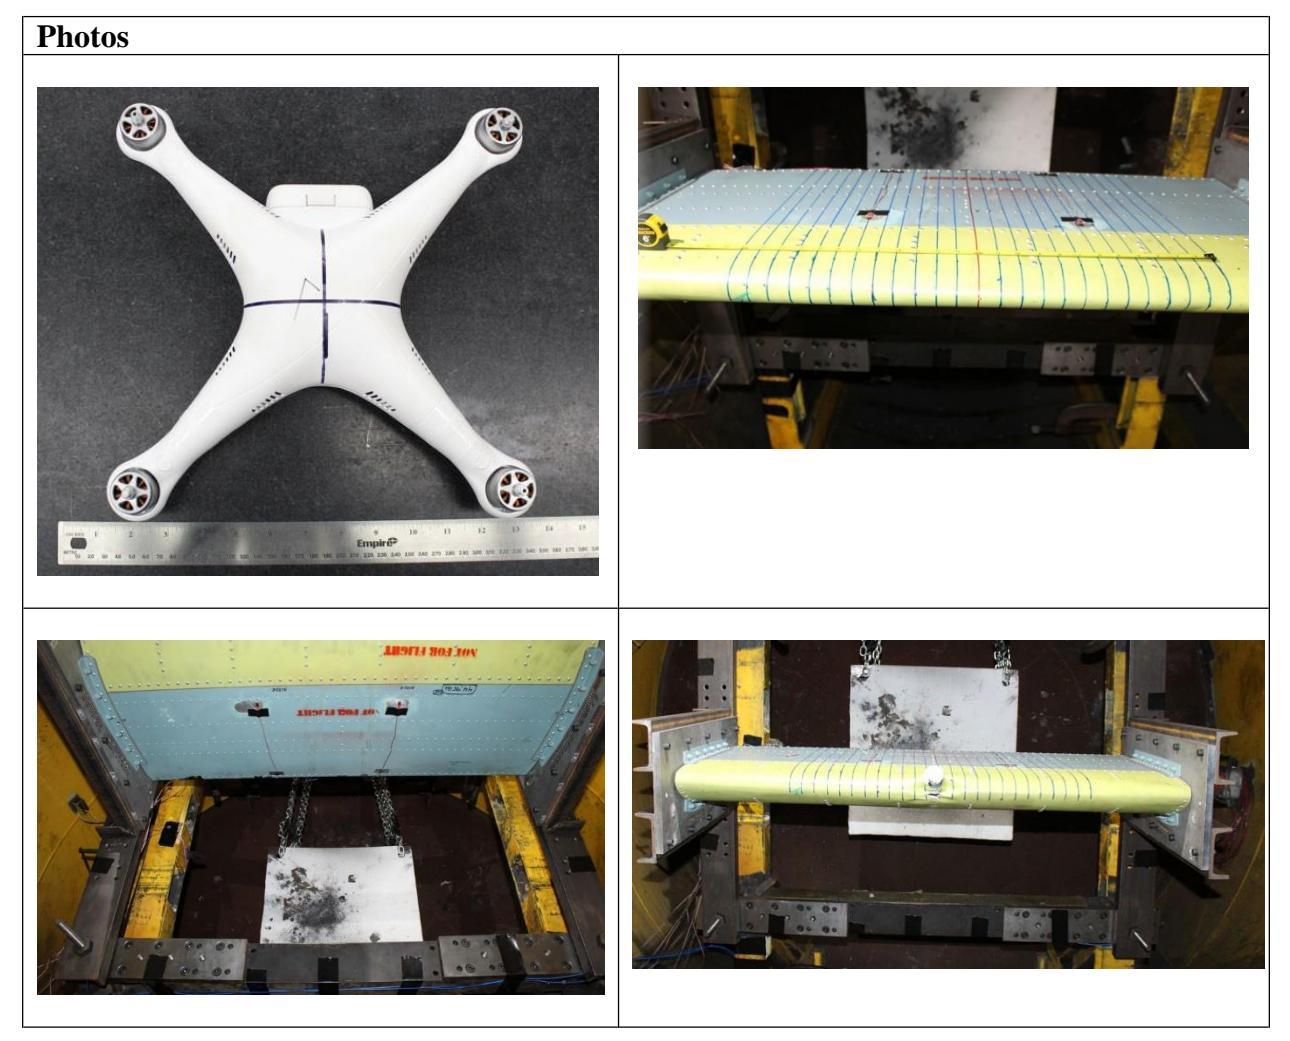
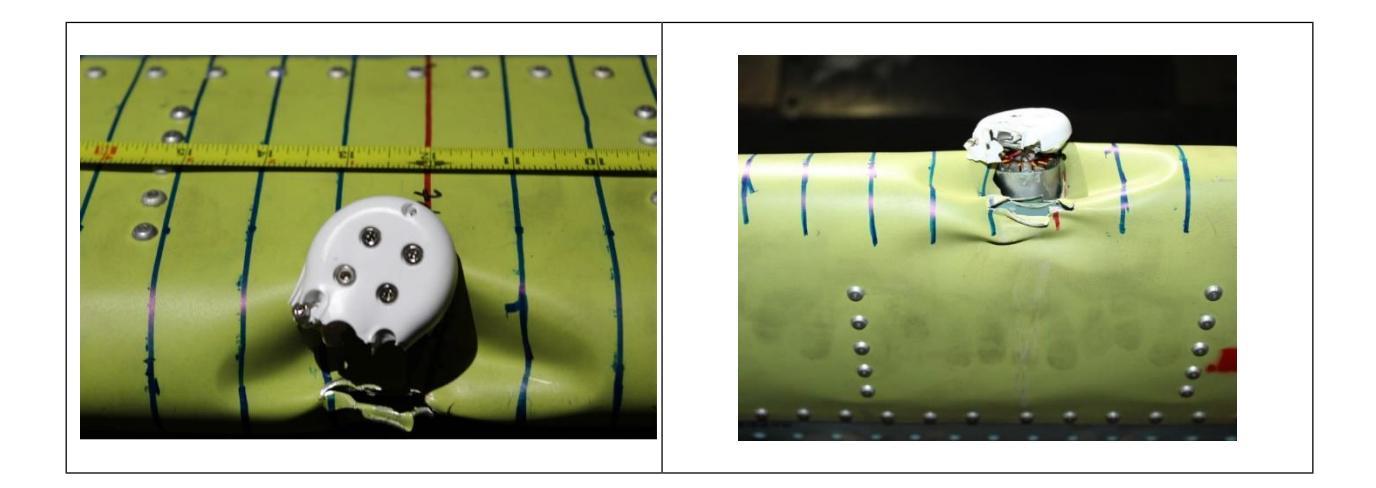
B.4.1.2.5 TEST 2-4 HORIZONTAL TAIL

The center body of the aircraft flew under the horizontal tail and a single motor impacted the horizontal tail. The impacting motor and plastic motor mount broke off of the Phantom 3 and embedded in the leading edge of the horizontal tail. This impact resulted in breaks and dents in the leading-edge skin, but this plastic deformation was limited to a 4.25" span across the leading edge of the horizontal tail.

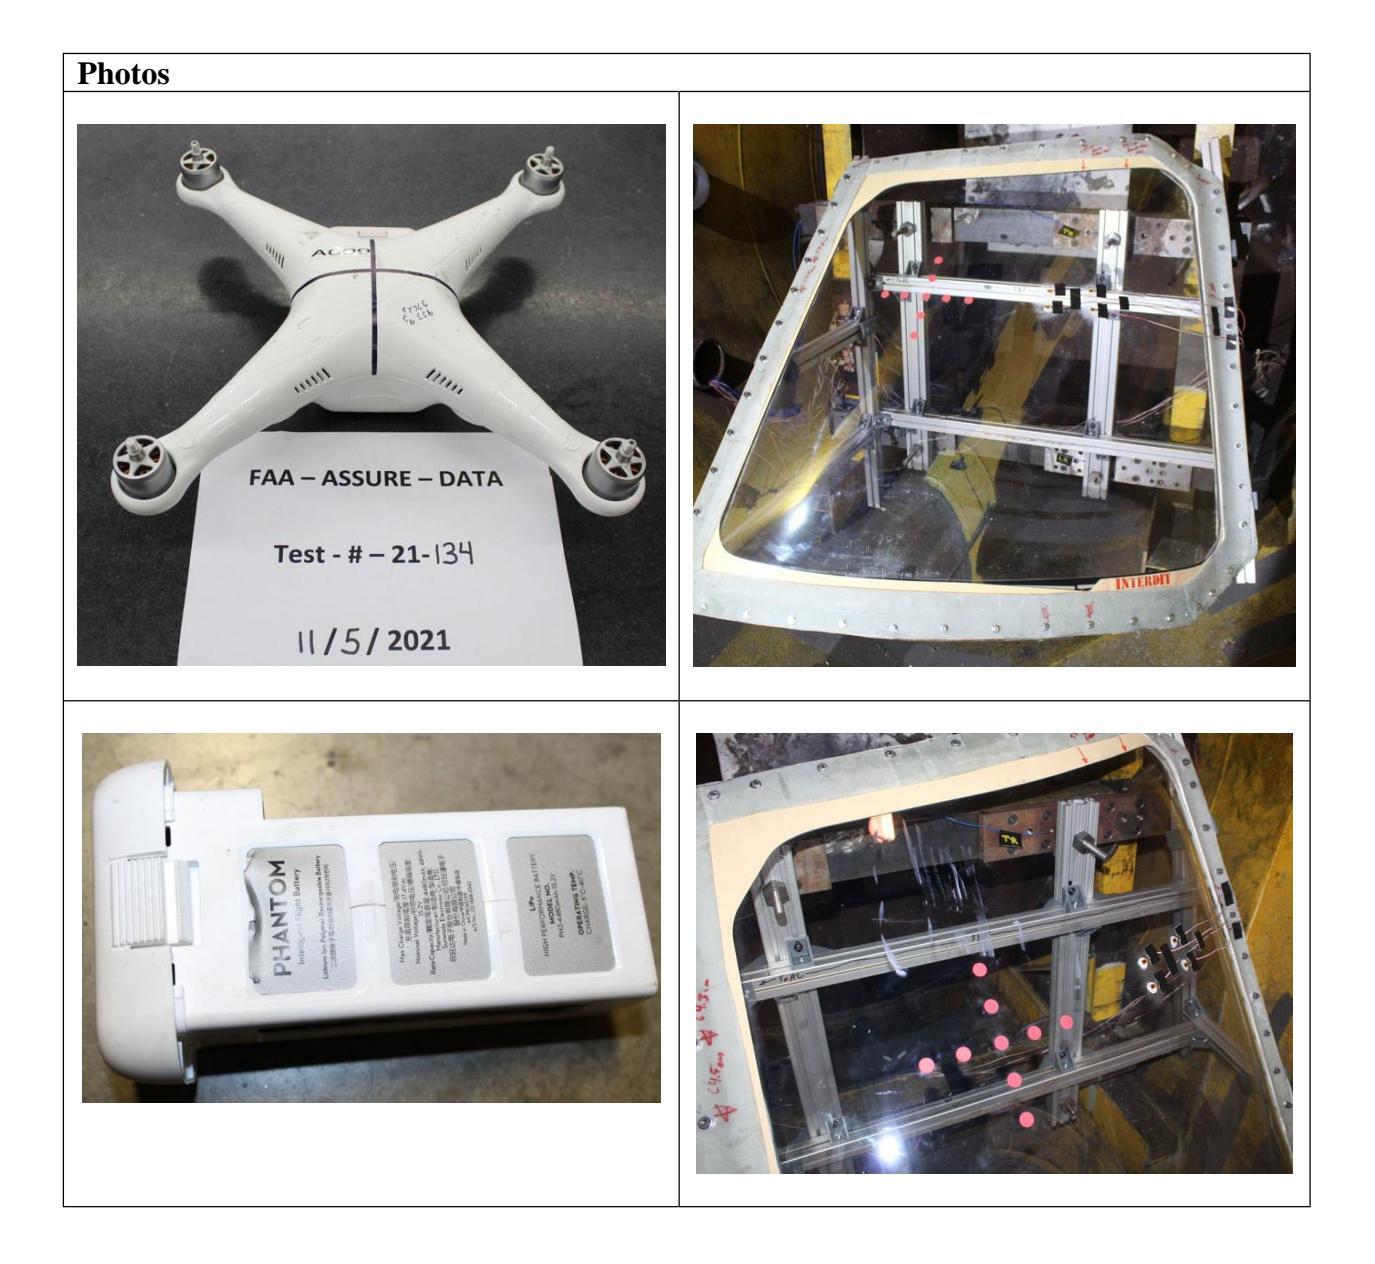
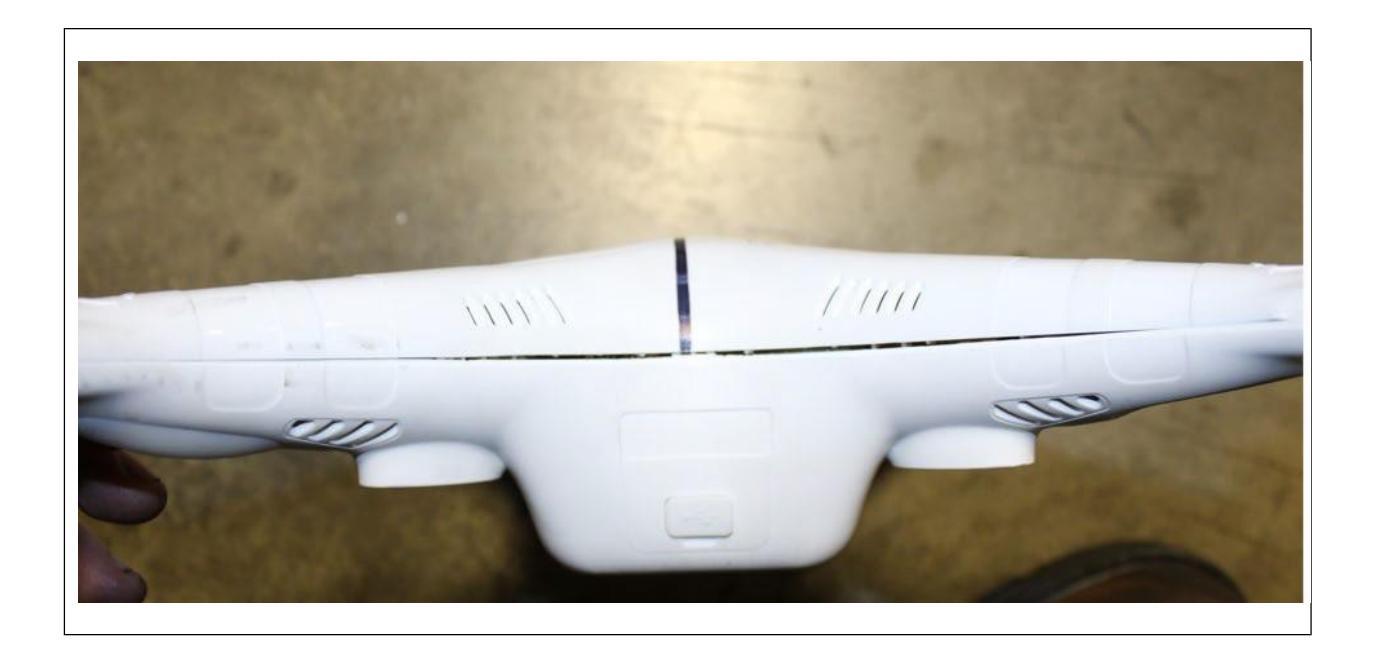
B.4.1.2.6 TEST 5 BI-LAYER WINDSCREEN

The DJI Phantom 3 impacted in a nose-low attitude and the impacting arms deformed during impact. The windscreen surface was scratched, but there was no structural damage to the windscreen the sUAS deflected upwards and landed behind the windscreen. Following the test, the windscreen was inspected for internal fractures in vicinity of the impact point. There were no visible fractures in the windscreen after the impact. There was minor damage to the drone and battery, which is shown in post-impact pictures. There was no post-impact battery "Fire Risk".

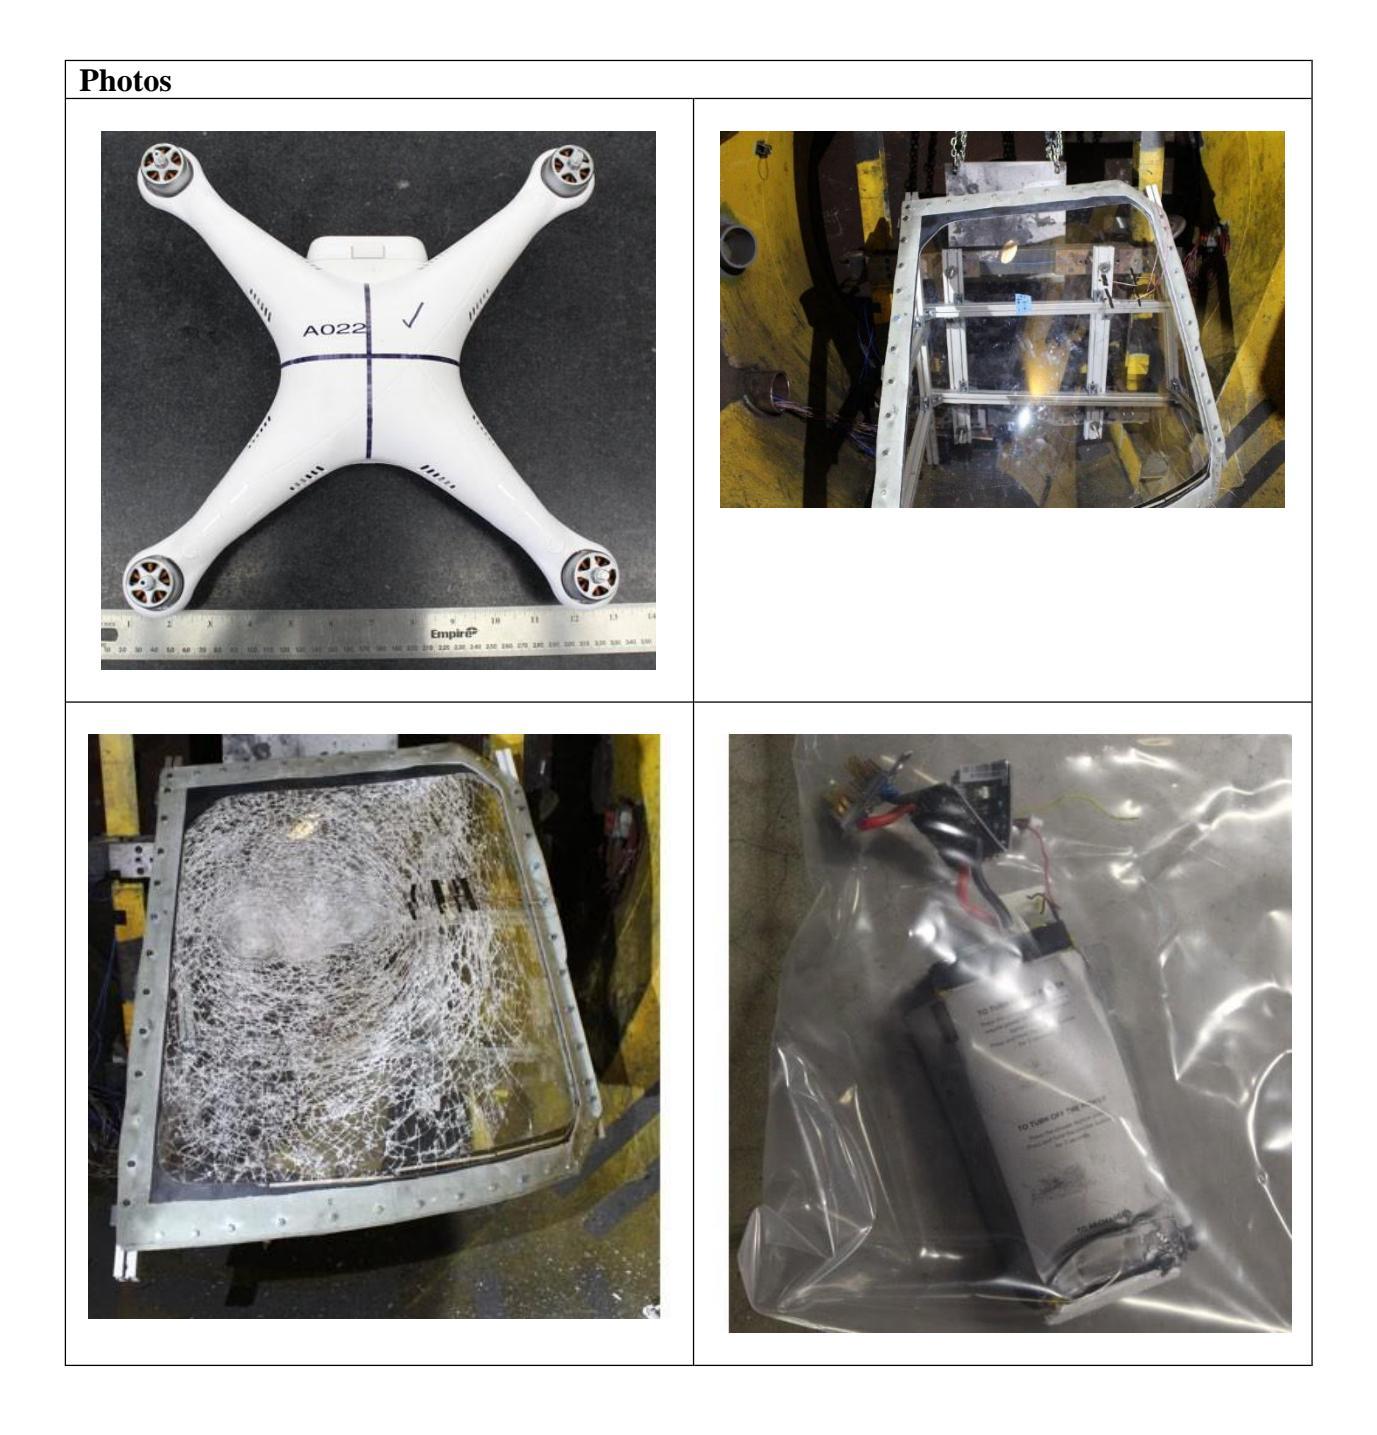
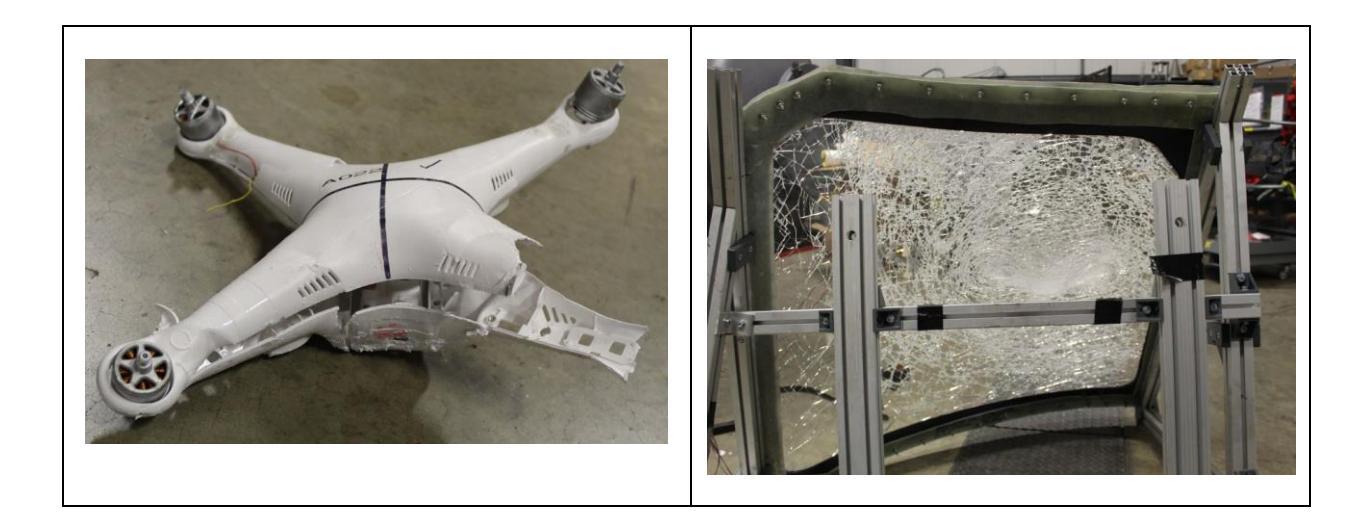
B.4.1.2.7 TEST 6 BI-LAYER WINDSCREEN

DJI Phantom 3 impacted 2 inches below target point. The aircraft upper and lower shells broke apart and the battery was ejected. The battery remained intact and did not pose a "Fire Risk". The aircraft body and battery deflected upwards and would have impacted the lower side of the main rotor in vicinity of the aircraft hub. The aircraft impact shattered >90% of the windscreen glass; however, the film on the inside of the glass remained intact and shards did not break off of the backside of the windscreen.

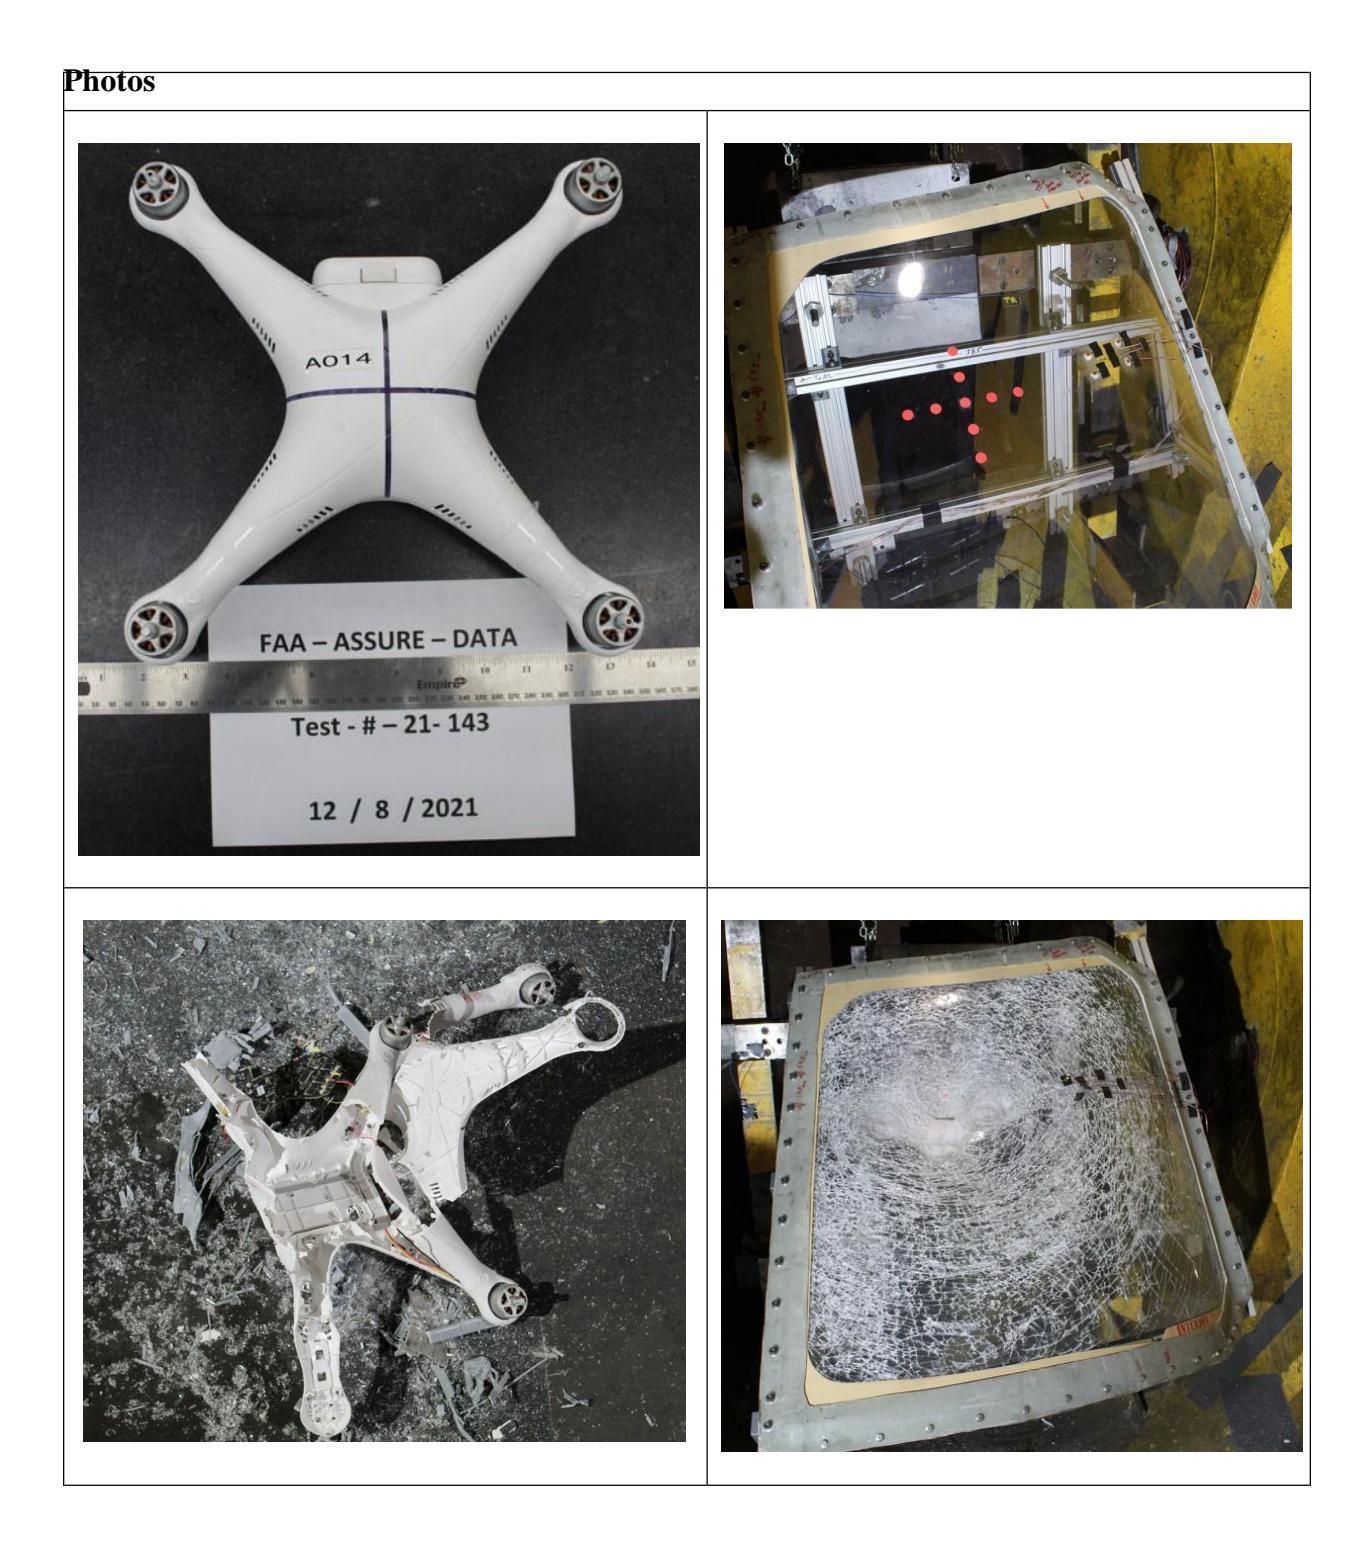
B.4.1.2.8 TEST 7 BI-LAYER WINDSCREEN

DJI Phantom 3 impacted 2 inches below target point. The aircraft upper and lower shells spread apart and the battery was breached the windscreen. As the battery breached the windscreen, the cells broke apart and became a cloud of lithium ion polymer dust on the back side of the windscreen. The front side of the windscreen was shattered and a large cloud of shards and glass dust came off of the front side of the windscreen during and after the impact. The film on the back side of the windscreen broke and glass shards came out of the back side of the windscreen.
